**MASTER MECHANICAL ENGINEERING  
SPECIALITE ADVANCED MANUFACTURING**

**Thèse de Master MENG-AM**

Analysis of welding problem and cracking of bolt hole  
that caused two leakage issues of C84E backlight in PSA

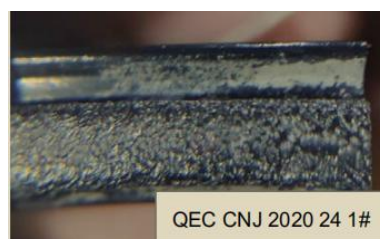
Figure. 1. Incident QEC 12

1. For the 6 defect lights from PSA Rennes, the lens and housing are separated from the welding joint.
2. From the macroscopic side : the surface of the housing welding joint is smooth.
3. There is no other material left over the housing welding line.

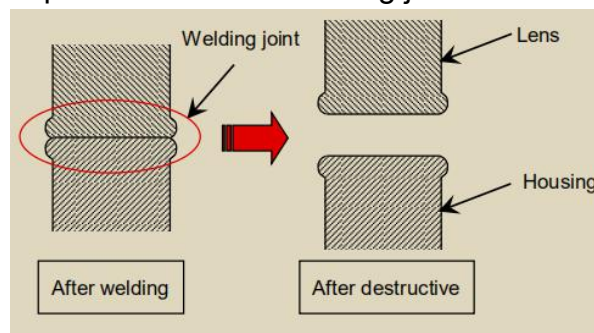
Here is a figure. 7. that shows the welding problem. After the welding, because of some reasons unknown, the welding force is not strong enough which makes the lens and the housing separated from the welding joint.

Figure. 7. Simulation of welding condition and after destruction of welding, this is for seeing the place of breaking

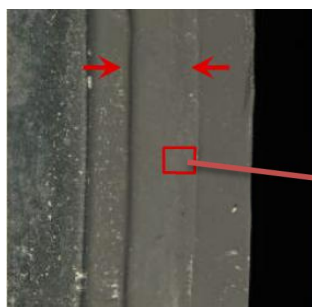
The two figures Figure 8 & Figure 9 show the surface of the joint after the separated, it's obviously that the surface is smooth and there isn't so much material left on each side.

Figure. 8. Surface of the joint separated, the surface is mainly smooth

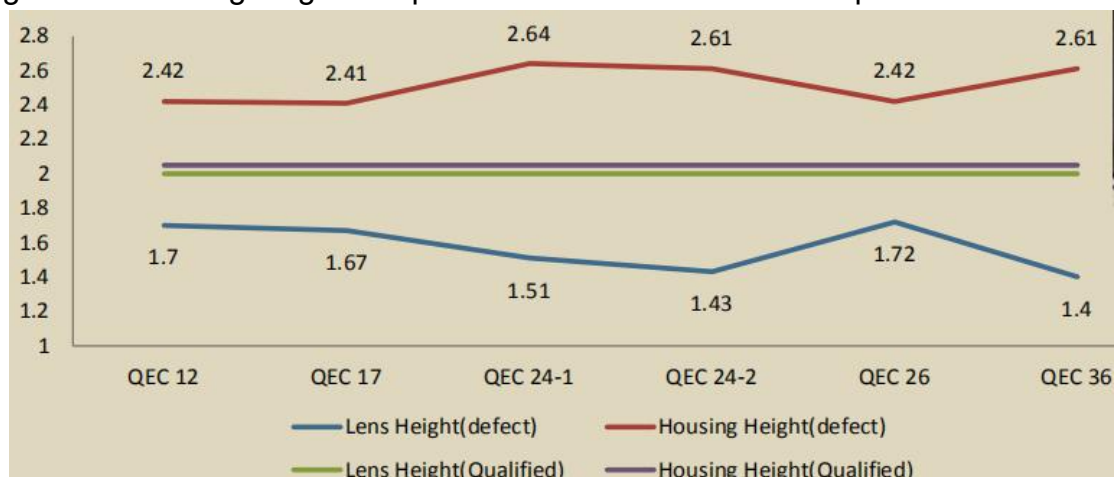
Figure. 11. Comparison of welding height statistics of each fault light and qualified welding height

We summary the measurement result for the welding line height of the lens and housing, and to compare with the qualified light. For the defect light, the height of the lens after welding is lower than qualified. And the height of the housing after welding is higher than qualified.

The connected material is obviously little, so here in this area the water will come in. The strength between the welding joint are insufficient because of the badly welding condition.

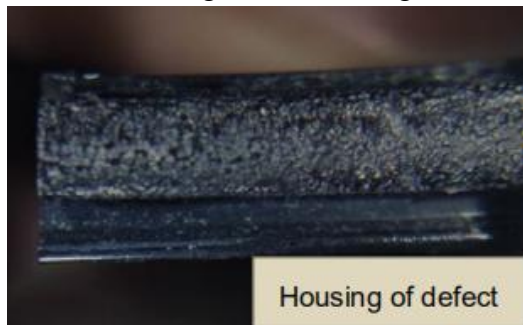
When the supplier got the defect light, further visual inspection result: the welding quality of this light is very poor, the lens and housing was separated from the welding joint. Shown in figure 12 and figure 13.

Figure. 12. The surface of defect housing of QEC 17 after destruction

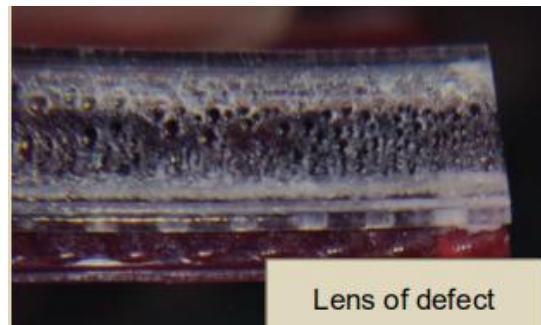
Figure. 13. The surface of defect lens of QEC 17 after destruction

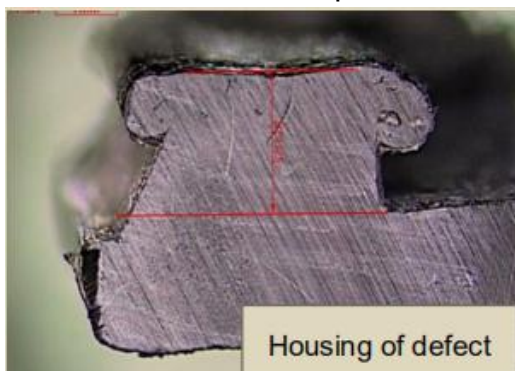
Figure. 14. The section view of defect light housing of Incident QEC 17

1. The welding line height of the housing for the defect light is higher than the qualified light.
2. And the welding line height of the lens for the defect light is lower than the qualified light.

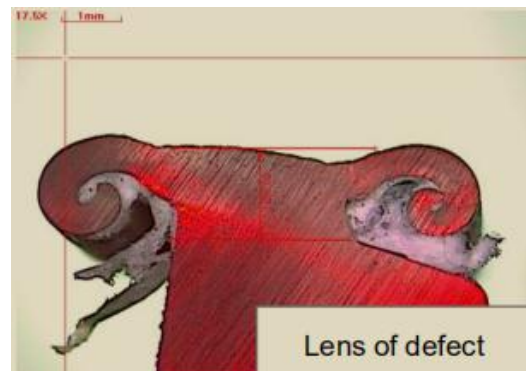
Figure. 15. The section view of defect light lens of Incident QEC 17

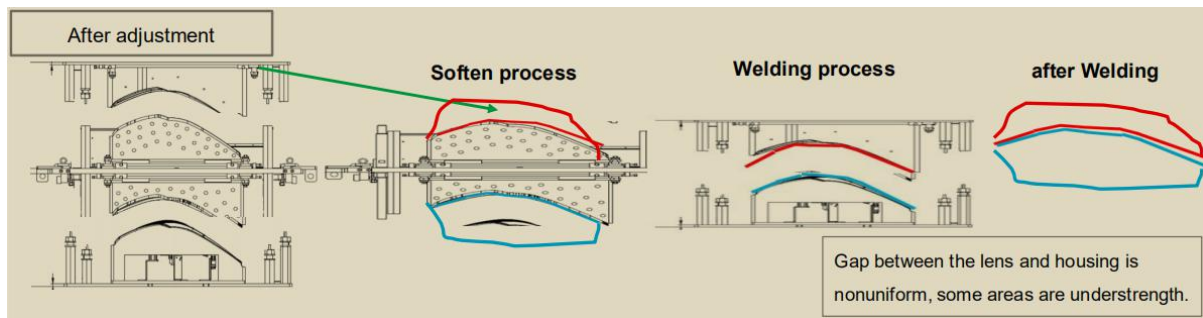
In soften process if the red part is badly matched with the hot tooling and certain part is melted more some part is melted less. This can be caused by different reasons, for example during a long time of working, the height of the mandril will have some changes. If the technician didn't adjust it in time, there will be some defective lights product.

We can see the welding effect is bad. They are not perfectly matched. Some parts might have a gap, but these lights won't be able to delivered to PSA since they are picked out in the process of leakage checking.

Figure. 25. The bad situation of soften process, welding process and after welding, the green and blue lines are connected badly with a gap between them

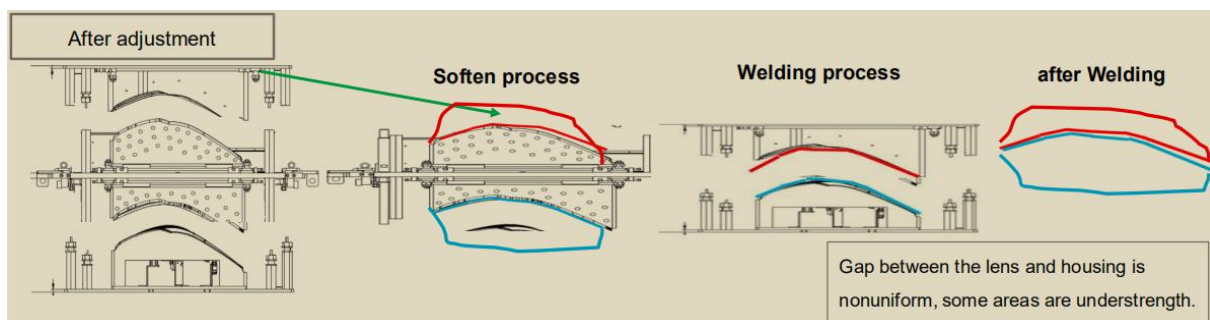
Then after the hot tooling is draw back, the red line which is the lens welding circle cannot matched well with the blue line which is the housing line. That is to say during the soften process, the lower area is soften more and the higher part is soften less. In a easier condition, supposing the housing welding circle is soften perfectly and averagely, when they weld, the more soften part will be connected easily and the less soften part won't be able to connected fully of its materials. The more soften area is too soft to hold the material, so it is pushed more and the material is squeezed out. And the less soften part is too hard to weld well, so this area is also poor adhesion. So in both areas the welding strength is weak.

Figure. 25. The bad situation of soften process, welding process and after welding, the green and blue lines are connected badly with a gap between them

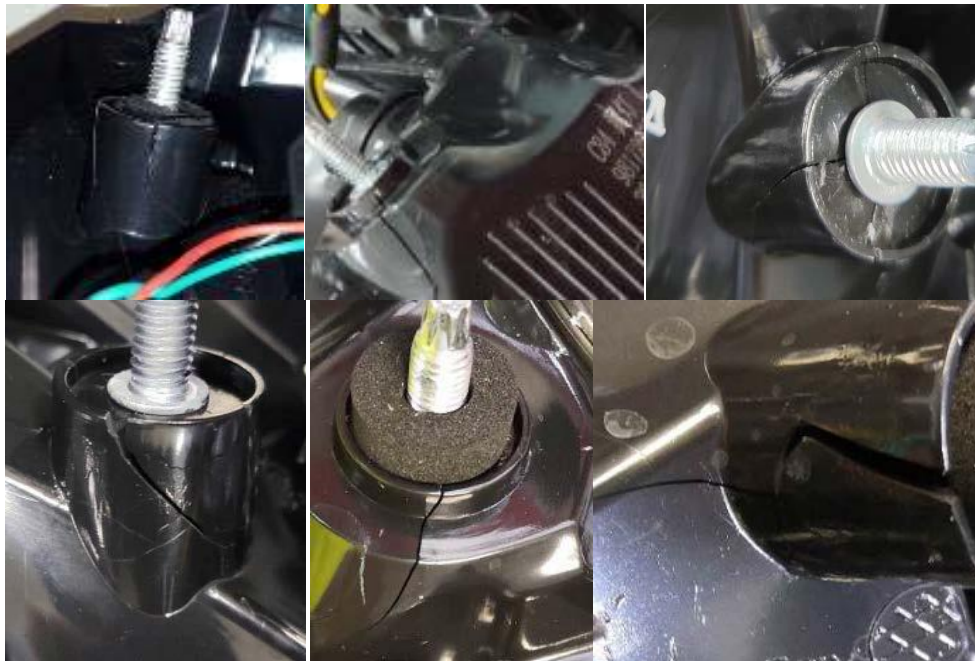
Figure. 29. Cracking situation

The water was entered from the bolt hole.

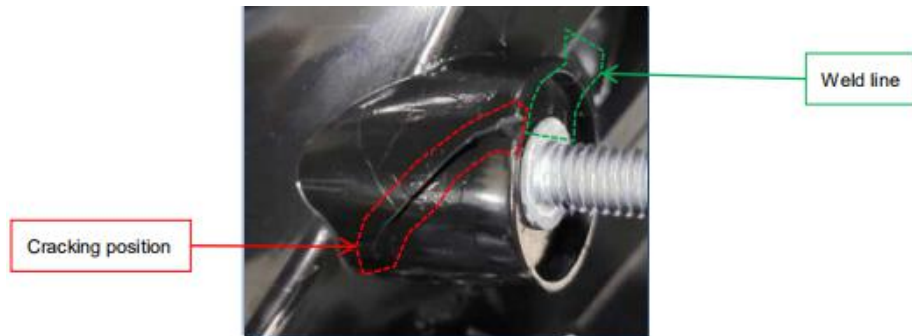
Checking the cracking position to see if it is the weld line. In the figure 37 the green area is where the weld line lies and the most serious cracking part is marked by the red line.

Figure.37. Cracking position and weld line position

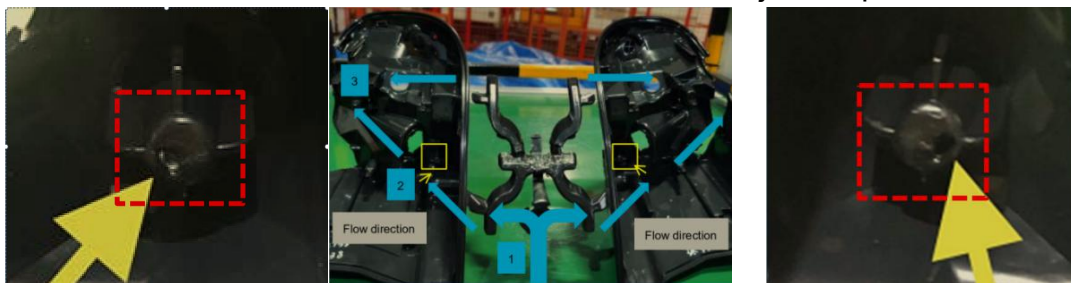
Figure. 45. R: bolt column not formed Figure. Inlet gate Figure. 46. R: bolt column not formed

From the process of injection, the bolt column hasn't formed in the position 2 while the position 3 has already formed. This means that there is some problems during the injection process. The problem is that the injection material isn't pure, that is to say some gas might be trapped inside the material. And since the position 2 is higher than other part so the gas is pushed in the end of the position 2. And finally under the high pressure, the gas caused the material couldn't form well.

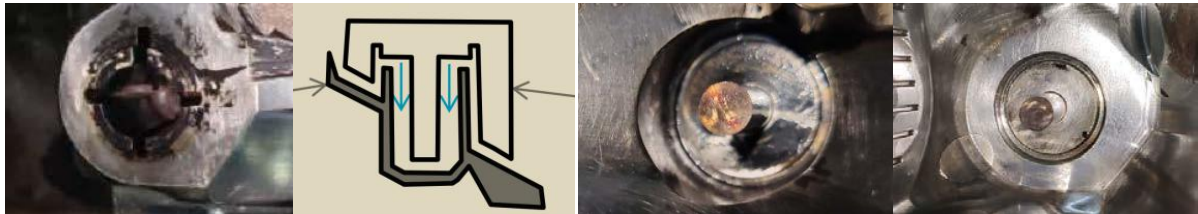
The surface of bolt hole tooling is scorched due to gas trapped shown in figure 47, because the gas will increase their temperature with the increasing of pressure and decreasing of volume. So it's better to add a gas exhaust structure design at the bolt hole. Figure 48 shows normal condition without scorching.

Figure. 47. The grey part is sealed

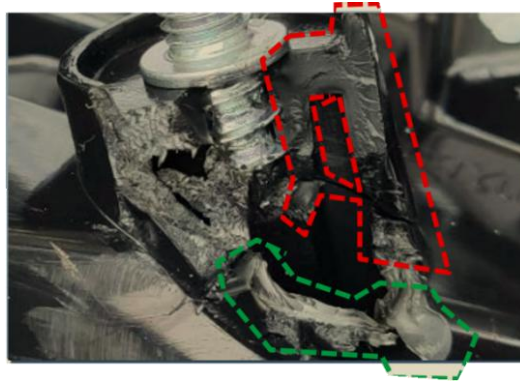
2) The green part is the not cracking part, the plastic turns white after being cracked manually with stress. Figure. 51.

Figure. 51. Compare of cracking and after stress cracking

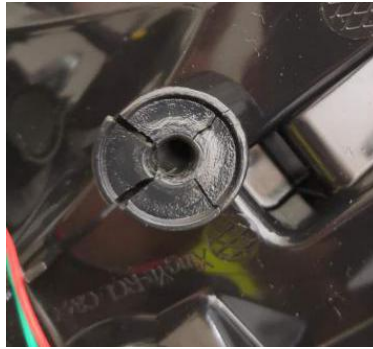
The supplier got less lights for doing the analysis, they didn't have enough lights to verify the situation. However, as a resident in PSA, I have checked many defective lights after sorted by Trigo. There are about 25 defect lights found cracking. It is sure that it was the bad injection that caused this issue. Because I checked each light cracked in the factory. For each light, the most serious cracking part is the same. Figure. 57. If the start cracking position is the most cracking area, then it is sure that they all caused by one same reason. This reason is injection process defect, either because when they start a day after stopped using their machines, the material might mixed with air in the beginning, or the material wasn't cool down well or concreted well. In this condition the material will be fragile so the cracking can happen with some vibration or torsion.

Figure. 57. Cracking situation after dismount the bolt
