Inspection Pictures

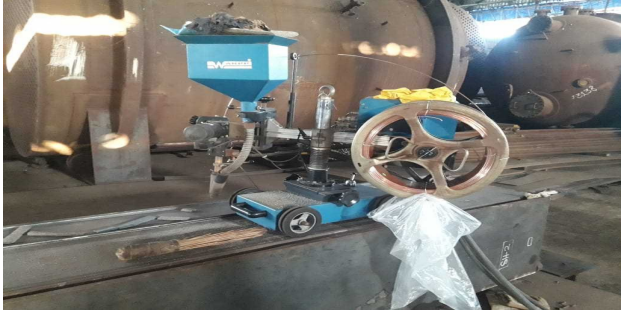
visual inspection

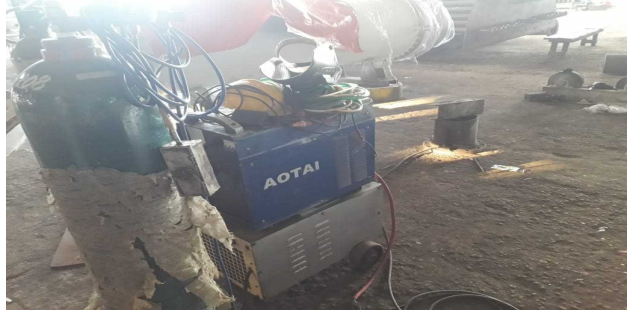
visual inspection
