adf

Client: adf  
Date: 2026-02-20

## EXECUTIVE SUMMARY

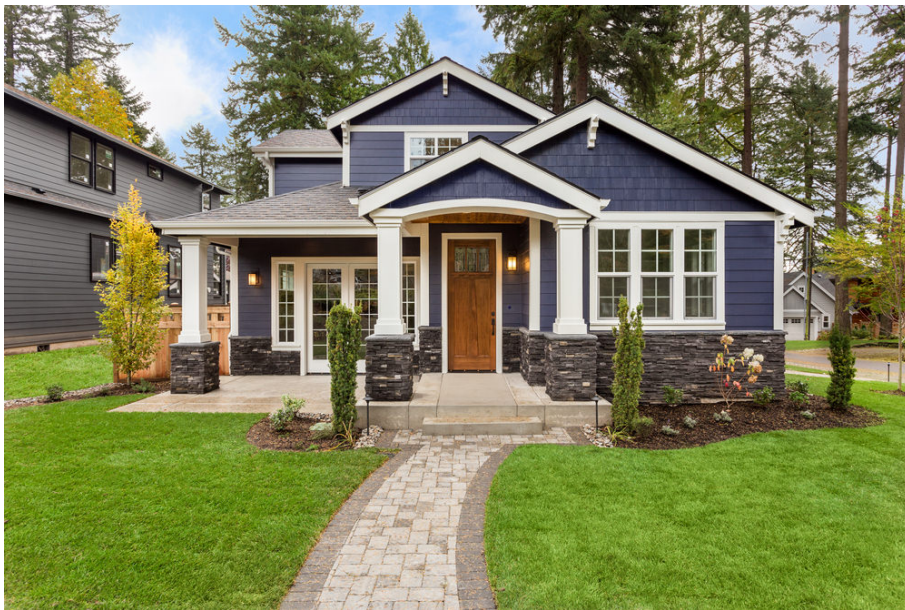
**Photo 1: Item of Interest**

**Observation:** A two-story house with dark blue siding and white trim, well-maintained landscaping, and visible materials in

**Condition:** Good

Observed the exterior of a two-story house with a dark blue siding and white trim. Noted the presence of well-maintained landscaping with green grass and small shrubs. Visible materials include shingles on the roof, stone accents around the foundation, and a wooden front door with glass panels. The overall condition rating is Good, with no visible defects, damage, or deterioration noted.

**Recommendation:** None

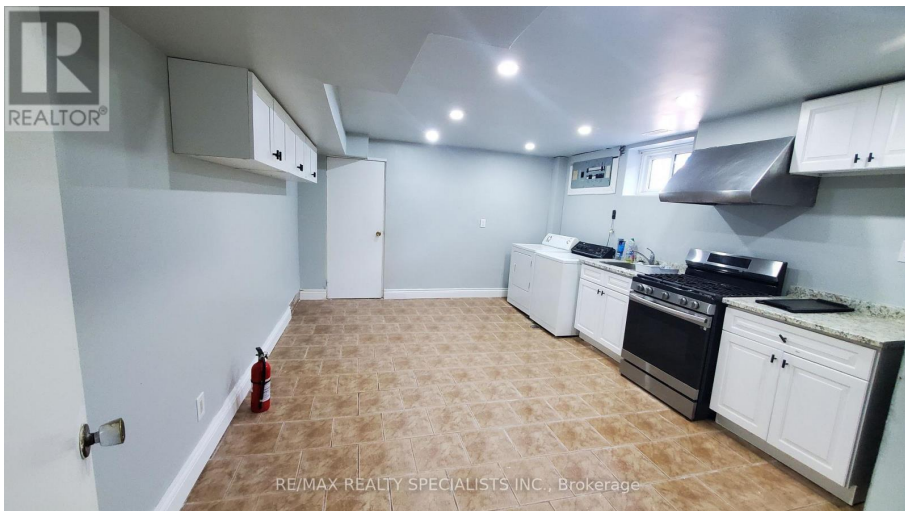
**Photo 2: Item of Interest**

**Observation:** A kitchen with white cabinetry, a stainless steel range hood, a fire extinguisher on the floor, a tiled floor, and

**Condition:** Good

Observed a kitchen with white cabinetry and a stainless steel range hood. Noted a fire extinguisher on the floor, indicating a safety measure is in place. Visible is a tiled floor and a white door, suggesting a functional and clean environment. The overall condition rating is Good, as there are no visible defects, damage, or deterioration noted.

**Recommendation:** None

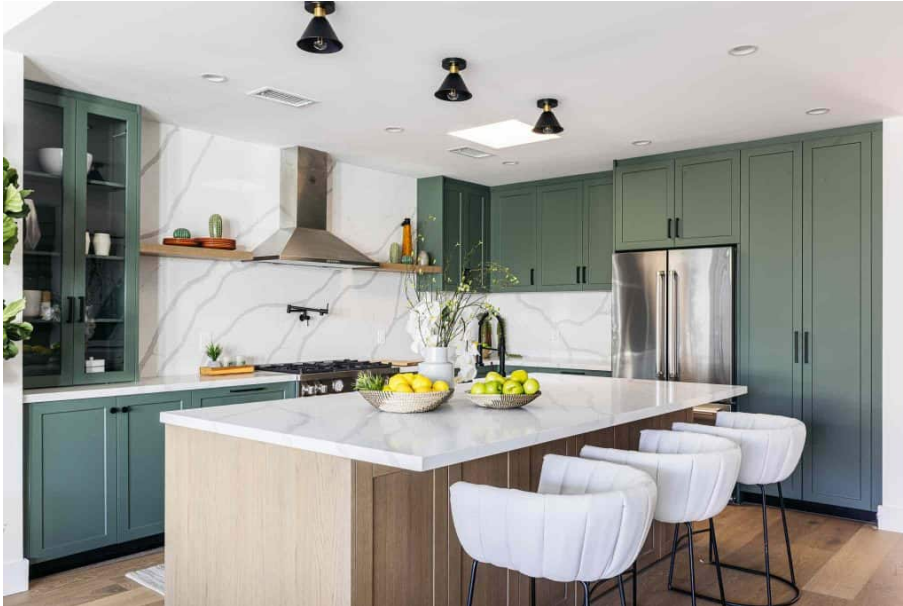
**Photo 3: Item of Interest**

Observed a modern kitchen with green cabinetry and a white marble countertop. Noted the presence of a stainless steel refrigerator and a central island with white bar stools. Visible materials include wood, metal, and glass. The overall condition rating is Good, with no visible defects, damage, or deterioration noted.

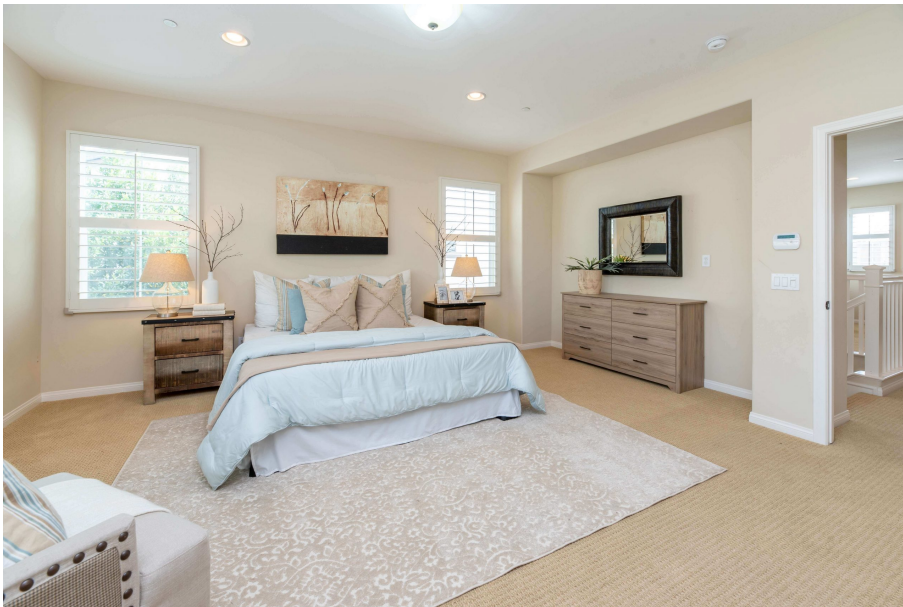
**Photo 4: Item of Interest**

Observed a well-maintained bedroom with neutral color tones and modern furnishings. Noted a large bed with a neatly arranged bedspread and decorative pillows, two nightstands with lamps, a dresser with a mirror, and a patterned area rug. Visible materials include wood finishes on the furniture, carpeted flooring, and a light-colored wall. The overall condition rating is Good, with no visible defects, damage, or deterioration noted.

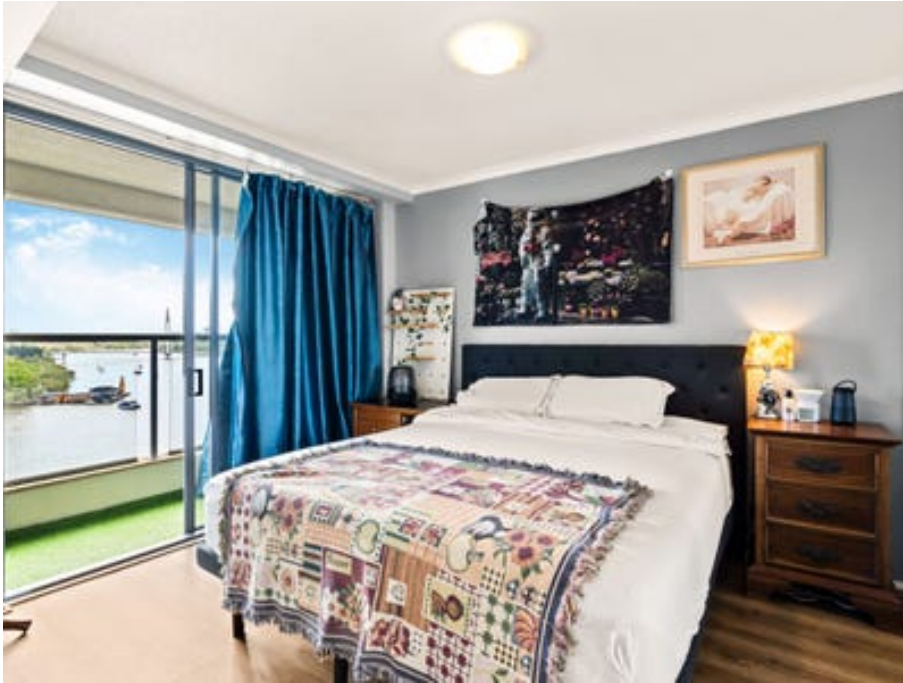
**Photo 5: Item of Interest**

Observed a well-maintained bedroom with a large bed, a nightstand, and a window with curtains. The bed has a patterned quilt and a white comforter. The window provides a view of a body of water. The overall condition rating for this room is Good, with no visible defects, damage, or deterioration noted. The materials and construction elements appear to be in good condition.

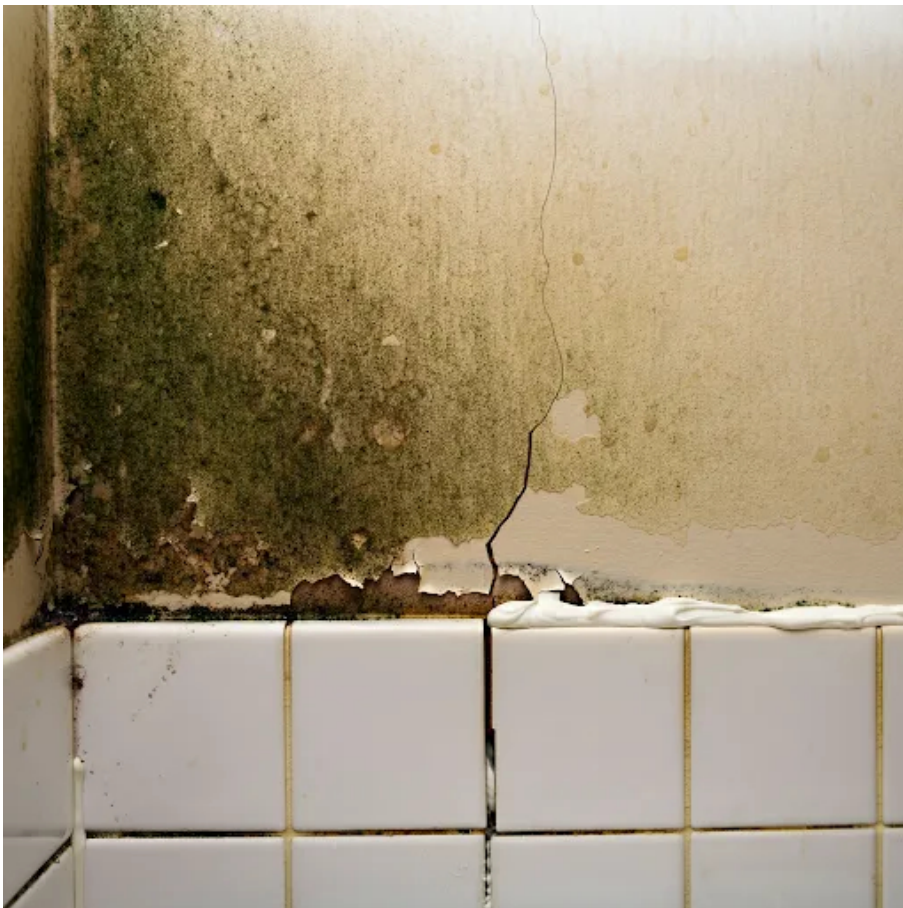
**Photo 6: Item of Interest**

Item of Interest: Bathroom Wall and Tile

Observed significant mold growth on the wall, particularly in the lower left corner, indicating prolonged moisture issues. Visible cracks in the wall and grout lines suggest structural weakness and potential water infiltration. The tiles appear intact but show signs of discoloration and possible efflorescence, likely due to water exposure. The overall condition rating is Poor, as the visible mold and structural cracks indicate a need for immediate remediation and repair.

Materials and construction elements visible include standard bathroom tiles and a wall with a visible crack.

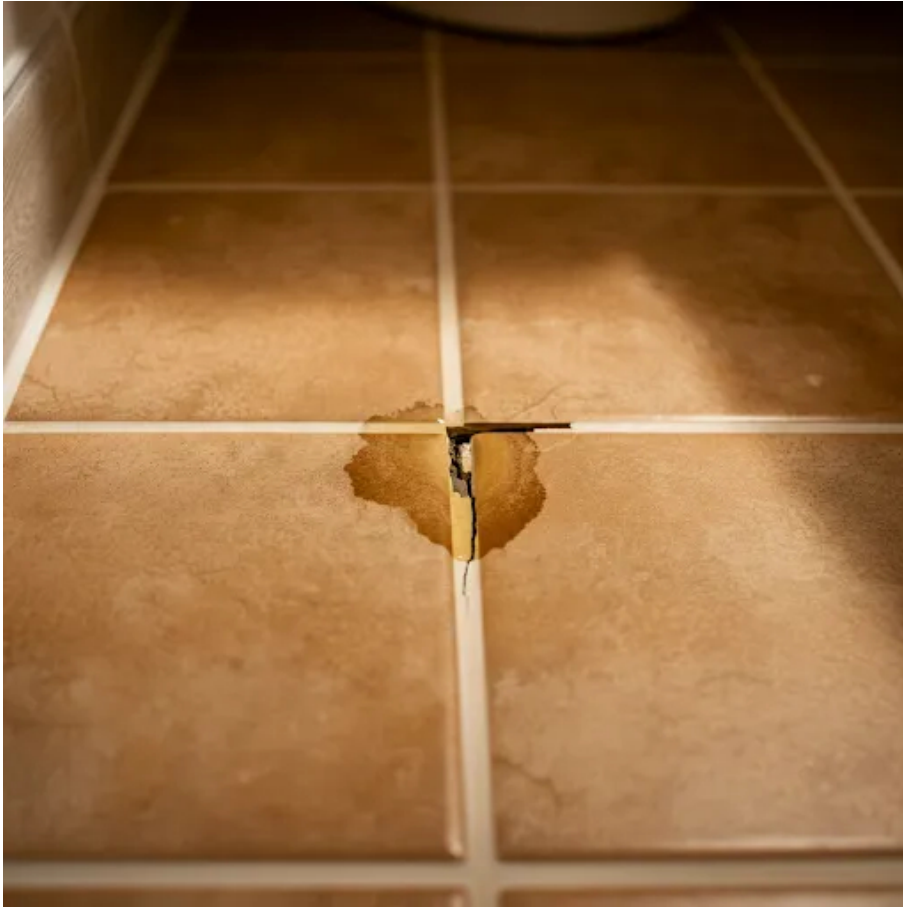
#### Photo 7: Item of Interest

Item of Interest: Floor Tile

Observed a noticeable crack running through the grout line of a floor tile. Visible water staining is present at the base of the crack, indicating potential moisture intrusion. The surrounding tiles appear intact, with no other visible defects.

Materials and construction elements: Ceramic floor tiles, grout, and possibly a subfloor beneath the tiles.

Overall condition rating: Fair. The crack and water staining suggest a need for repair, but the rest of the floor appears to be in good condition.

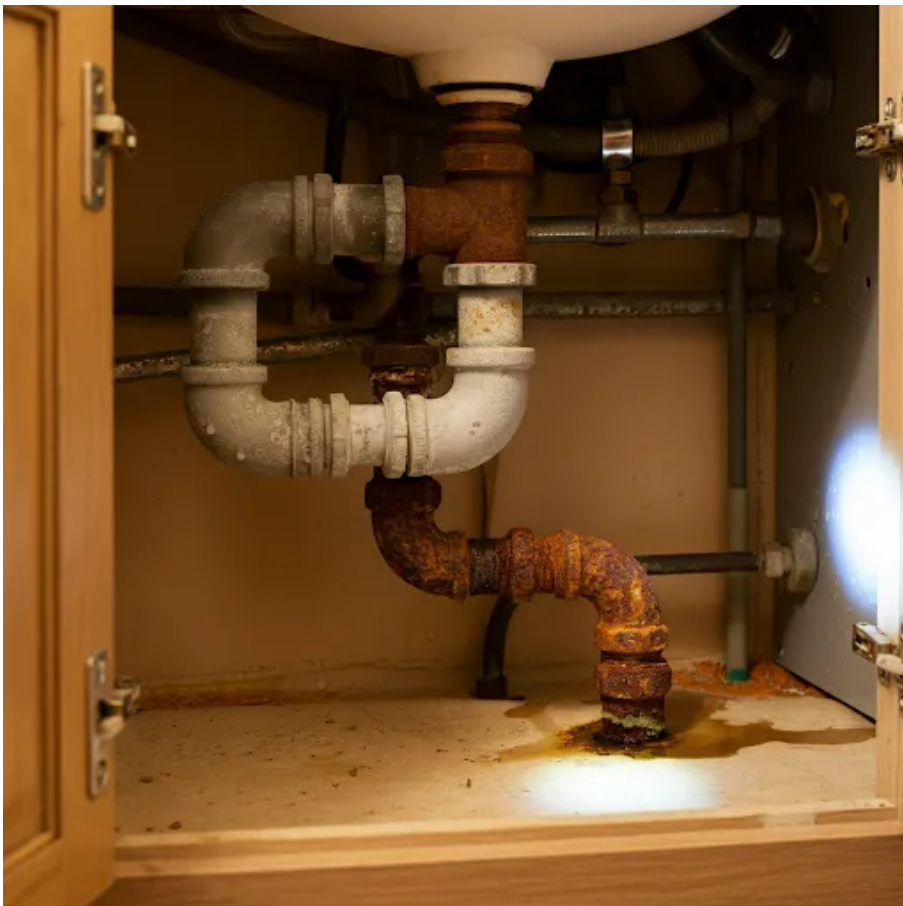
#### Photo 8: Item of Interest

Item of Interest: Plumbing System

Observed significant corrosion on the pipe connections and the exposed pipe itself, indicating potential structural damage. Visible water staining and rust suggest prolonged exposure to moisture, which could lead to further deterioration. The overall condition rating is Poor, as the visible defects and corrosion indicate a need for immediate maintenance or replacement to prevent further damage.

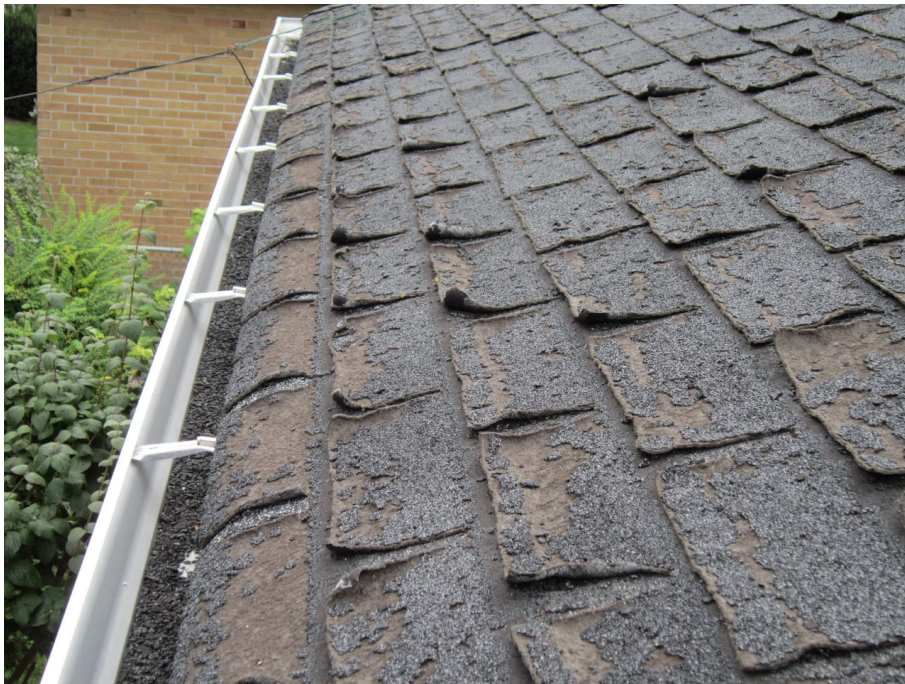
**Photo 9: Item of Interest**

Item of Interest: Roofing System

Observed significant deterioration of the roofing shingles, with many missing or severely damaged pieces. Visible signs of wear include cracks and peeling, indicating extensive aging and potential water infiltration. The overall condition rating is Poor, as the roof appears to be in a state of disrepair and requires immediate attention to prevent further damage.

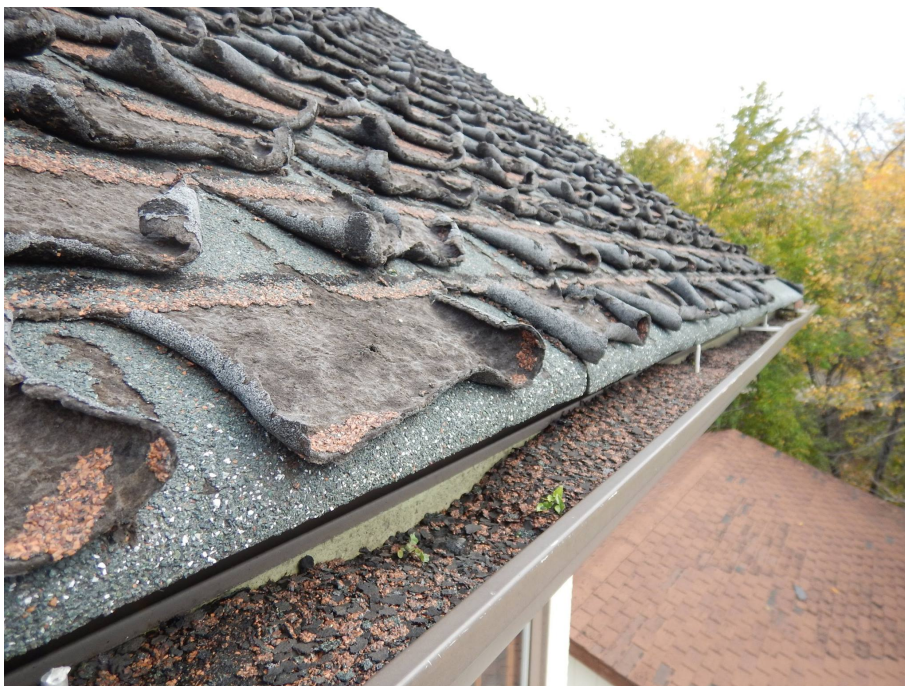
**Photo 10: Item of Interest**

The item of interest in this photo is the Roofing System. Observed significant damage to the shingles, with several areas showing extensive wear and tear, including curled and broken edges. Noted the presence of debris and potential water infiltration at the edge of the roof, where the shingles meet the gutter. The overall condition rating for this roofing system is Critical, as the damage appears severe and requires immediate attention to prevent further deterioration and potential water damage to the structure.
