Vehicle Damage Report

Peugeot 108

Generated 2025-06-26 14:46 UTC

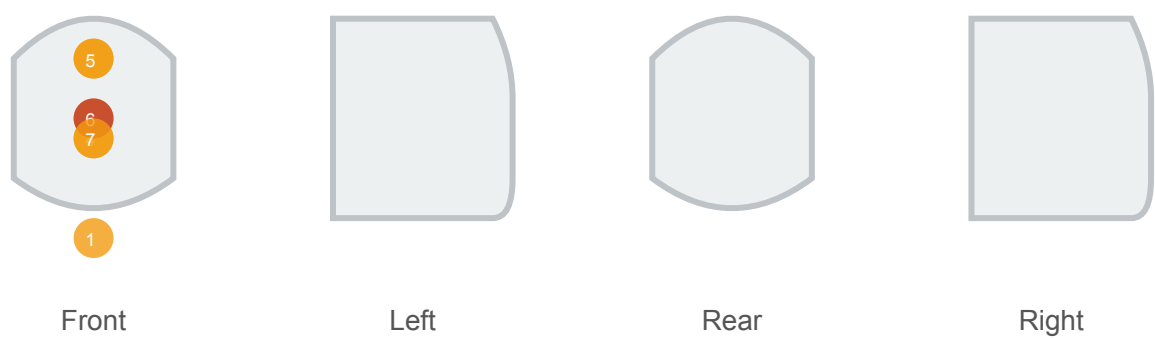
Damage Map

Part	Location	Severity	Damage Type	Repair Method	Image Ref
Front bumper cover	front	moderate	deformation	repair	image3.jpg #1
Bonnet	front	moderate	deformation	repair	image3.jpg #2
Left headlight	front LH	moderate	crack	replace	image4.jpg #3
Right front fender	front RH	moderate	deformation	repair	image8.jpg #4
Bonnet	front	moderate	deformation	repair	image3.jpg #2
Right headlight	front RH	severe	crack	replace	image5.jpg #4
Left front fender	front LH	moderate	deformation	repair	image8.jpg #5
