An Investigation of the Therac-25 Accidents

— Nancy G. Leveson, University of Washington
Clark S. Turner, University of California, Irvine

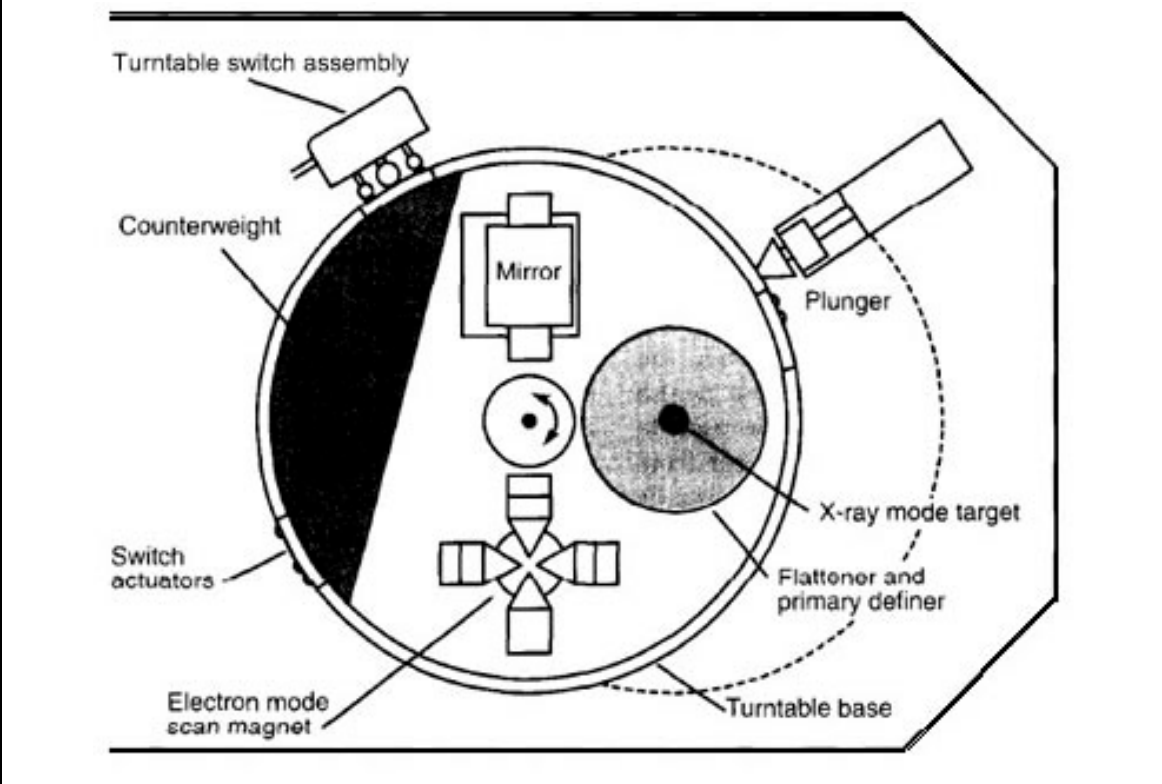
Figure B. Upper turntable assembly

The computer senses and controls turntable position by reading a 3-bit signal about the status of three microswitches in the turntable switch assembly (see the sidebar “Turntable positioning”). Essentially, AECL determined that a 1-bit error in the microswitch codes (which could be caused by a single open-circuit fault on the switch lines) could produce an ambiguous position message for the computer. The problem was exacerbated by the design of the mechanism that extends a plunger to lock the turntable when it is in one of the three cardinal positions: The plunger could be extended when the turntable was way out of position, thus giving a second false position indication. AECL devised a method to indicate turntable position that tolerated a 1-bit error: The code would still unambiguously reveal correct position with any one microswitch failure.

high dose-rate capability is required because a “beam flattener” is used to produce a uniform treatment field. This flattener, which resembles an inverted ice-cream cone, is a very efficient attenuator. To get a reasonable treatment dose rate out, a very high input dose rate is required. If the machine produces a photon beam with the beam flattener not in position, a high output dose rate results. This is the basic hazard of dual-mode machines: If the turntable is in the wrong position, the beam flattener will not be in place.

No accelerator beam is expected in the field-light position. A stainless steel mirror is placed in the beam path and a light simulates the beam. This lets the operator see precisely where the beam will strike the patient and make necessary adjustments before treatment starts. There is no ion chamber in place at this turntable position, since no beam is expected.

In addition, AECL altered the software so that the computer checked for “in transit” status of the switches to keep further track of the switch operation and the turntable position, and to give additional assurance that the switches were working and the turntable was moving.

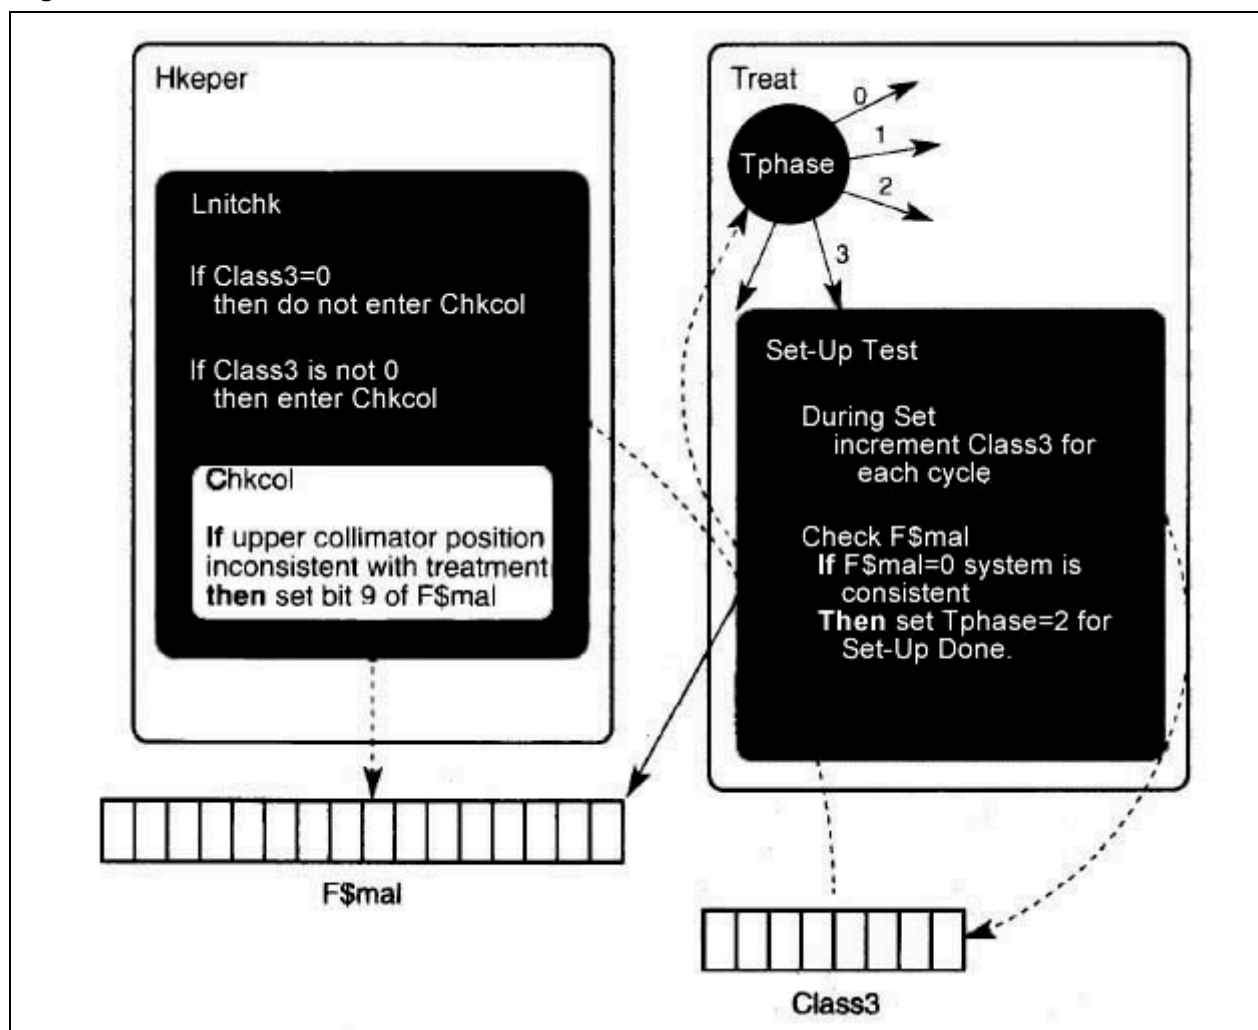
Figure 4. Yakima software flaw.

The actual interlock checking is performed by a concurrent Housekeeper task (Hkeper). The upper collimator position check is performed by a subroutine of Hkeper called Lmtchk (analog/digital limit checking). Lmtchk first checks the Class3 variable. If Class3 contains a nonzero value, Lmtchk calls the Check Collimator (Chkcol) subroutine. If Class3 contains zero, Chkcol is bypassed and the upper collimator position check is not performed. The Chkcol subroutine sets or resets bit 9 of the F\$mal shared variable, depending on the position of the upper collimator (which in turn is checked by the Set-Up Test subroutine of Datent so it can decide whether to reschedule itself or proceed to Set-Up Done).

During machine setup, Set-Up Test will be executed several hundred times since it reschedules itself waiting for other events to occur. In the code, the Class3 variable is incremented by one in each pass through Set-Up Test. Since the Class3 variable is 1 byte, it can only contain a maximum value of 255 decimal. Thus, on every 256th pass through the Set-Up Test code, the variable overflows and has a zero value. That means that on every 256th pass through Set-Up Test, the upper collimator will not be checked and an upper collimator fault will not be detected.

The overexposure occurred when the operator hit the “set” button at the precise moment that Class3 rolled over to zero. Thus Chkcol was not executed, and F\$mal was not set to indicate the upper collimator was still in field-light position. The software turned on the full 25 MeV without the target in place and without scanning. A highly concentrated electron beam resulted, which was scattered and deflected by the stainless steel mirror that was in the path.
