Chlorine Manufacturing Facility

Geismar, Louisiana

Date of Service: March 2017

GEA

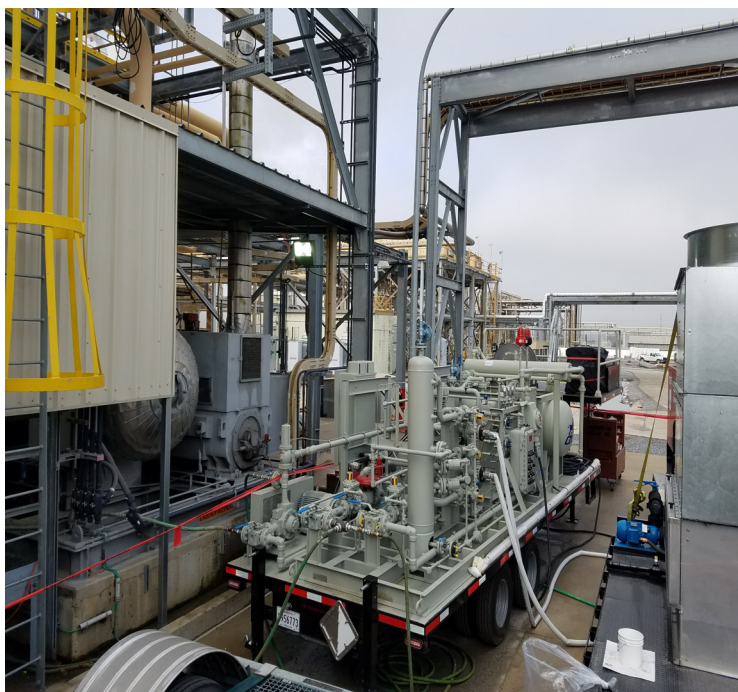
Customer owns and operates a GEA refrigeration skid containing 20,000 lbs. of R-507 used to liquefy chlorine as of their manufacturing process. The machine was experiencing internal icing issues due to leak and excess water in refrigerant.

Troubleshooting revealed that the charge of R-507 was severely water logged with most of the ice trapped in the evaporator. As part of planned outage, it was ChillCo's recommendation that entire charge be removed and dehydrated to an acceptable standard.

ChillCo's recovery & recycling equipment (The Ox) was delivered to the site and set up for operation. As part of planned outage for repair of system leaks, refrigerant was removed from the owner's system and put into an ISO tank. Refrigerant was then dehydrated through The Ox and placed into a second (clean) ISO tank for onsite storage, until repairs of unit were completed.

The dehydrated refrigerant was transferred back into the owner's system and the equipment was put back into service. Subsequent refrigerant analysis showed moisture content to be at an acceptable level and ice buildup in evaporator was no longer an issue.
