# Bereshit Crash - Technical Overview

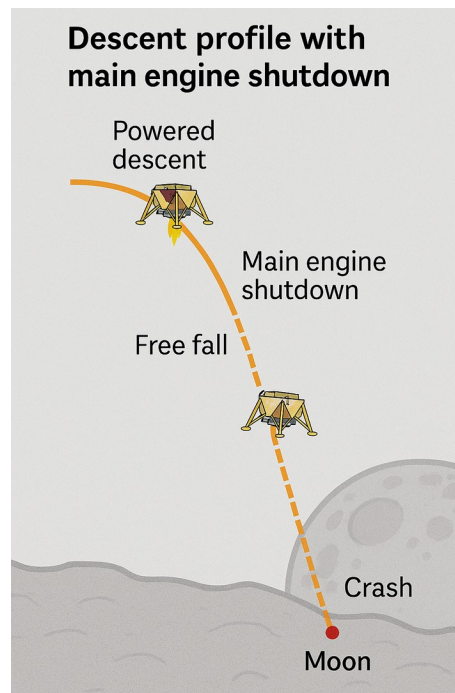
These repeated restarts caused the main engine, which was supposed to operate continuously to slow the descent, to shut down. While the computer was programmed to restart the engine immediately, another issue arose - the engine required power from two sources to restart, but due to the system reboot, only one was functional, preventing the main engine from turning back on.

Due to the downtime of the engine, as short as it was, and due to the lack of atmosphere on the Moon – the spaceship was in free-fall mode. This can be observed in the video when the shuttle accelerates towards the surface while the angle relative to the surface remains constant – 3 deg (since one IMU device is still working correctly). This can be observed in the following diagram:

As a result, Bereshit remained on a crash trajectory accelerating up to a speed of 3,000 km/h and was destroyed upon impact with the Moon.
