PRE-PURCHASE BUILDING REPORT

Property Address	123 Hillview Road, Alexandra, Otago 9391		
Client	Paul O'Connell		
Date of Inspection	23rd August 2022	Time	12:00 pm
Inspector	Mike Waymouth National Certificate in Carpentry		
LBP Number	257024		
Inspection Type	Pre-Purchase Report		
People Present	Owner, Inspector		
House Occupied	Yes

CERTIFICATE OF INSPECTION IN ACCORDANCE WITH NZS 4306:2005

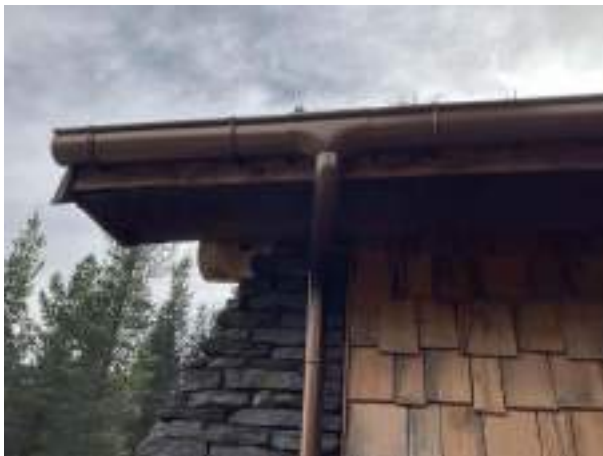
Photo 50

PVC guttering requires cleaning out.

Clean out gutters of foliage to prevent the gutters from overflowing.

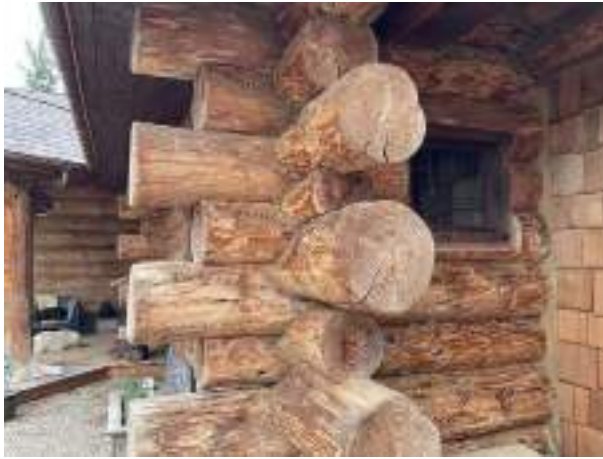
Photo 57

Douglas Fir 350 dia temple pole
Finish - CD50
Damage - Some end splitting noted - Noted below.

Some end grain splitting noted in logs.

Maintenance would include regularly cleaning all exterior surfaces to remove grime and contaminants, particularly where rain washing is not achieved typically below spouting and eaves. Cleaning is important as grime and contaminants can cause accelerated deterioration to construction materials. Normal maintenance and repairs will be required over the coming years.

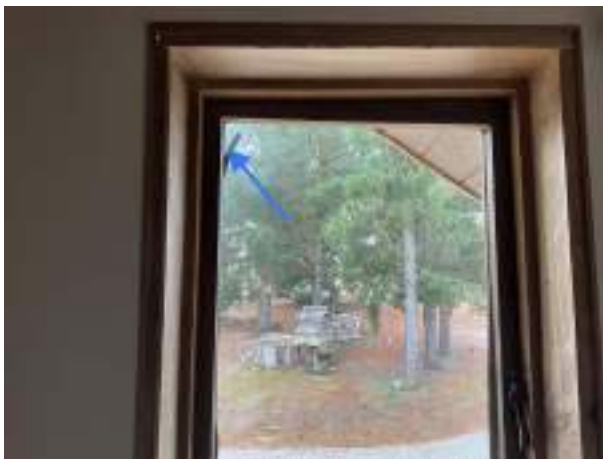
Photo 63

Glazing rubber loose in apartment bedroom window.

Rubber seals should be replaced or re-seated to prevent water ingress where required.

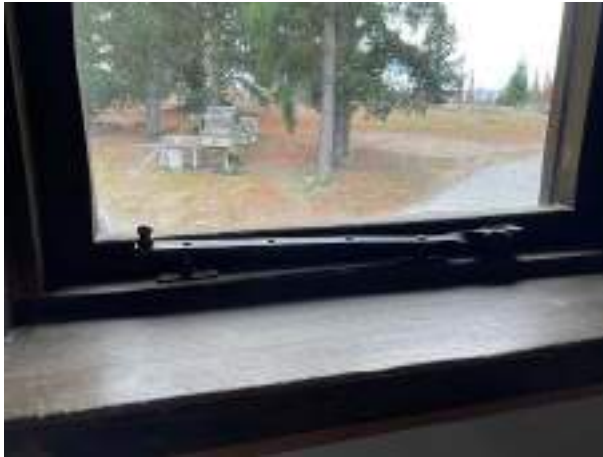
Photo 64

Joinery hardware in apartment bedroom needs maintenance.

Some window latches were loose and/or require minimal repairs, it is recommended these are remedied as part of general maintenance to the property to assist with drafts.

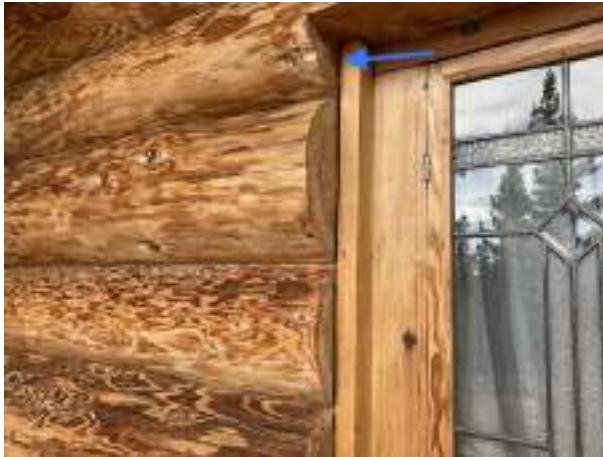
Photo 67

Log cladding and exterior joinery detail sealant noted.
