PRE-PURCHASE BUILDING REPORT

Property Address	65 The Masthead Whitby Porirua 5024		
Client	The Law Family Trust		
Date of Inspection	24th August 2022	Time	12:00 pm
Inspector	Trevor Garrett MSc, Licensed Building Practitioner, Advanced Trade Certificate Carpentry, National Diploma Construction Management. Member of NZIOB.		
LBP Number	131790		
Inspection Type	Pre-Purchase Report		
People Present	Owner		
House Occupied	Yes

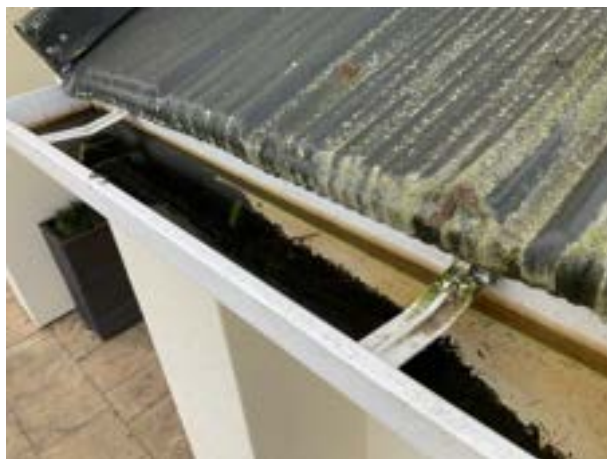
Photo 2

Southeast gutter holding water.

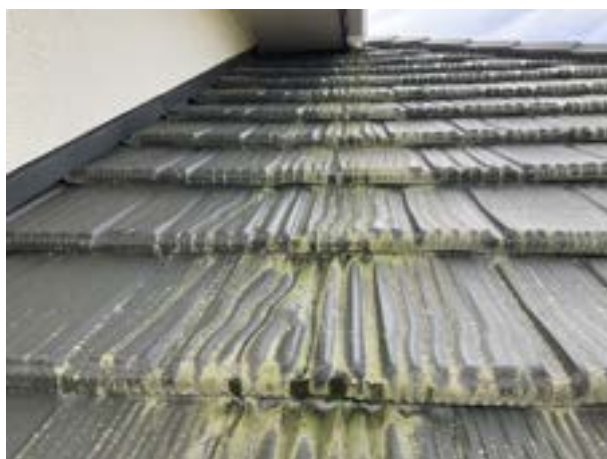
Photo 3

Southeast mould or pollen visible.

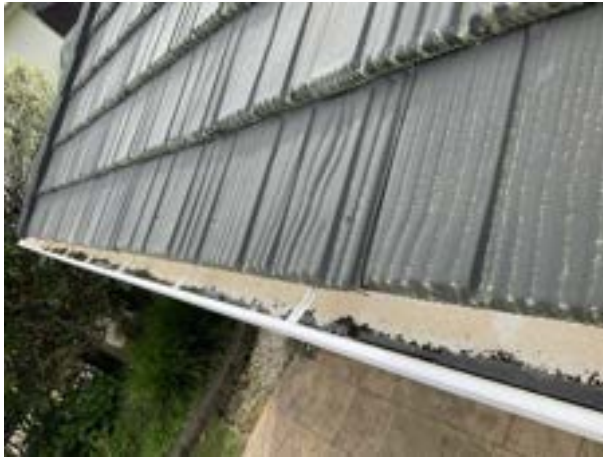
Photo 4

Southwest fixings starting to show rust.

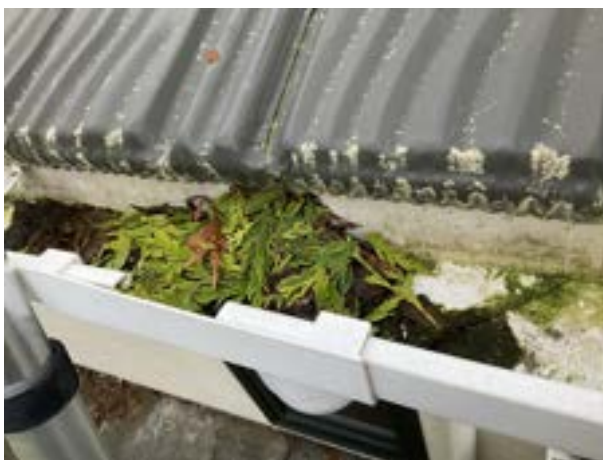
Photo 5

West side has a blocked downpipe dropper.

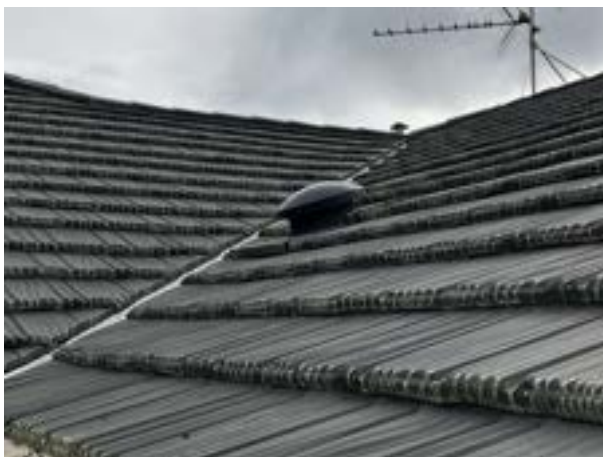
Photo 6

East side valley paint has deteriorated. Roof penetration, no visible issues.

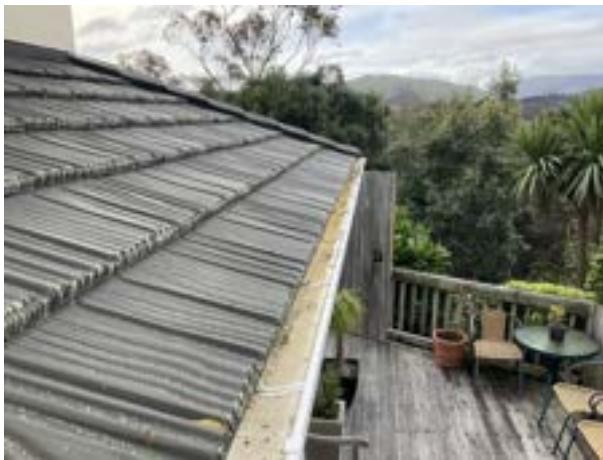
Photo 8

Northeast gutter is holding water.

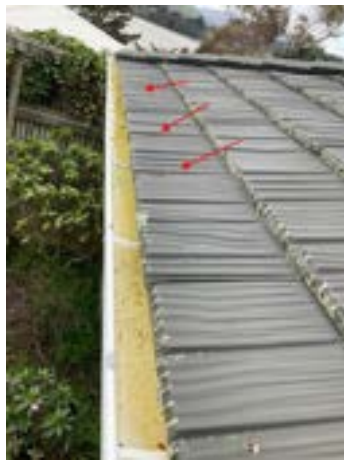
Photo 11

Northwest gutter is holding water and has visible rust around fixings.

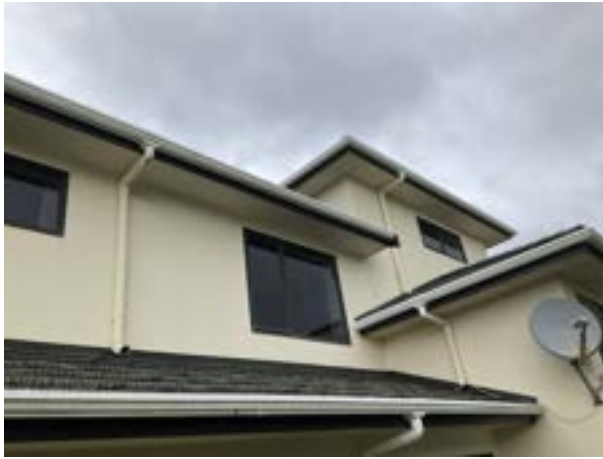
Photo 13

West side upper downpipes discharge onto lower roof.

We recommend the installation of a spreader to the downpipes discharging onto the lower roof.

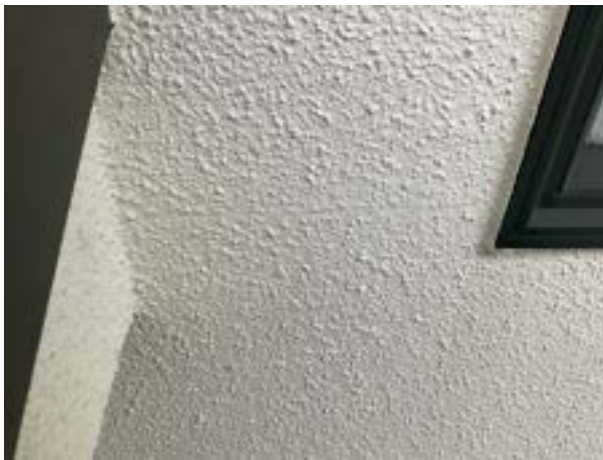
Photo 19

East side visible horizontal joint.

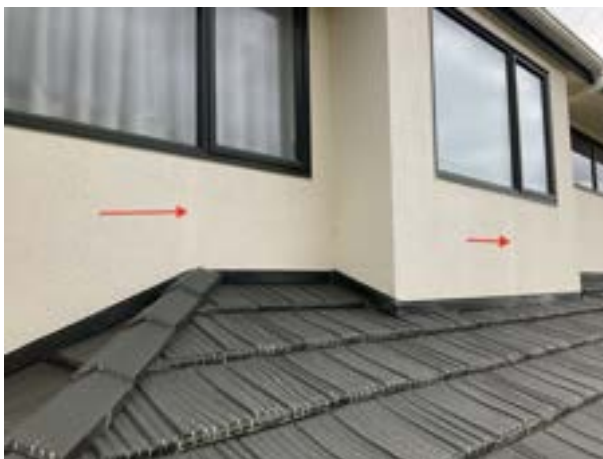
Photo 20

East side visible vertical joints.

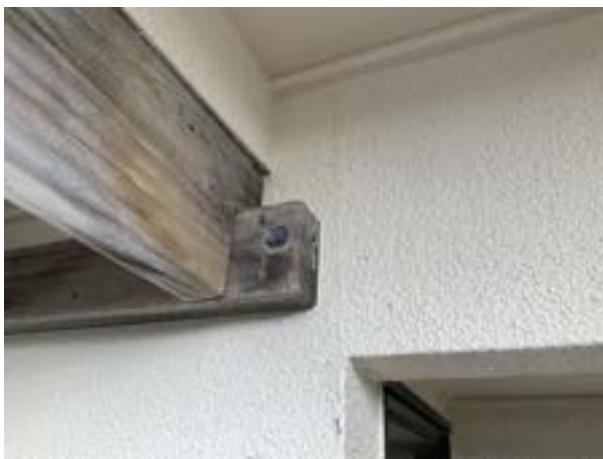
Photo 23

North side visible sheet joint and pergola fixings through the cladding.

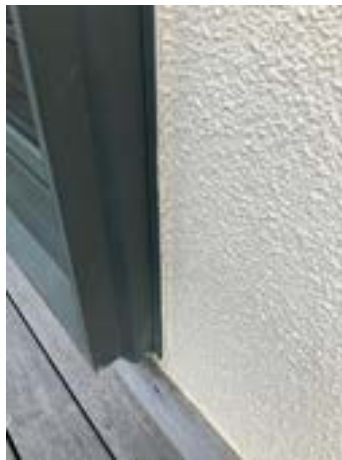
Photo 25

North side kitchen ranchslider has a visible crack.

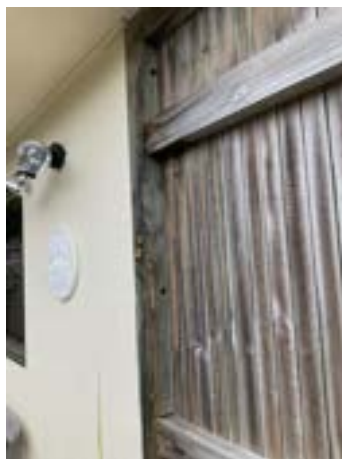
Photo 26

North side fence with fixings into cladding.

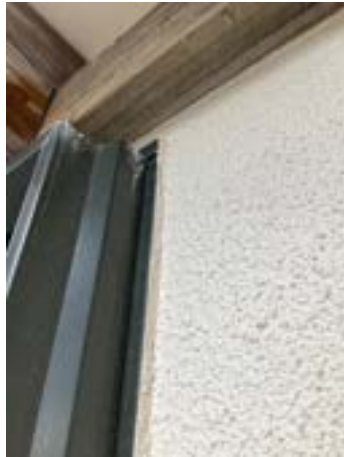
Photo 27

North side kitchen ranchslider crack.

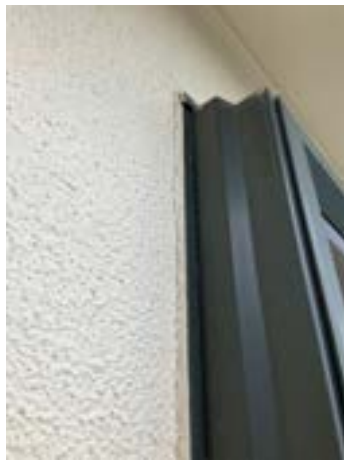
Photo 28

Northeast ranchslider left side has a visible crack.

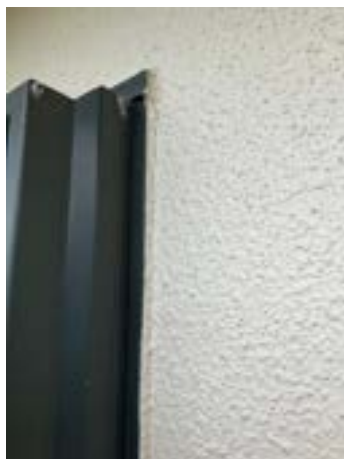
Photo 29

Northeast ranchslider right side has a visible crack.

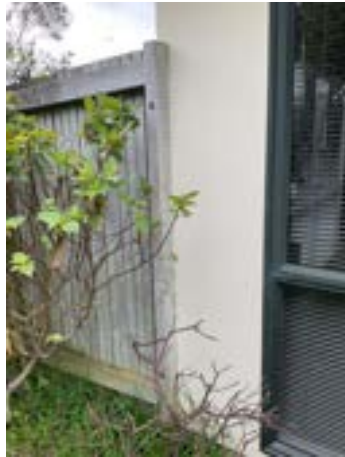
Photo 30

Northwest fence has fixings through the cladding.

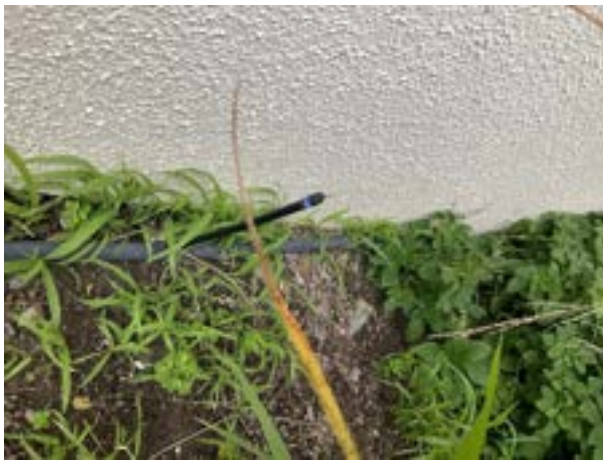
Photo 31

Ground clearances - Areas of remediation to lower ground levels recommended on the lower west side.

West side soil is touching the cladding.

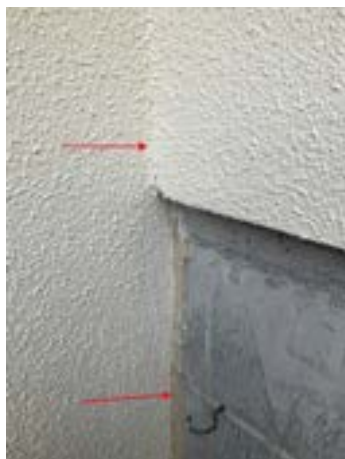
Photo 32

West side internal corner has a visible crack.

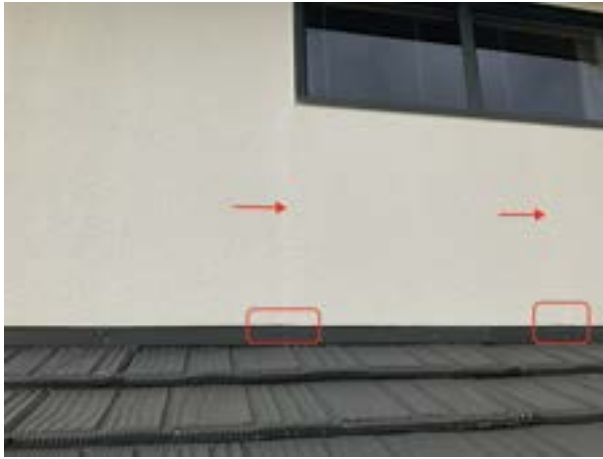
Photo 33

West side has visible sheet joints and delamination of the sheet joint within the highlighted boxes.

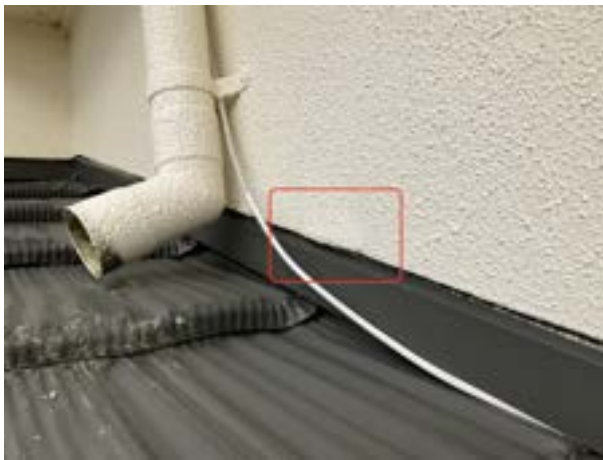
Photo 37

West side visible delamination of sheet joint.

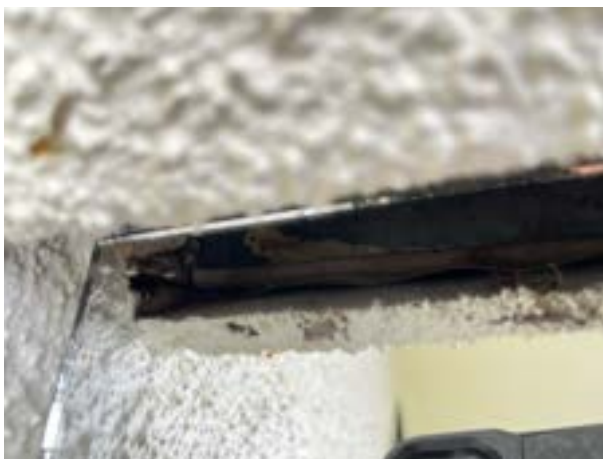
Photo 38

West side internal corner looking up from the bottom of the sheet with no visible internal flashing.

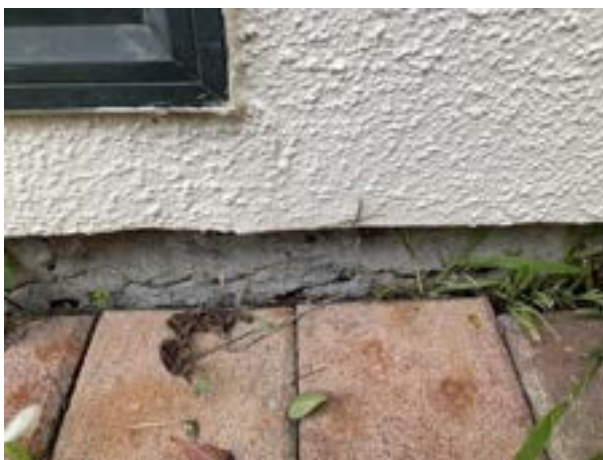
Photo 40

West side corner of window, visible delamination of sheet joint.

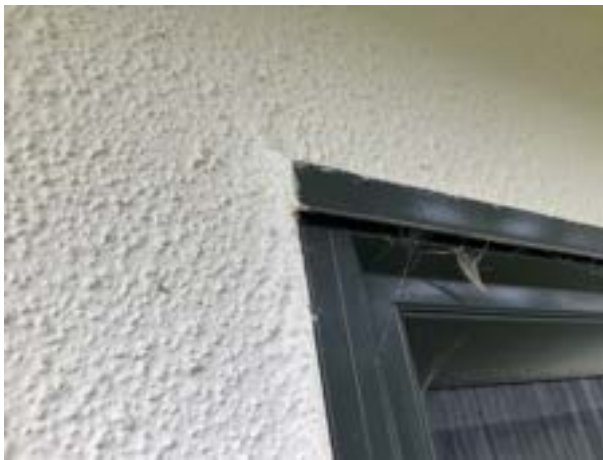
Photo 44

Typical window headflashing detail. All headflashings finish flush with the end of the window rather than an overhang.

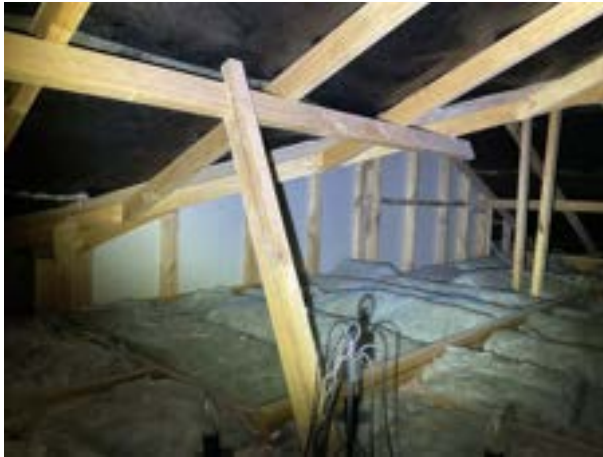
Photo 50

Interior walls have no insulation.

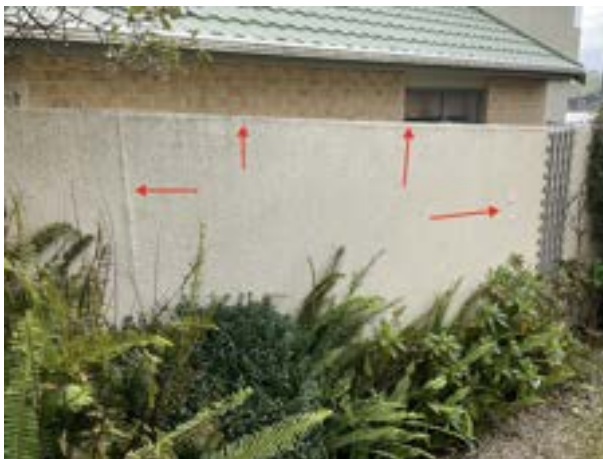
Photo 84

West has visible delamination of the joints.

General upkeep and maintenance, keep vegetation and soils clear of timbers as these timbers are only exterior treated and will rot if vegetation or soils are up against them.

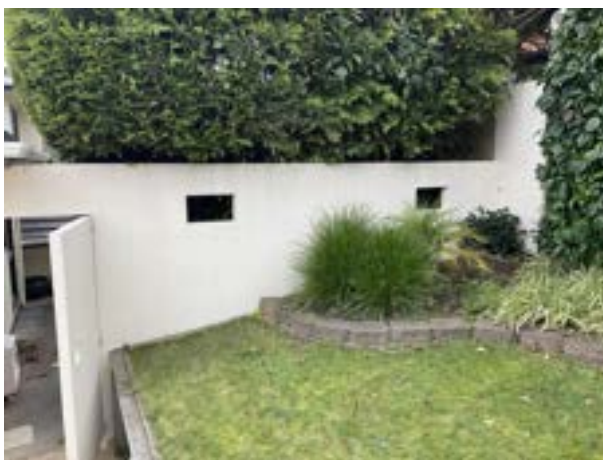
Photo 87

South side some similar delamination as the west side, functional.

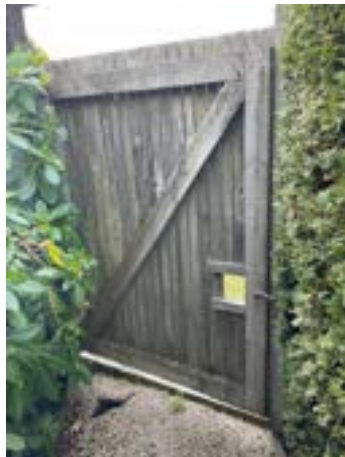
Photo 102

West side is sticking.

Recommend easing and regular lubrication of the hinges and latch to maintain full function.

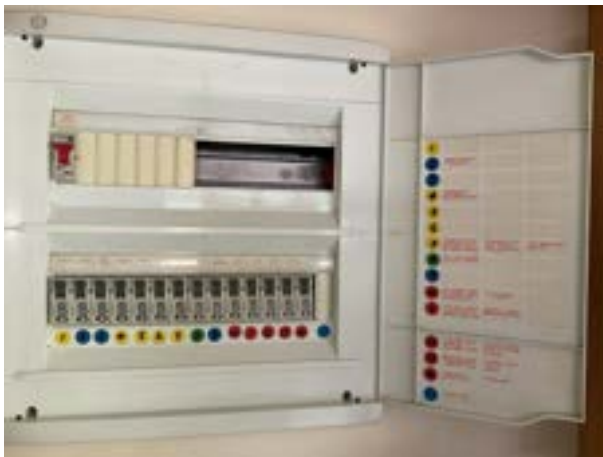
Photo 123

Distribution board is located in garage 1. There is several 'pole filler' or 'MCB fuse way' blank plates missing.

Recommend installing cover plates to distribution board to cover the bus bar.
