Roof Inspection Report

16513 Bonnie Lane, Los Gatos

Kenneth Carlin
May 3, 2024

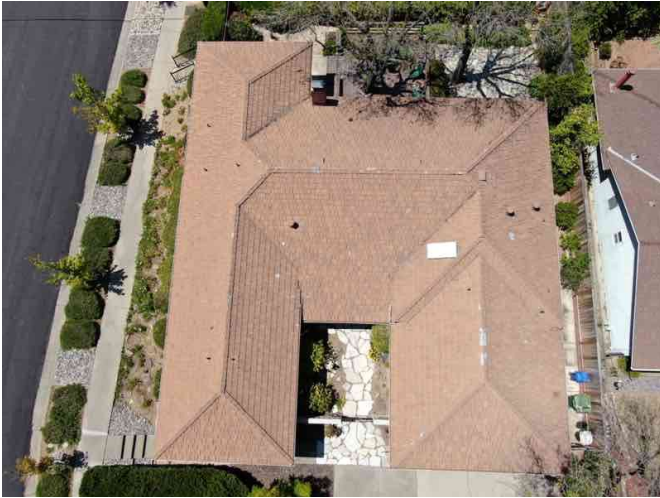
Photo 01

1. A bird's-eye view of the roof: (See Photo 1)
2. Most of the tile are broken and beyond meaningful repair. (See Photo 2) (See Photo 3) (See Photo 4)
