Richard H Lambie

104 Amanda Ln
Los Gatos CA 95032

Inspection Date
5/15/2024

Inspected By
Brett Reeder

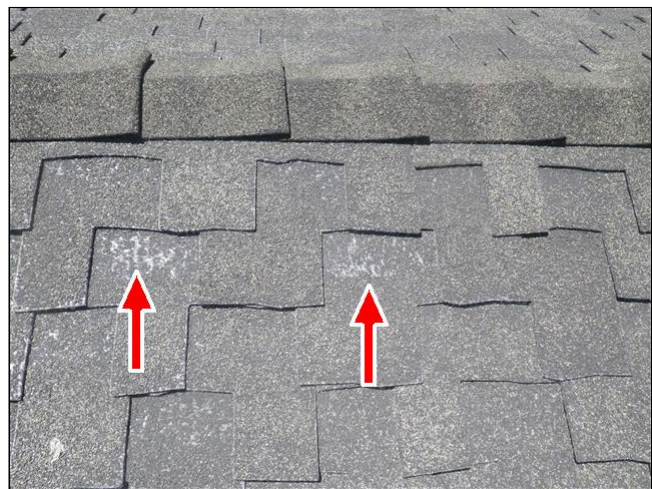
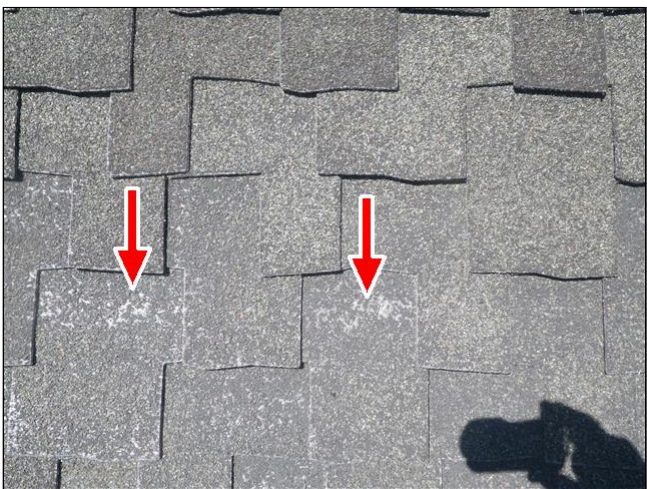
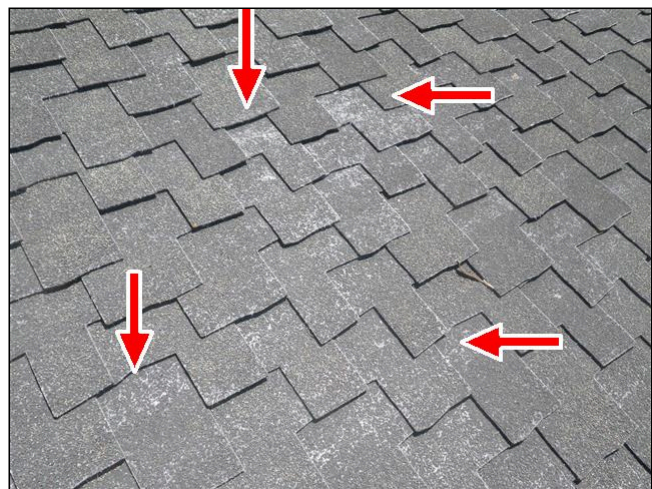
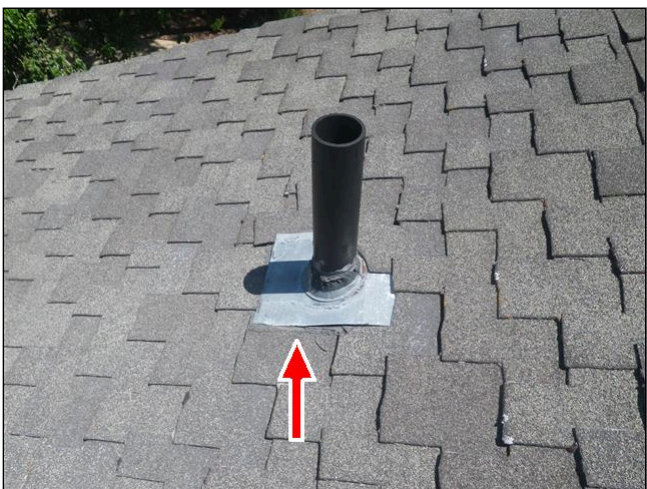
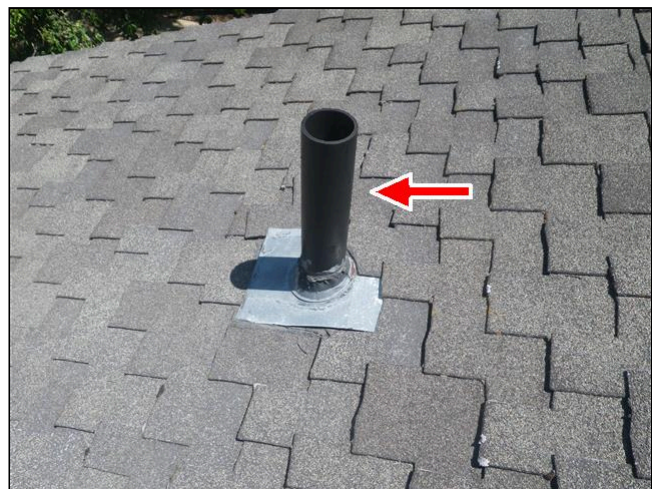
Items	
1.0	ROOF COVERING: ITEM(S) IN NEED OF FURTHER EVALUATION AND/OR CORRECTIONS BY OTHERS
There was widespread degranulation noted to the composition shingles on the roof and there is visible fiberglass in the composition shingles in several areas (Pictures 1-3 are examples). There was an incorrectly installed flashing noted on the roof (Picture 4). To help ensure a leak free installation I recommend contacting a qualified licensed roofing contractor at this time for further evaluation and to perform corrections where needed.	
There were unpainted ABS plastic plumbing vent pipes noted on the roof (Pictures 5 is an example). These plastic vent pipes need to be painted at this time to help prevent premature deterioration of

these pipes. I recommend contacting a qualified licensed painting contractor for corrections.

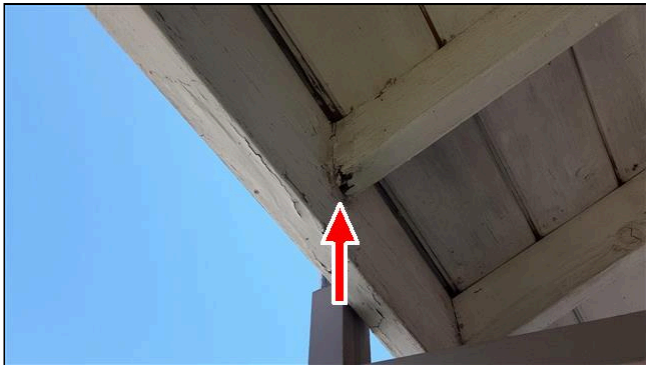
1.1 (Picture 1)

There was damage noted to rafter tails in various areas around the perimeter of the house (Pictures 1-5)

are examples). To prevent further damage this damage and the condition(s) causing this damage need to be corrected. I recommend contacting a qualified licensed structural pest control company at this time for further details to determine the extent of the damage and for appropriate corrections as needed.

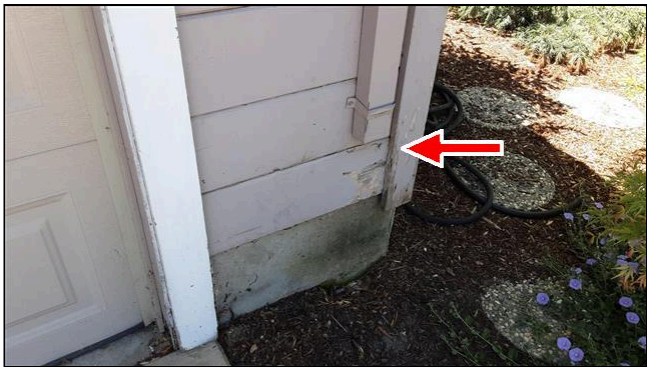
1.2 (Picture 1)

There was a downspout noted to be missing a portion at the right front corner of the garage (Picture 1). This missing portion of the downspout needs to be installed at this time to help properly drain the water away from the garage.

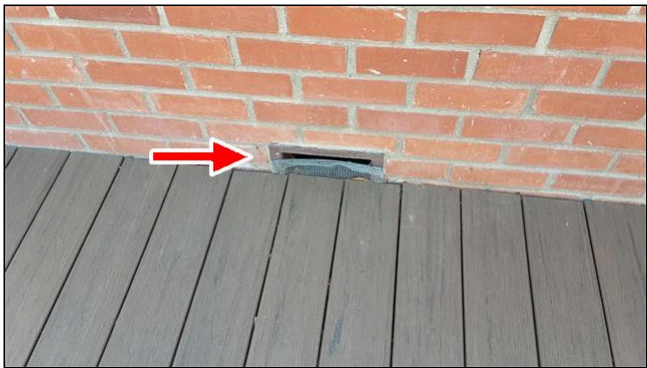
1.3 (Picture 1)

The exterior fireplace ash door was missing (Picture 1). This door needs to be installed to properly seal this area. I recommend contacting a qualified licensed masonry contractor for further evaluation at this time and corrections.

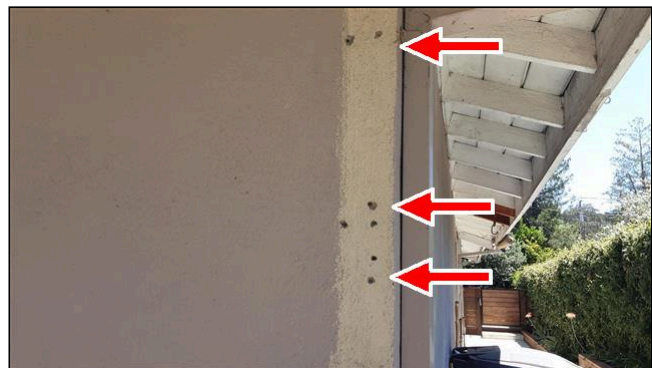
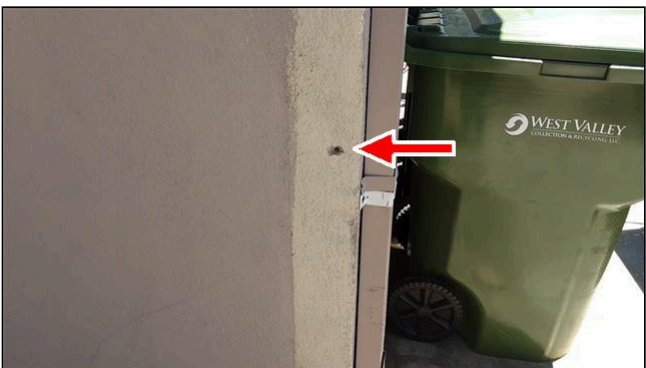
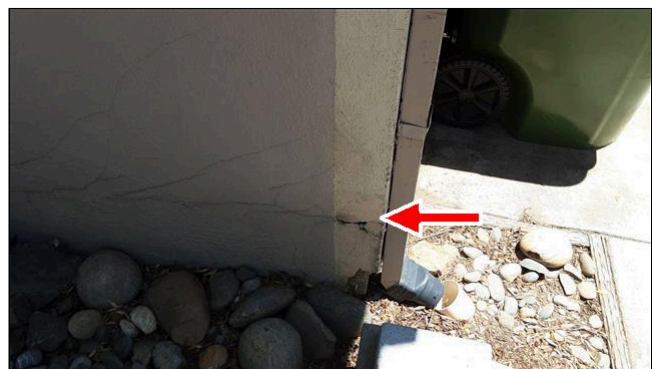
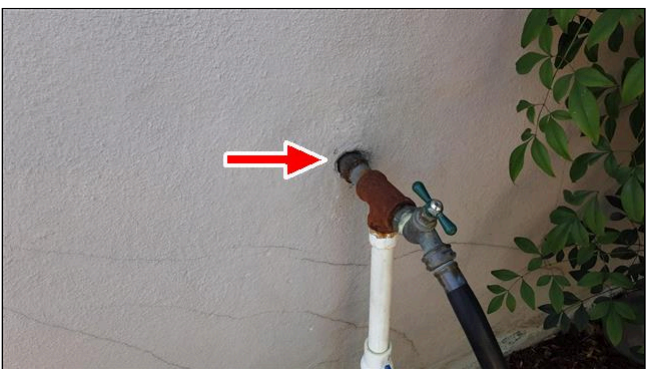
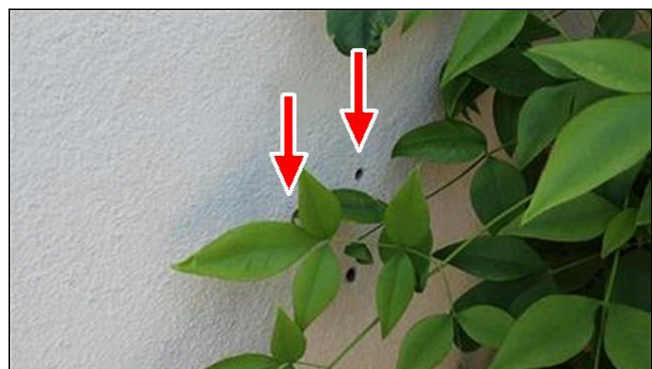
There were unsealed penetrations in the stucco siding at the right rear corner of the garage and at the right side of the garage (Pictures 1-5) and in the wood siding at the front of the house (Picture 6). These penetrations need to be properly sealed at this time to help prevent possible water intrusion to the wood framing and/or damage.

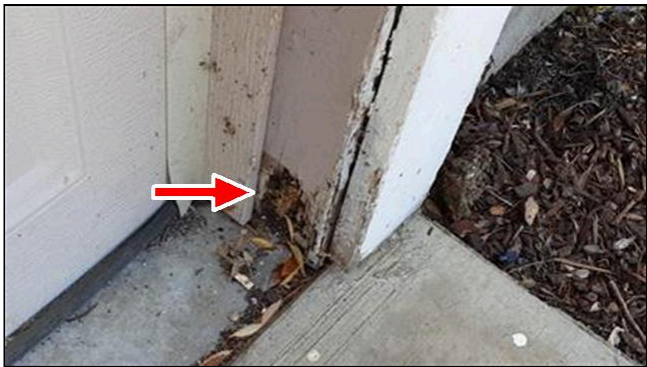
1.4 (Picture 7)

There was damage noted to the car door jamb at the right side of the garage at the right side of the car door opening (Picture 7). To prevent further damage this condition needs to be corrected. I recommend contacting a qualified licensed structural pest control company at this time for further details and to determine the extent of the damage and for appropriate corrections as needed.

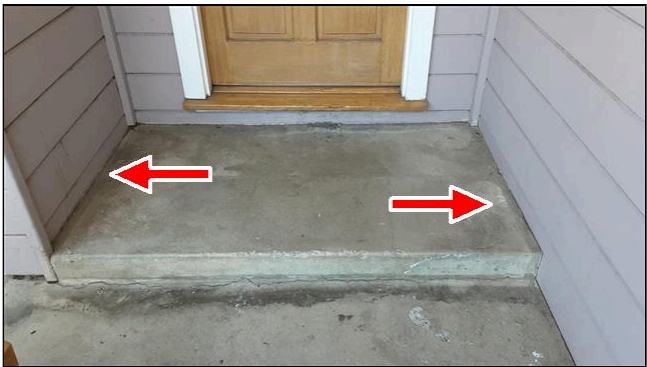
1.4 (Picture 8)

The wood siding was too close to the hardscape at the front porch area (Picture 8). To help prevent possible damage and meet modern standards these situations need to be corrected to ensure a minimum of 2 inches between the wood and the hardscape. I recommend contacting a qualified licensed general contractor for corrections as needed.

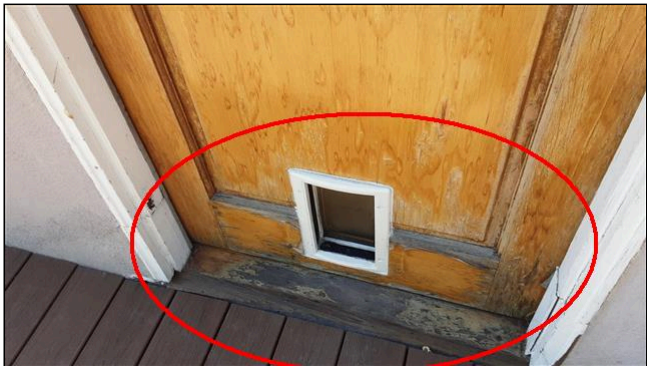
1.4 (Picture 9)

The stain on the rear exterior pantry room door was weathered/deteriorated (Picture 9). To help prevent damage to the door this situation needs corrections. I recommend contacting a qualified licensed painting contractor at this time.

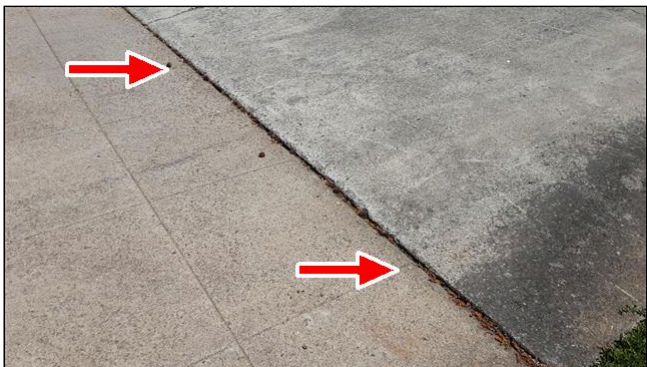
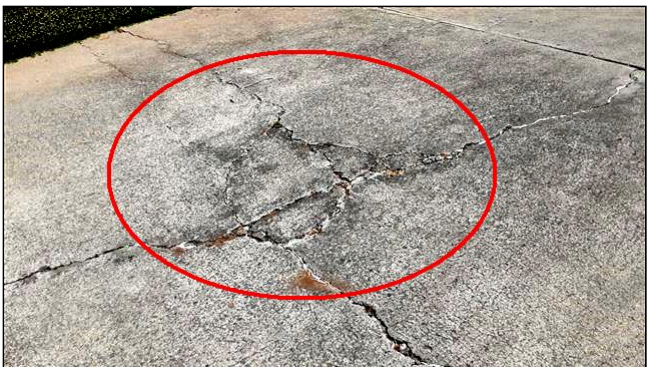
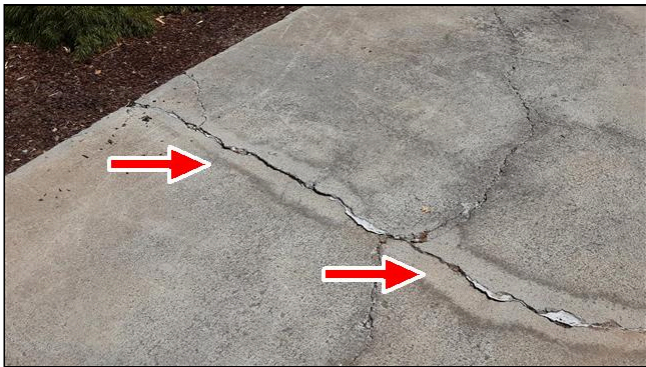
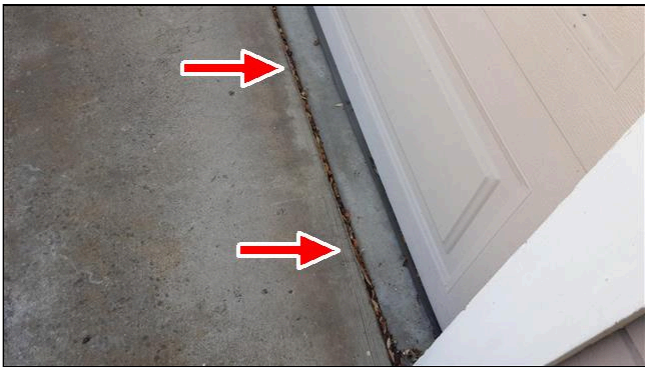
There was lifting / settling noted to the driveway where it meets the sidewalk, driveway and the driveway where it meets the garage slab (Pictures 1-4 are examples). These areas of lifting / settling are tripping hazards and need to be corrected at this time for the safety of passing foot traffic.

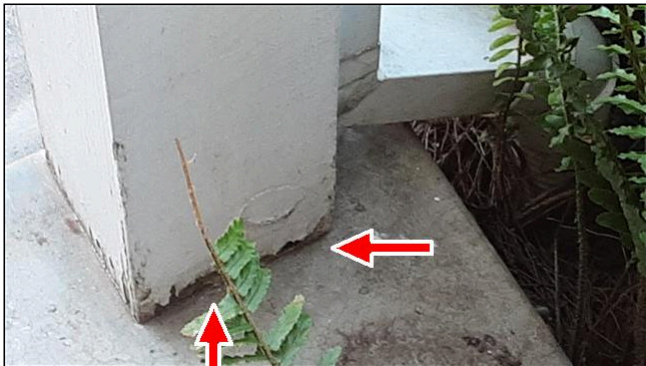
1.6 (Picture 1)

There was damage noted to a support post at the front porch area (Picture 1). To prevent failure/injury and/or further damage this condition needs to be corrected. I recommend contacting a qualified licensed structural pest control company at this time for further details and to determine the extent of the damage and for appropriate corrections as needed.

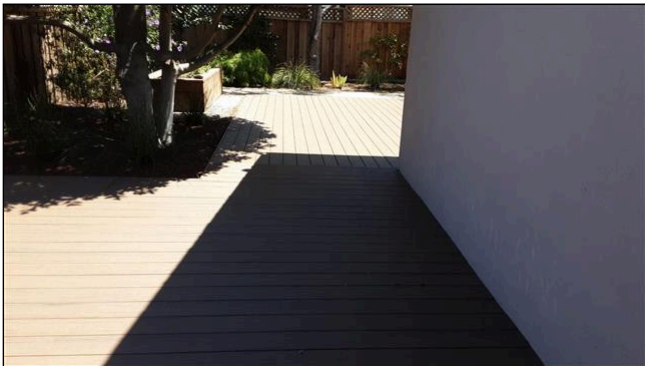
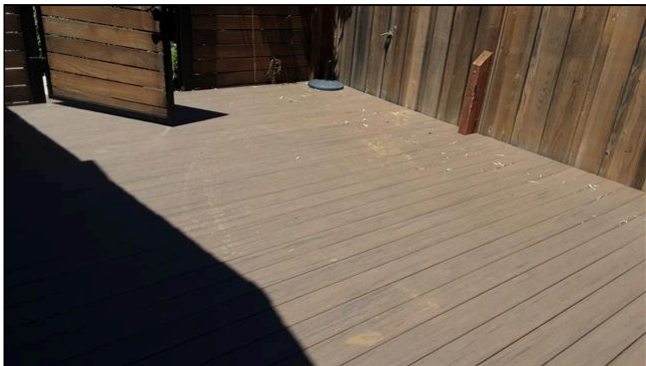
There was no access under the deck for inspection of any connections between the deck and the house, or of the support structure or of the underside of the deck boards (Pictures 2-4 are examples). The condition or suitability of these items is unknown. Please note: Decks and their components need ongoing maintenance, and periodic inspections for safety. Decks and their components can not be expected to last forever and will not improve with age. In areas where decks attach to the house there is the potential of concealed damage that is not visible. Further detailed evaluation by qualified others at this time is advised in these circumstances.

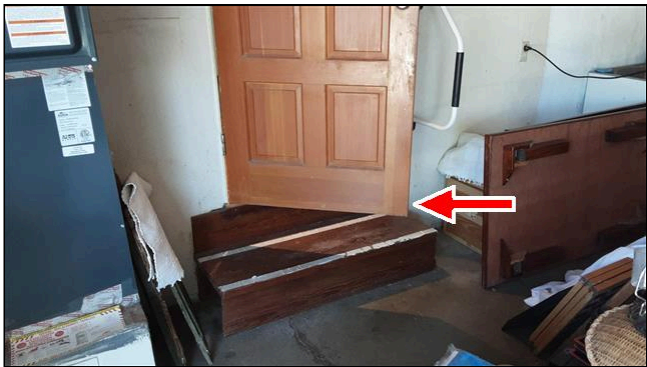
1.7 (Picture 1)

The door between the garage and the house opened out over a step (Picture 1). For the safety of passing foot traffic this situation needs to be corrected. I recommend contacting a qualified licensed general contractor for further evaluation at this time and for corrections as needed.

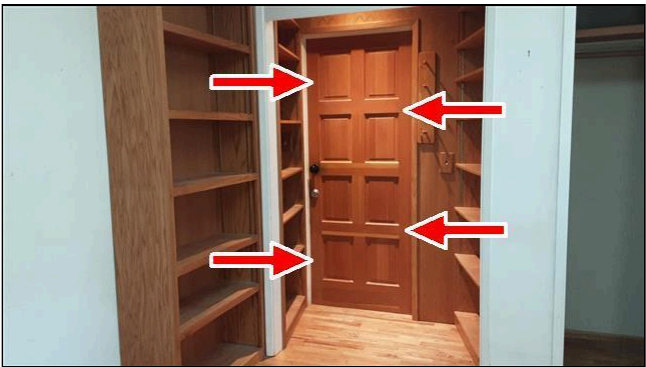
1.7 (Picture 2)

Please Note: There was a door between the garage and left front bedroom (Picture 2). This is an unsafe situation and does not meet building standards. For occupant safety, to prevent the possible intrusion into the bedroom (sleeping area) by exhaust gases from cars, the gas furnace or the gas water heater in the garage this door needs to be removed and the wall needs to be properly sealed. Taking this appropriate action would eliminate the need to do the corrections noted in paragraphs 2-5. I recommend contacting a qualified licensed general contractor for the removal of the door and to properly restore the sheet rock firewall between the garage and the house.

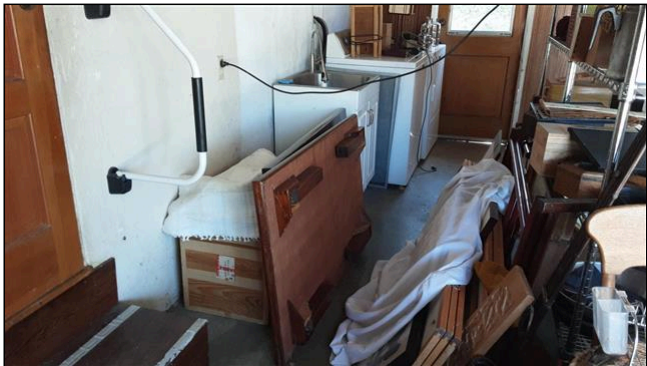
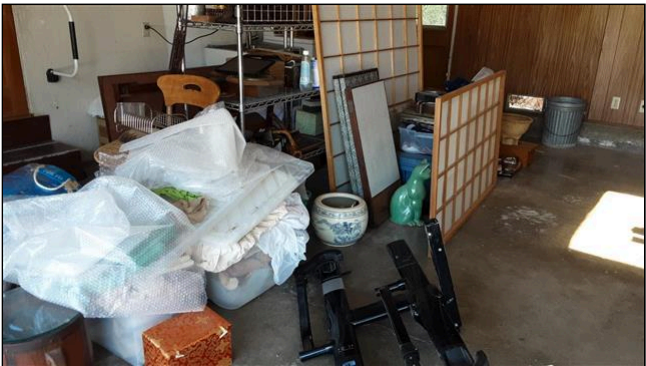
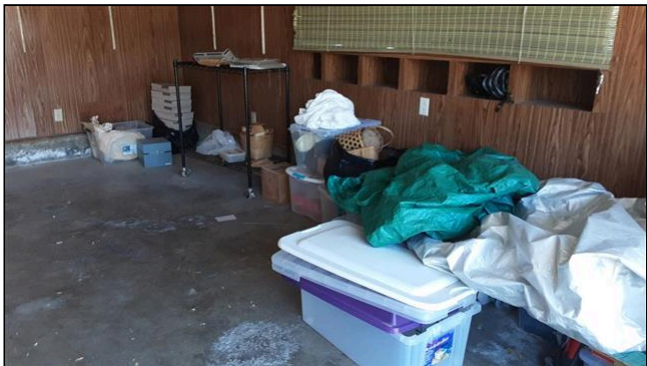
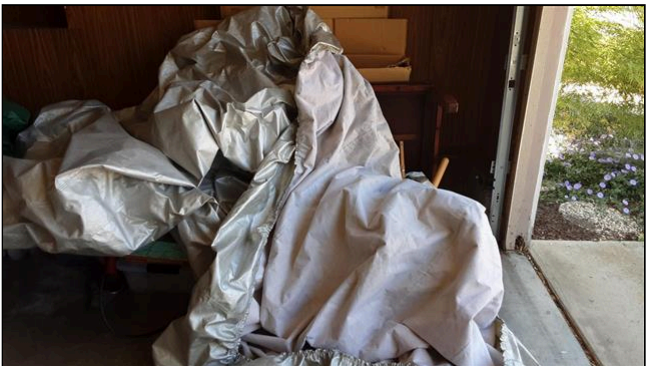
Please note: The garage was not fully accessible due to stored materials (Pictures 3-6 are examples). Garage components behind these materials were not inspected. Conditions in these areas of the garage and of the components in these areas are unknown. Damage may or may not exist behind these materials. The garage area contains important structural components (foundation) and other systems (electrical, plumbing, fire shield, etc), that may or may not need immediate corrections for safety and to help prevent possible damage or further damage. For a complete evaluation of the garage and all of its components, these inaccessible areas of the garage need to be made accessible and be fully inspected by appropriate qualified licensed contractors at this time.

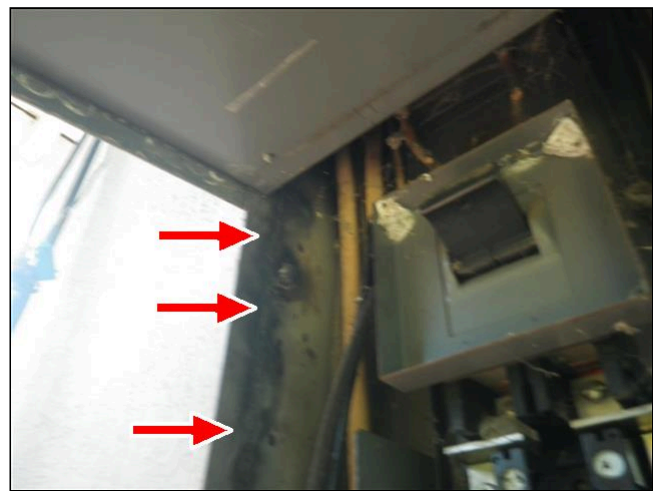
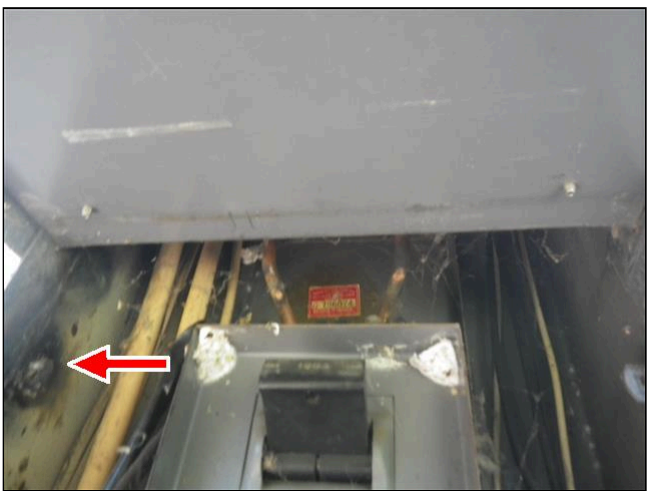
There were scorch marks noted in the panel (Pictures 1 & 2 are examples) and the main bare copper conductors feeding the panel were damaged (Picture 3). I could not determine the cause of this condition or its implications. For fire safety I recommend contacting a qualified licensed electrical contractor for further evaluation at this time and repairs as needed.

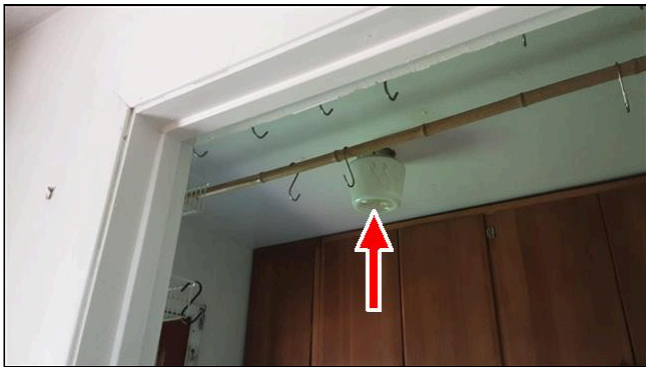
1.10 (Picture 1)

A ceiling light did not respond to the wall switch in the pantry area (Picture 1). This light needs further evaluation and repair (may just need a new bulb to be functional). I recommend contacting a qualified licensed electrical contractor at this time for correction as needed.

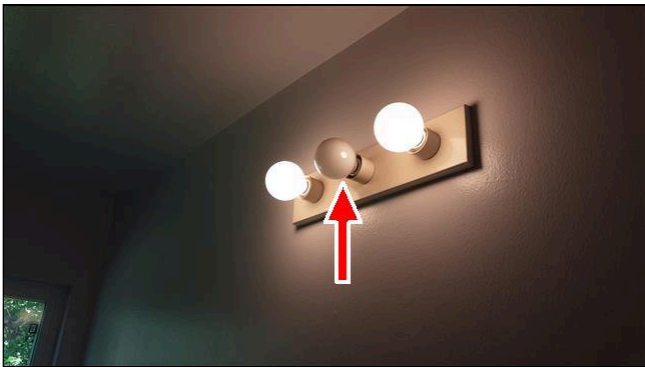
1.10 (Picture 2)

A wall light fixture did not fully respond to the switch in the hall bathroom (Picture 2). This light fixture needs further evaluation and repair (may just need a new bulb to be fully functional). I recommend contacting a qualified licensed electrical contractor at this time for corrections as needed.

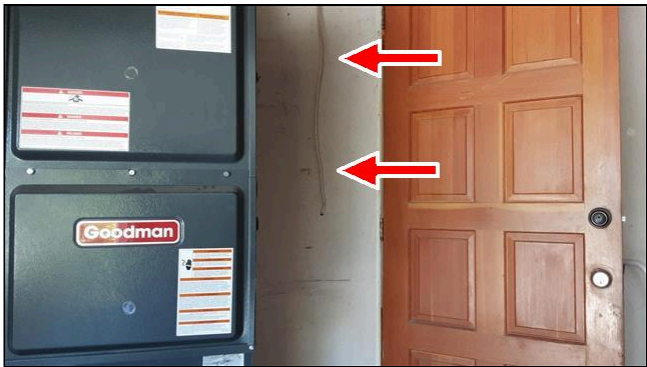
1.11 (Picture 1)

There was unprotected nonmetallic sheathed electrical wiring noted at the left side of the garage (Picture 1). For safety, this wiring needs to be removed or be properly shielded. I recommend contacting a qualified licensed electrical contractor for further evaluation and correction of this item.

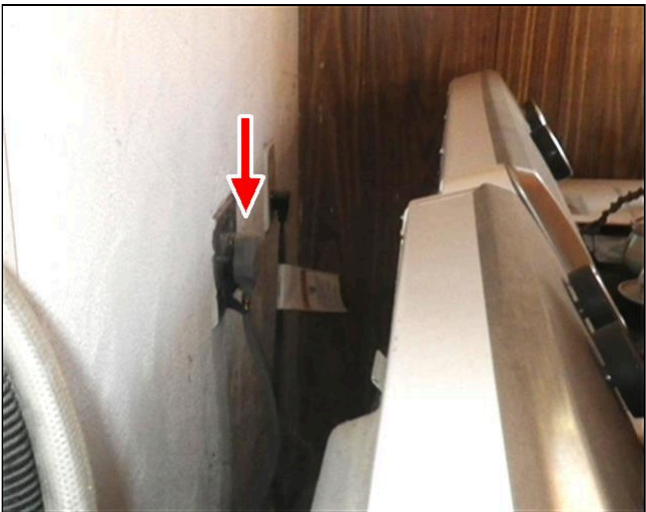
1.11 (Picture 2)

There was an older three pronged 240 volt electrical outlet for the dryer in the garage (Picture 2). For safety and to meet current standards, I recommend upgrading this outlet to a four pronged 240 volt outlet. I recommend contacting a qualified licensed electrician at this time for proper replacement.

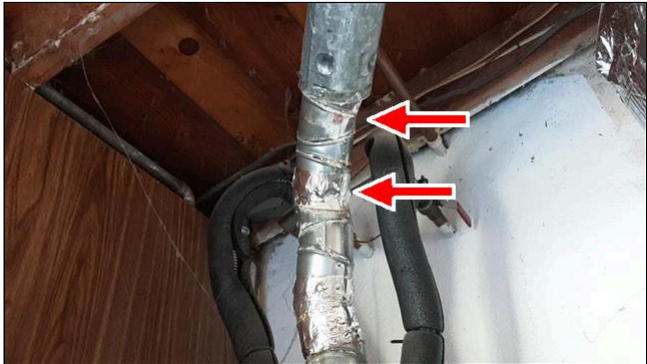
2.0 (Picture 1)

There was corrosion noted on the exhaust flue for this water heater (Picture 1). To prevent further damage this situation needs corrections. I recommend contacting a qualified licensed plumbing contractor at this time for further evaluation and correction of this item as needed.

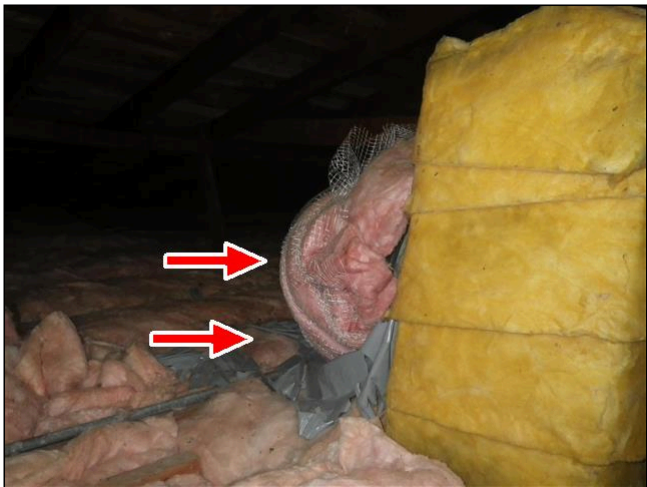
2.1 (Picture 1)

The grey plastic wrap on a heat duct in the attic was noted to be damaged (Picture 1). To prevent further damage and for energy efficiency this situation needs to be corrected. I recommend contacting a qualified licensed heating contractor for further evaluation at this time and correction as needed.

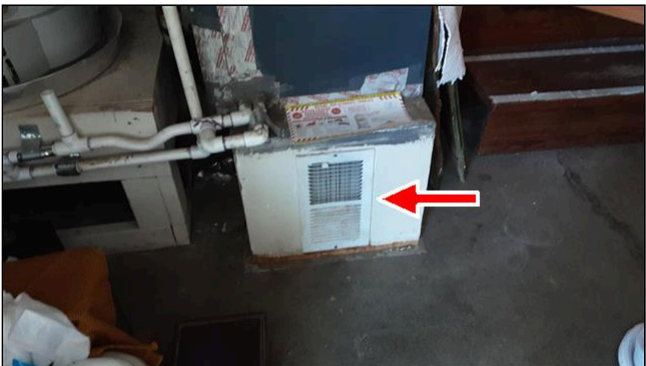
2.1 (Picture 2)

There was a heat register in the garage at the furnace platform (Picture 2). This is an unsafe situation. For occupant safety this situation needs to be corrected. I recommend contacting a qualified licensed heating contractor at this time for further evaluation and correction of this item as needed.

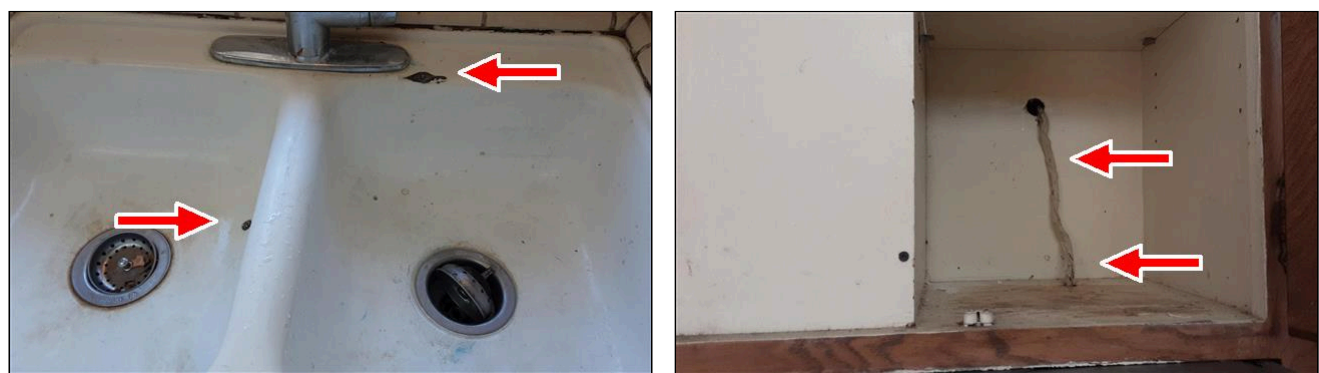
The sink finish was chipped (Picture 1) Correction is needed to help prevent further damage. I recommend contacting a qualified licensed general contractor for correction as needed.

There was some unshielded nonmetallic sheathed electrical wiring noted in the wood cabinet above the stove cooktop area (Picture 2). This wiring needs to be removed or be properly shielded for safety. I recommend contacting a qualified licensed electrical contractor for further evaluation at this time and for corrections as needed.

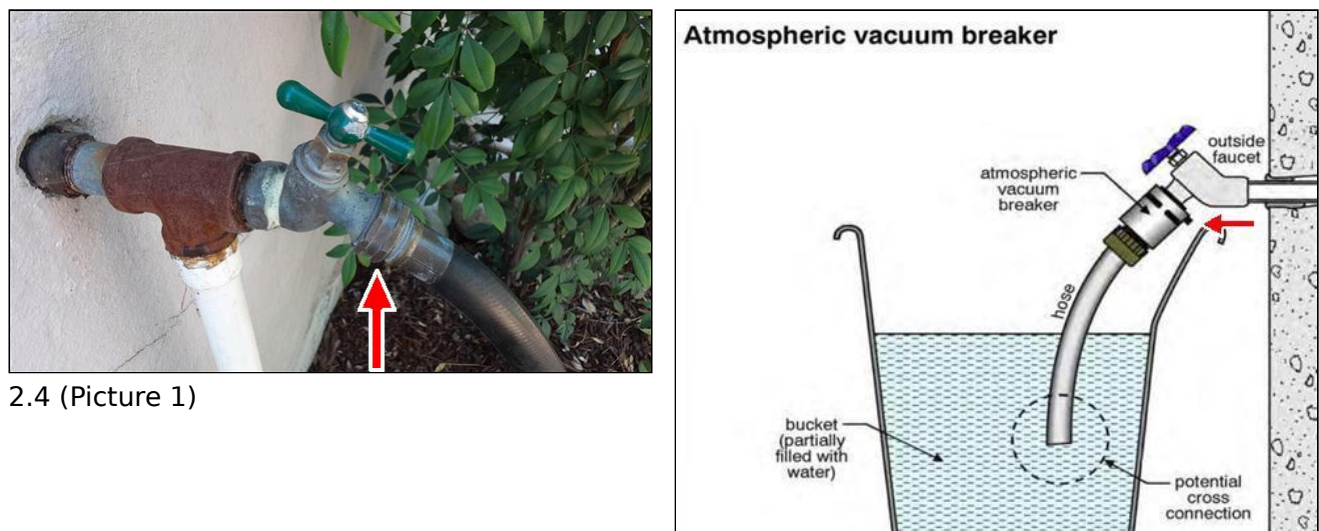
There were no atmospheric vacuum breakers installed on the exterior hose faucets at this house (Picture 1). This is a potential cross connection, for safety and to help prevent soiled water from being pulled back into the house drinking water this situation needs to be properly corrected (please see the drawing of a vacuum breaker installed on a faucet, Picture 2). I recommend contacting a qualified licensed plumbing contractor at this time for installation of these items where needed.

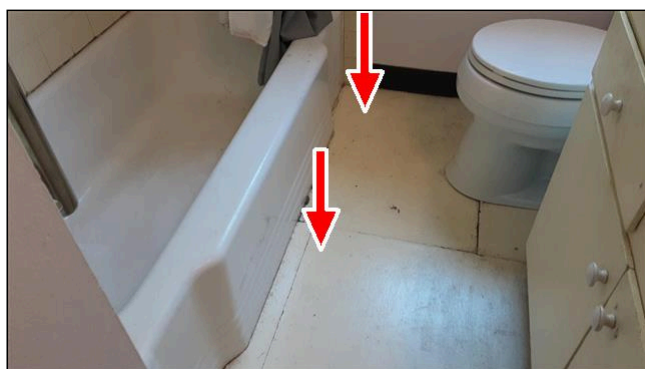
2.5 (Picture 1)

There appeared to be possible water damage noted to the floor between the tub/shower and the toilet area (Picture 1). To prevent further damage this condition needs to be corrected. I recommend contacting a qualified licensed structural pest control company at this time for further details and to determine the extent of the damage and for appropriate corrections as needed.

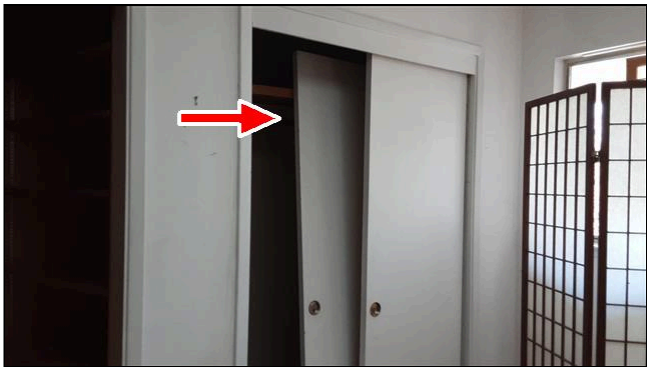
2.6 (Picture 1)

A closet door in the left front bedroom was off the track (Picture 1). This door needs further evaluation and repairs / adjustments to be fully functional. I recommend contacting a qualified licensed general contractor for further evaluation at this time and for corrections as needed.

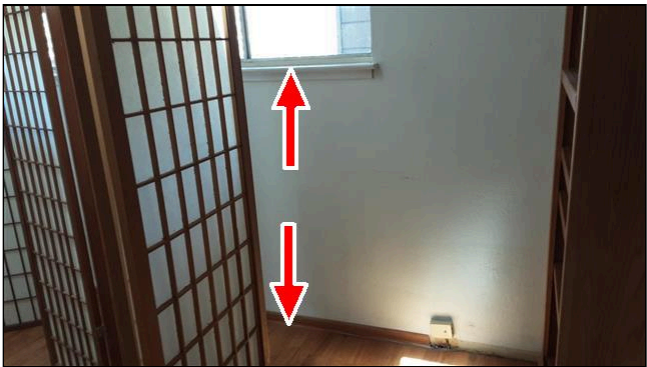
2.6 (Picture 2)

Per modern building standards the bedroom windows were noted to be located too high off of the floor for fire safety and rescue left front bedroom and right front bedroom (Pictures 2 & 3). For increased fire safety, and to meet modern building standards these situations need to be corrected at this time. I strongly recommend contacting a qualified licensed general contractor for further evaluations at this time and corrections.

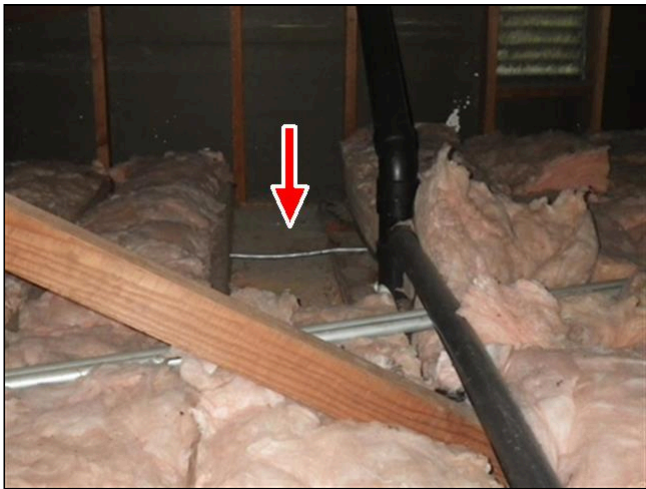
2.8 (Picture 1)

There was some missing insulation in the attic noted over the rear of the house (Picture 1). Properly installing insulation in this area may improve energy efficiency. I recommend contacting a qualified licensed general contractor for further evaluation at this time, and to perform installation where needed.

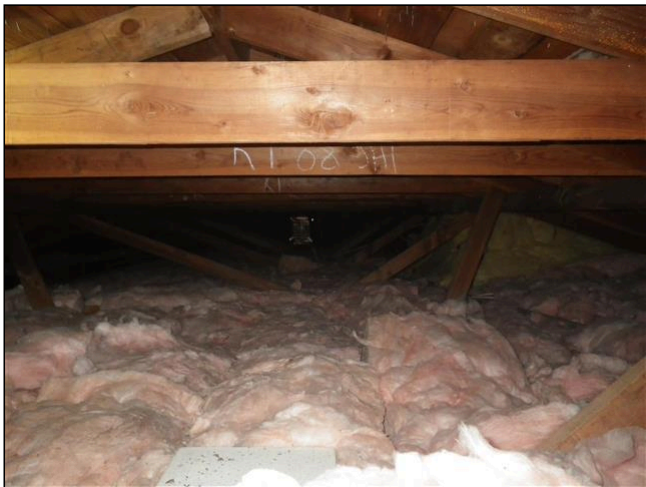
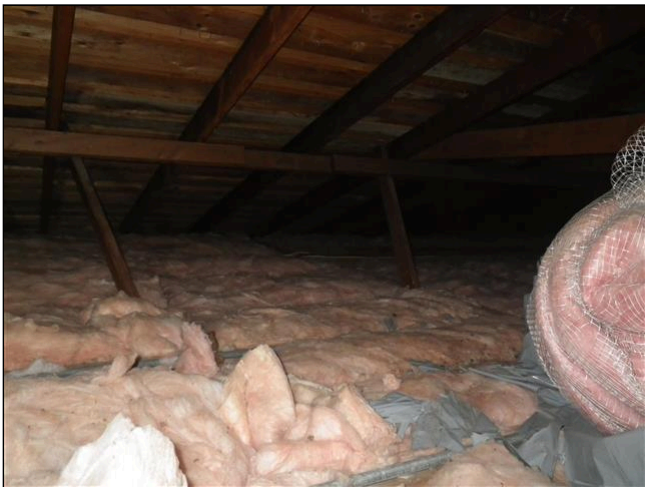
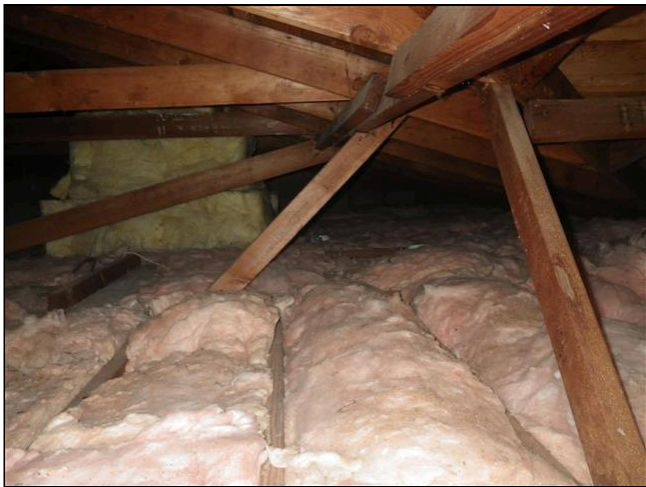
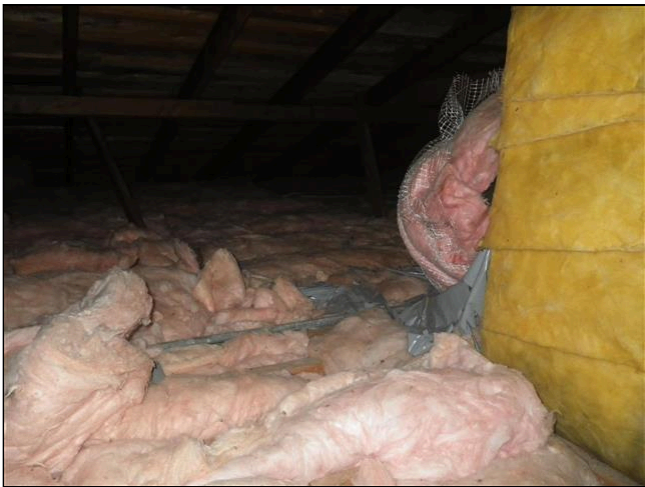
The attic was not accessible beyond the access opening due to the depth of the insulation (Pictures 1-4 are examples). The attic areas beyond the access opening were not entered and were not fully inspected. Conditions in the attic and of the components beyond the immediate access opening are unknown. The attic area contains important structural components, and other systems (electrical, etc), that may or may not need immediate corrections for safety and to help prevent possible damage. For a complete evaluation, these inaccessible areas need to be made accessible and be fully inspected by appropriate qualified licensed contractors.

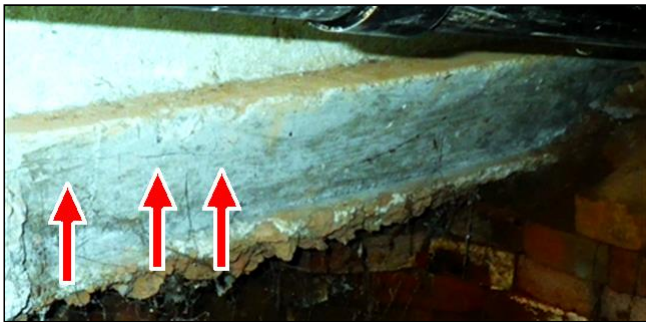
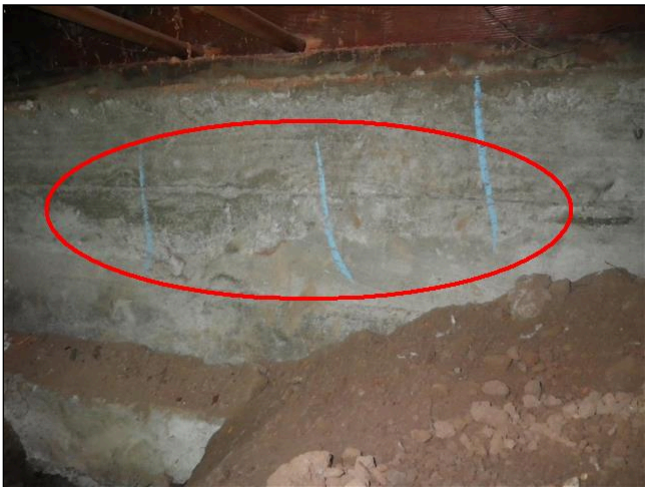
There were two horizontal cracks noted to the foundation between the garage and the left front bedroom (Pictures 1 & 2). These situations all need further evaluation and repairs/maintenance to help prevent further damage, and to restore full support/attachment during seismic events in these areas. I recommend contacting an appropriate qualified licensed contractor for further evaluation of these items at this time and to perform repairs/corrections where needed.

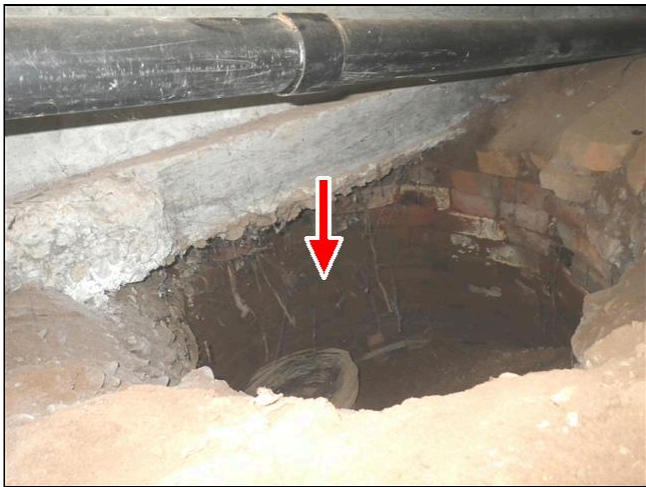
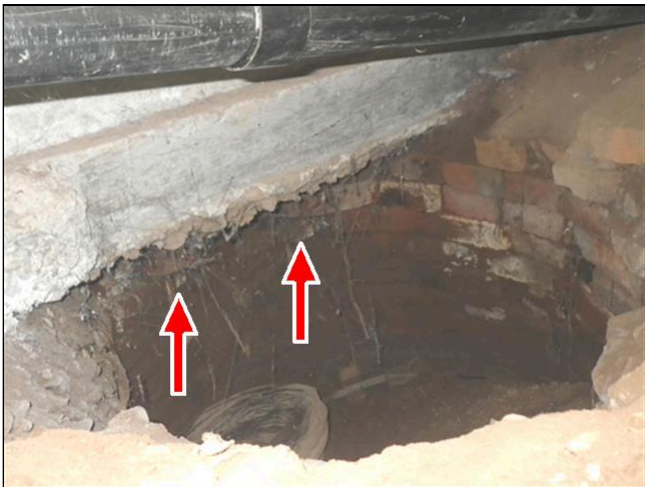
There was a brick lined hole under the left front bedroom (Picture 3) that is partially under the foundation between the garage and the left front bedroom (Picture 4). I could not determine what the purpose of this hole was or had been for. This situation needs further evaluation and corrections to provide full support to the foundation in this area. I recommend contacting an appropriate qualified licensed contractor for further evaluation of this item at this time and to perform corrections as needed.

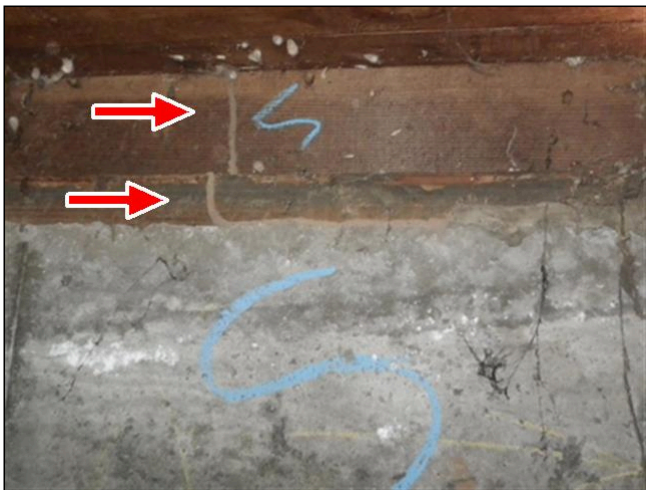
2.11 (Picture 1)

There appeared to be some possible insect activity noted to the wood framing in a few locations (Picture 1 is an example). A current pest control report should be consulted at this time to determine if there is any damage in these areas and the extent of any damage.

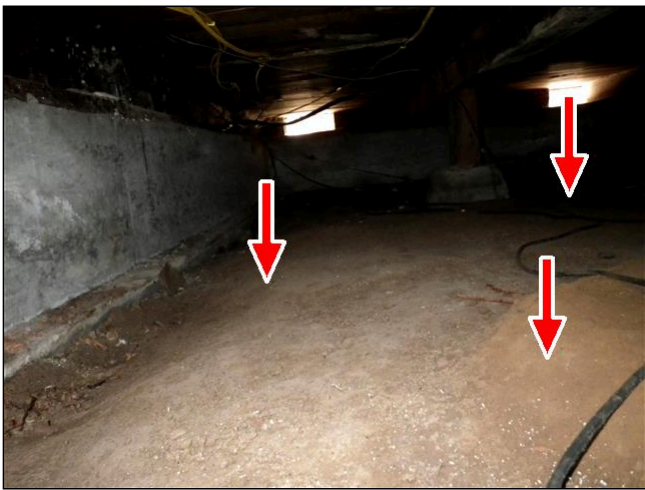
2.11 (Picture 2)

It was damp under the house at this time under the right front bedroom (Picture 2). There was past standing water marks noted under the left rear corner of the house. Please note: We can not determine the source, extent, amount, frequency or possible duration of any current, past or future water intrusion in the sub areas during periods of wet weather, plumbing leaks, or from excessive landscape watering on or off site. We can not determine if this water intrusion leads to, has led to, or will lead to any significant damage to the wood framing, structural steel or to the foundation and support system, any odors, or organic growths. I recommend contacting appropriate qualified licensed engineer(s) at this time for full evaluation of this property and these situations before the removal of any applicable contingency periods, and to perform corrections where needed when appropriate. In addition a current pest control report should be consulted at this time (your own report and any others) concerning this situation to determine if there is any damage as a result of this water intrusion, or damp conditions (past or current), and the extent of any damage.
