## Home Inspection Report

**16513 Bonnie Lane, Los Gatos**

Shawn Anderson  
May 3, 2024

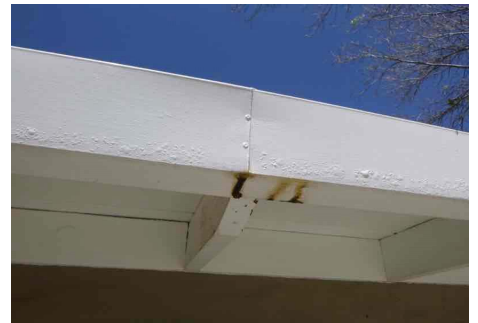
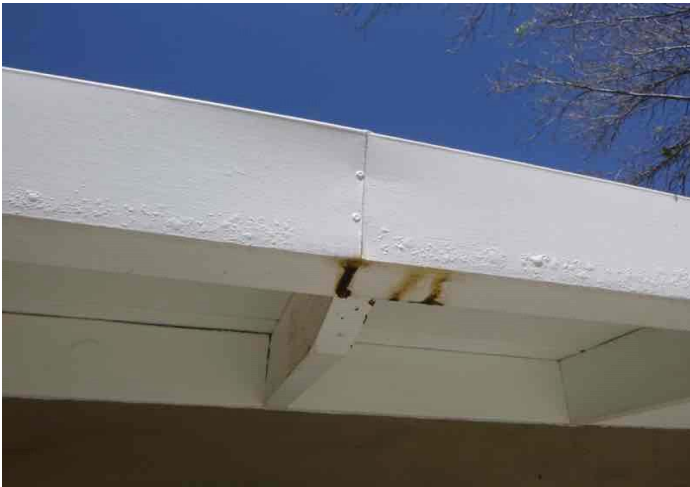
Photo 07

1. Leaks were noted in the downspouts and/or gutters at the front. During wet weather conditions these areas are more obvious and during dry weather conditions they are noted from the stains at the areas where the leaks have occurred. We recommend all leaks be repaired. (See Illustration 2D) (See Photo 7)

- ! 1. Leaks were noted in the downspouts and/or gutters at the front. During wet weather conditions these areas are more obvious and during dry weather conditions they are noted from the stains at the areas where the leaks have occurred. We recommend all leaks be repaired. (See Illustration 2D) (See Photo 7)

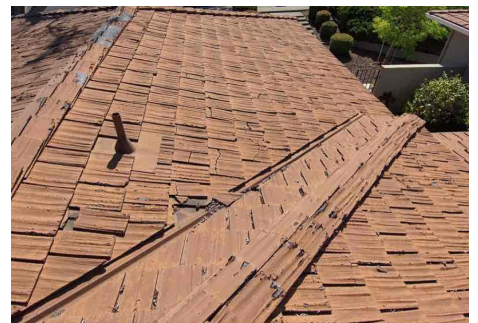
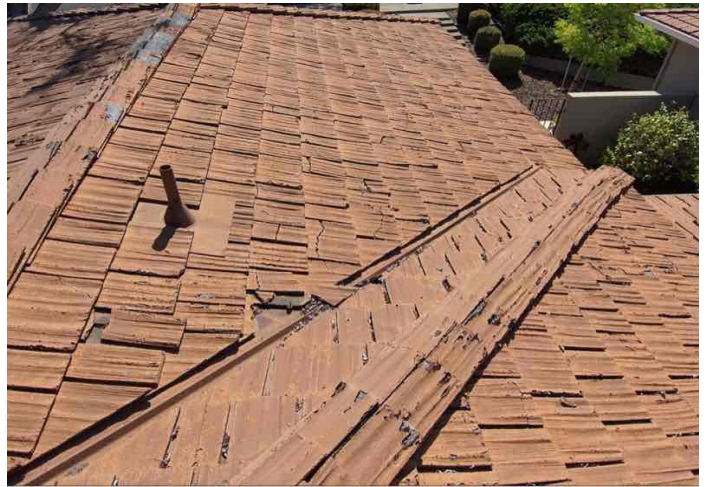
Photo 20

2. The sloped roofing is nearing or past the end of its life cycle. There are a significant number of deteriorated and/or cracked tiles on the ridge and throughout the field. For further evaluation of the condition of the roof we recommend you consult a licensed roofing contractor. (See Photo 20)

- ! 2. The sloped roofing is nearing or past the end of its life cycle. There are a significant number of deteriorated and/or cracked tiles on the ridge and throughout the field. For further evaluation of the condition of the roof we recommend you consult a licensed roofing contractor. (See Photo 20)

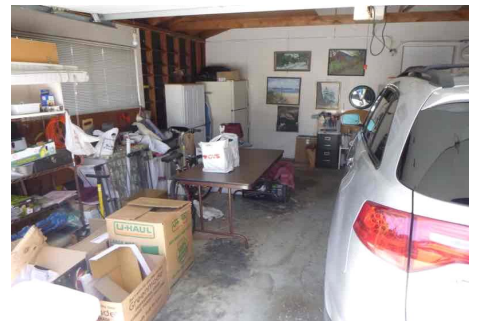
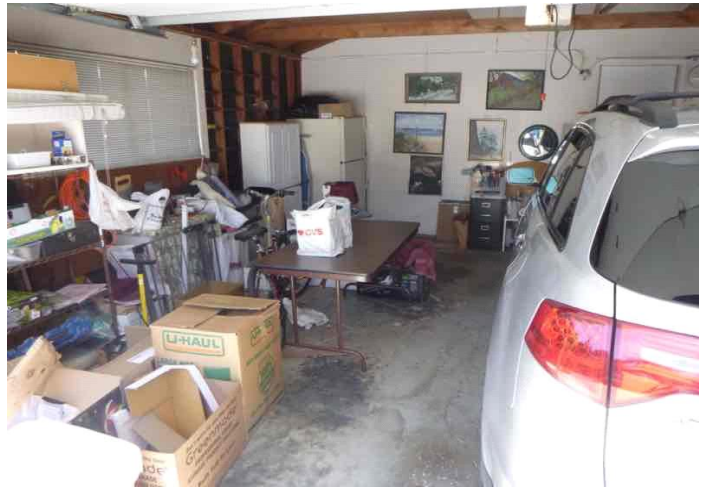
Photo 08

3. Personal storage was blocking access to the interior of the garage. Therefore, the area is considered inaccessible and was not fully inspected. With access and an opportunity for complete inspection, conditions in need of attention may be discovered. Ideally, the personal belongings should be removed so the area may be inspected. (See Photo 8)

Personal storage was blocking access to the interior of the garage. Therefore, the area is considered inaccessible and was not fully inspected. With access and an opportunity for complete inspection, conditions in need of attention may be discovered. Ideally, the personal belongings should be removed so the area may be inspected. (See Photo 8)

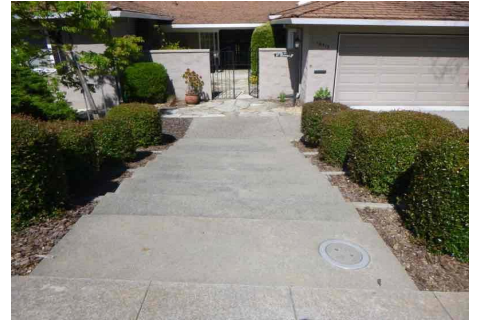
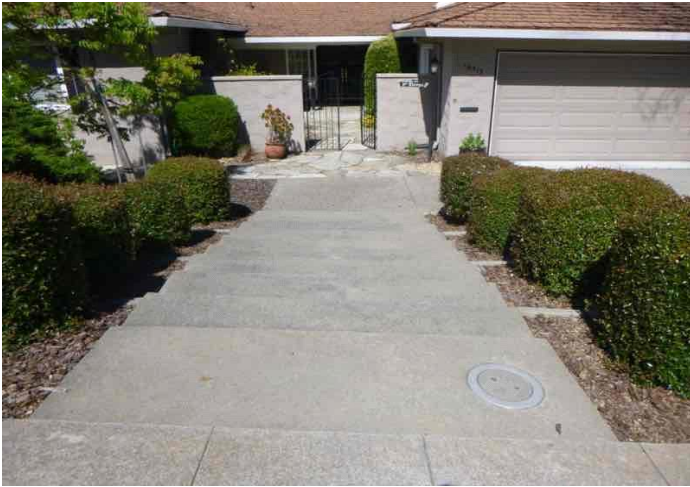
Photo 01

4. For safety purposes, railing(s) should be provided at the front. (See Illustration 3J) (See Photo 1)

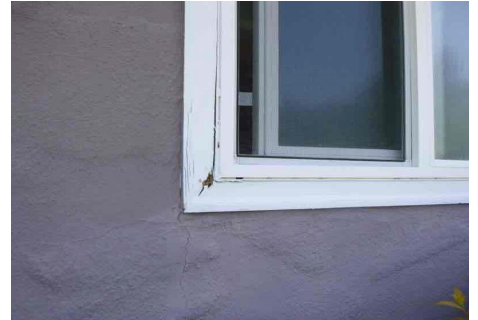
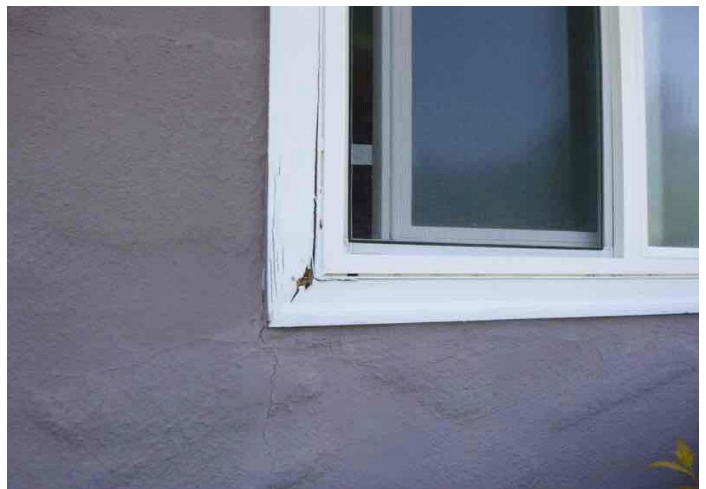
Photo 10

5. The window trim at the left side shows evidence of water damage. We recommend the advice and services of a general contractor and/or structural pest control company regarding repairs. (See Photo 10)

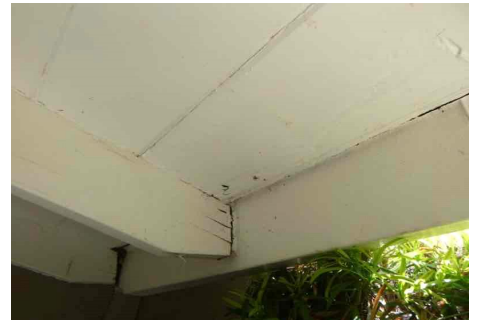
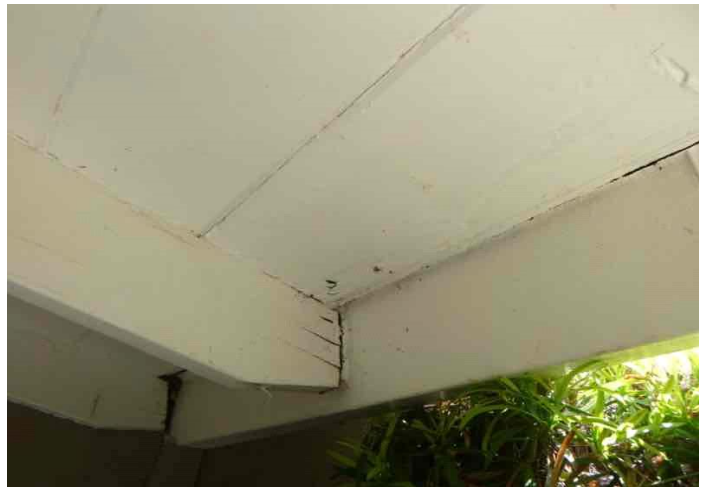
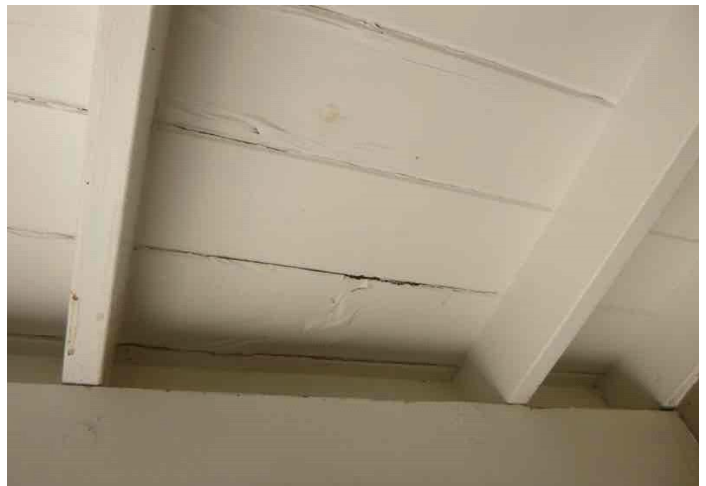
Photo 04

6. Water damage was observed to the roof eaves/sheathing at the front. We recommend the services of a licensed general contractor and/or structural pest control company. (See Photo 4) (See Photo 6)

- ! 3. Water damage was observed to the roof eaves/sheathing at the front. We recommend the services of a licensed general contractor and/or structural pest control company. (See Photo 4) (See Photo 6)

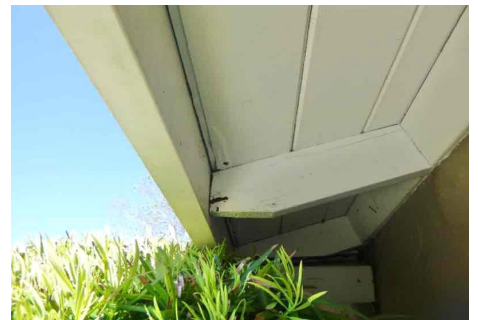
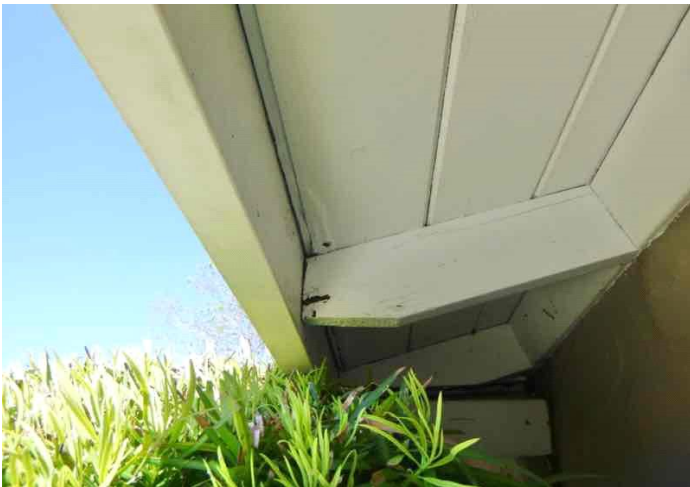
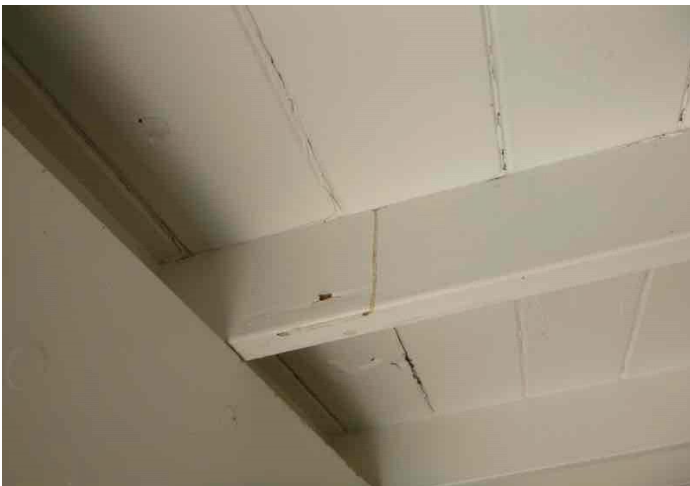
Photo 03

7. Water damage was observed to the rafter tails at the front. We recommend the services of a licensed general contractor and/or structural pest control company. (See Photo 3) (See Photo 5)

- ! 4. Water damage was observed to the rafter tails at the front. We recommend the services of a licensed general contractor and/or structural pest control company. (See Photo 3) (See Photo 5)

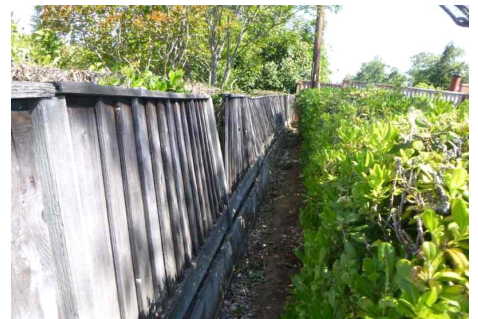
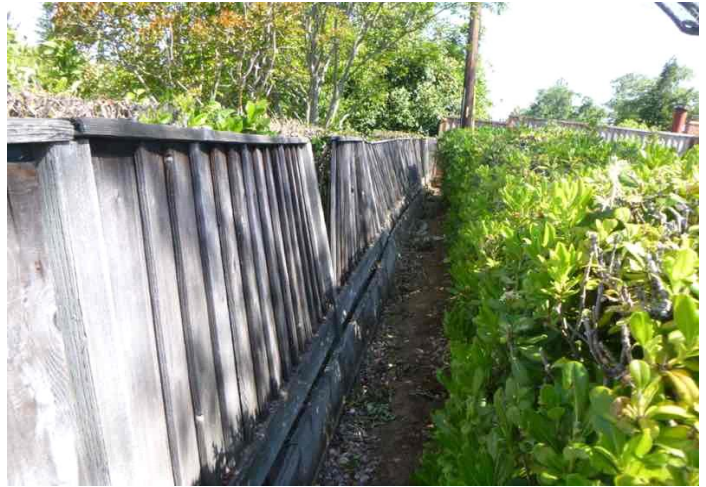
Photo 02

8. The fence is in satisfactory condition, however one or more fence posts are loose at the rear. We recommend all loose, damaged or deteriorated posts be reinforced or replaced as necessary. (See Photo 2)

- ! 5. The fence is in satisfactory condition, however one or more fence posts are loose at the rear. We recommend all loose, damaged or deteriorated posts be reinforced or replaced as necessary. (See Photo 2)

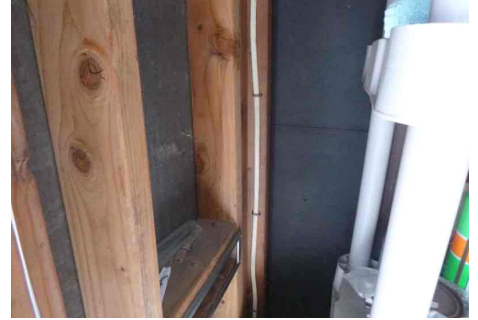
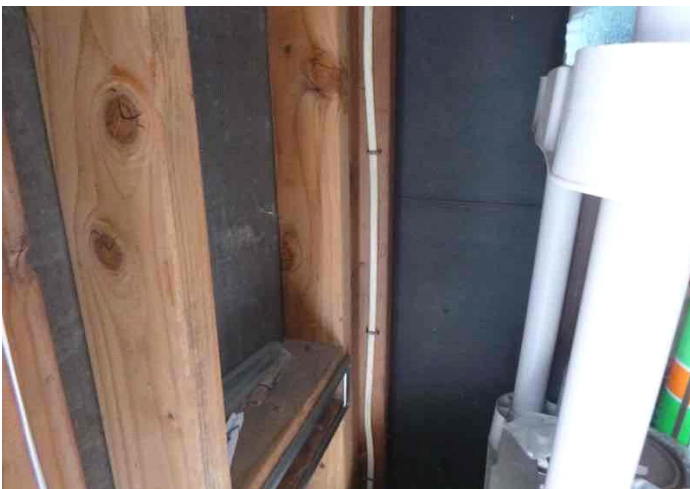
Photo 09

9. We found exposed wiring at the garage walls below 7' feet. Even if insulated, we recommend all wiring be encased in conduit or otherwise protected in accordance with present standards. (See Illustration 4E) (See Photo 9)

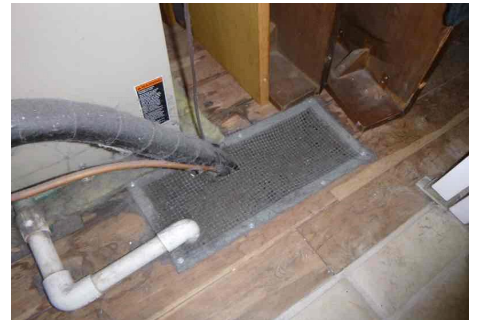
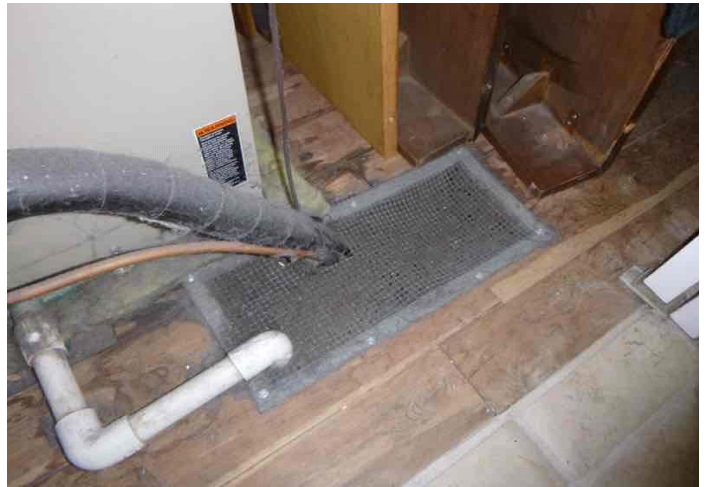
Photo 14

10. The combustion air and/or draft air upper and/or lower vents for the heating system appears to be clogged. This condition limits proper cross ventilation. We recommend improvements. (See Photo 14)

- ! 1. The combustion air and/or draft air upper and/or lower vents for the heating system appears to be clogged. This condition limits proper cross ventilation. We recommend improvements. (See Photo 14)

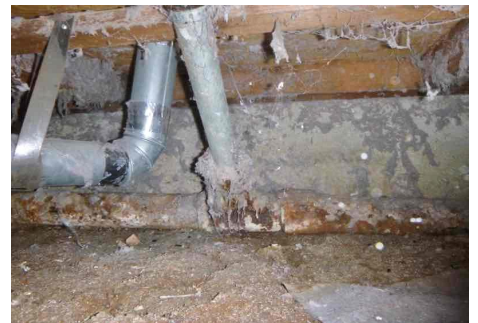
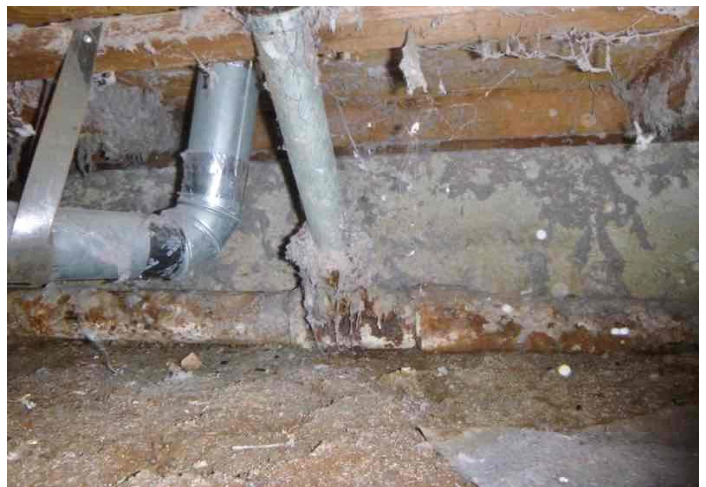
Photo 18

11. The drain is deteriorated and leaking into the crawl space under the laundry room. We recommend all leaks be repaired. (See Photo 18)

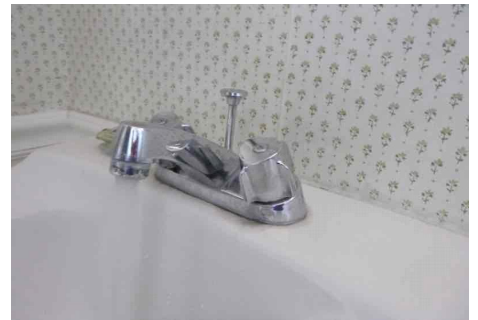
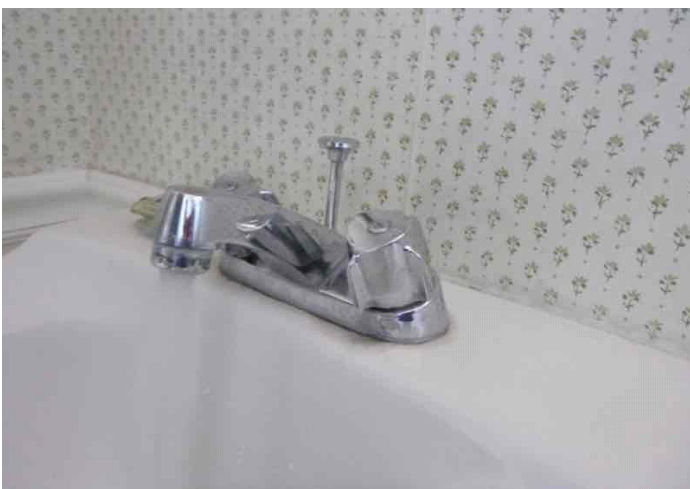
Photo 11

12. The sink faucet handles leak at the half bathroom. We recommend all leaks be repaired. (See Photo 11)

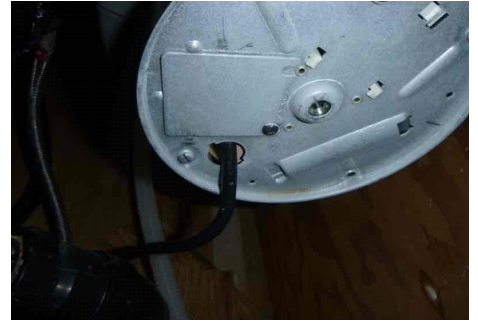
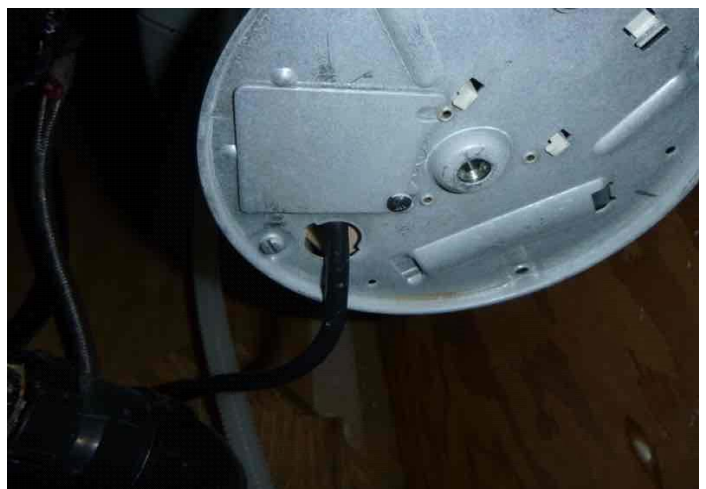
Photo 12

13. The power cord is not secured where it enters the bottom of the disposal and can be easily damaged. For maximum safety, we recommend the power cord be properly connected to the disposal. (See Illustration 9H) (See Photo 12)

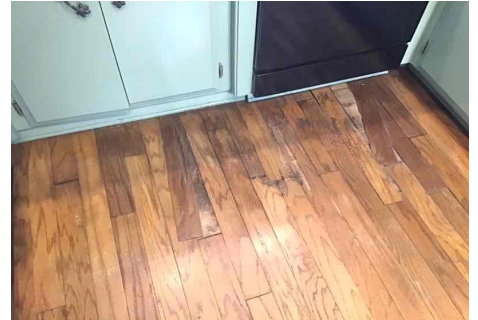
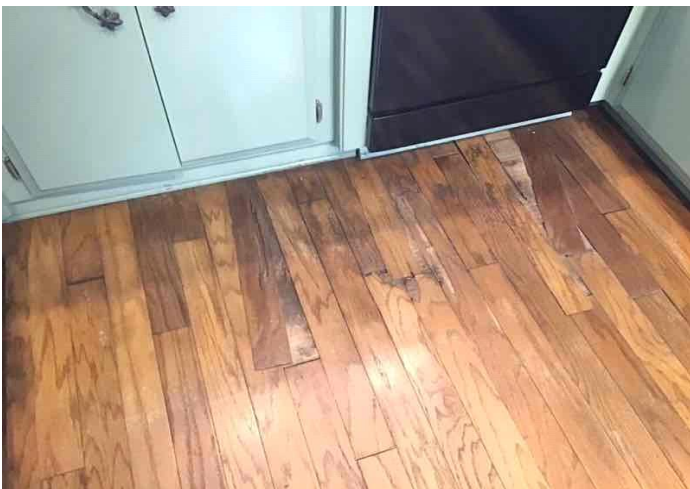
Photo 21

14. Evidence of water damage at the kitchen floor was observed. The extent of the damage is difficult to predict without removing floor coverings. We recommend the services of a licensed structural pest control operator for investigation of this condition. (See Photo 21)

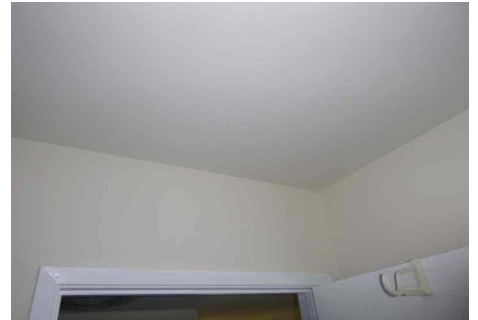
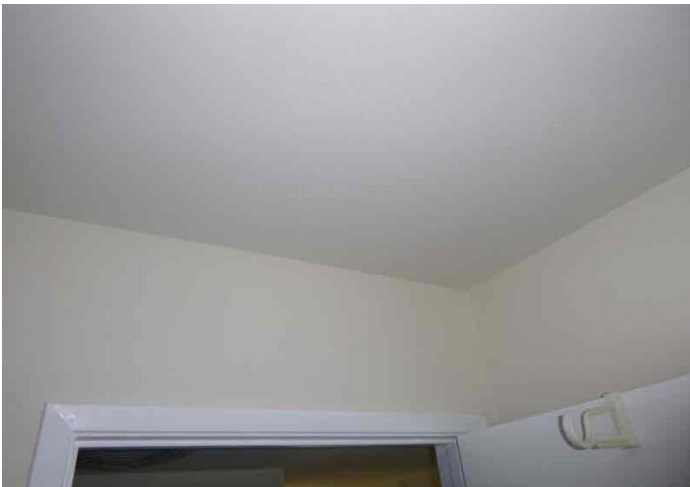
Photo 15

15. This home does not have enough smoke detectors installed. The installation of smoke detectors should be placed on each floor in non-sleeping areas. In addition, one smoke alarm must be installed in each room where sleeping occurs and one smoke alarm should be located in each hallway that leads directly to sleeping rooms. (See Photo 15)

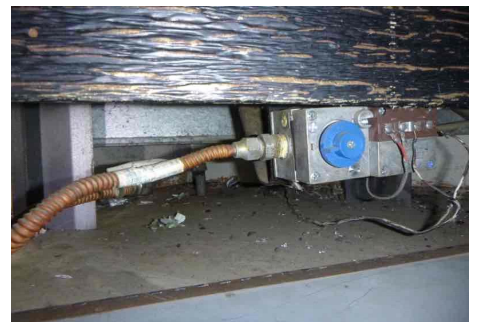
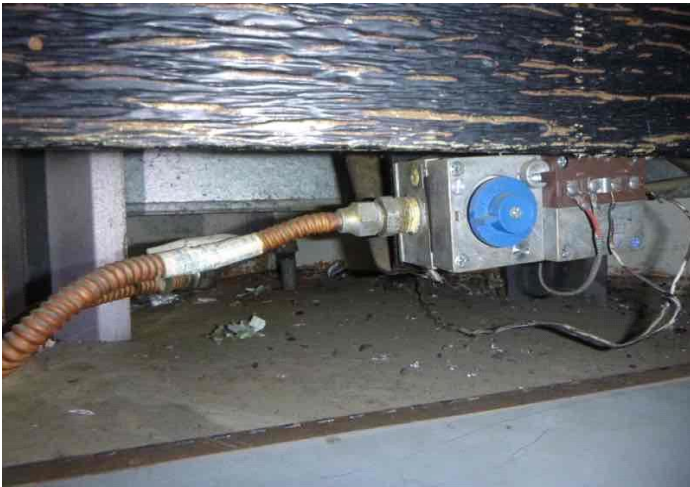
Photo 13

16. The cosmetic gas fireplace was not operational at the time of our inspection, possibly due to the system being turned off. We cannot offer opinions about system performance or general condition. We recommend the fireplace be tested when the system has been restored or repaired. (See Photo 13)

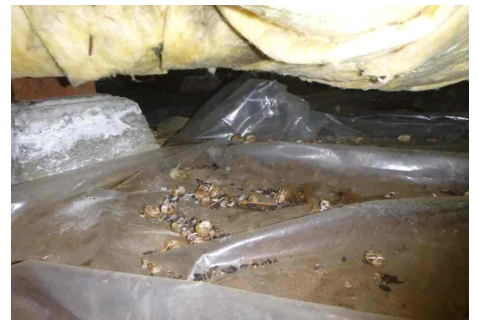
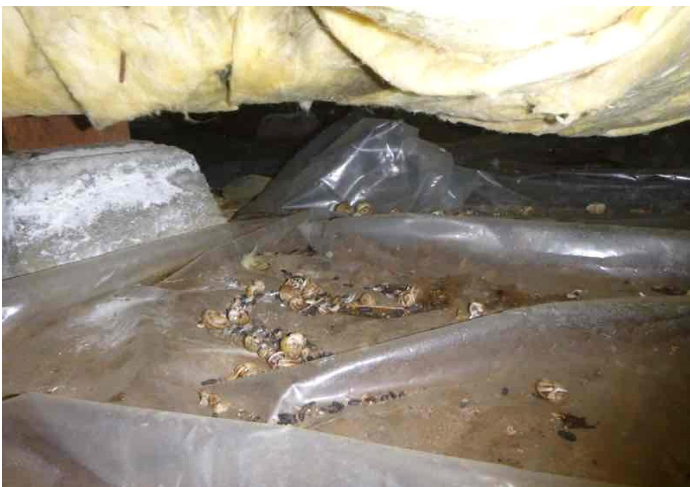
Photo 17

17. Evidence of vermin activity was observed within the structure. It is likely this evidence will extend into inaccessible areas. The owner is advised to contact the appropriate trade for further evaluation and remedial measures if necessary. (See Photo 17)

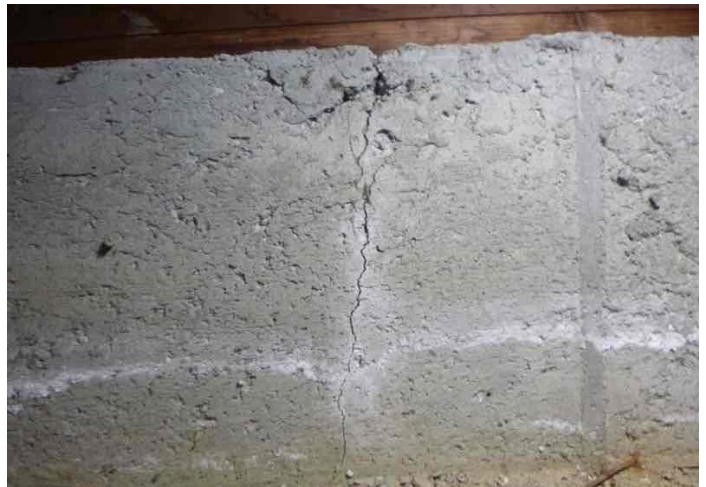
Photo 16

1. Minor vertical cracks were observed in the foundation walls of the structure. Smaller foundation cracks are not uncommon and often indicate some settlement and/or movement may have occurred. The rate of movement cannot be predicted during a one-time inspection. A thorough evaluation of this condition is beyond our qualifications. For additional information we recommend contacting a licensed foundation contractor for further evaluation. (See Photo 16)

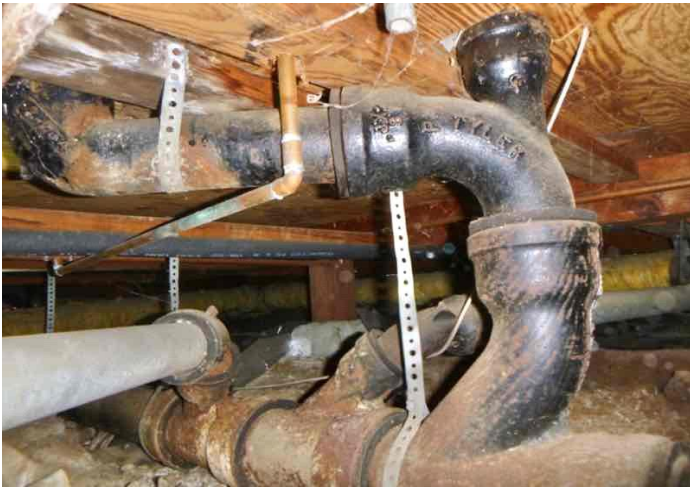
Photo 19

1. The metallic drain piping may be nearing the end of its effective service life. Older piping is subject to corrosion on the interior and/or exterior which may result in clogging and eventual leakage. We recommend the piping be further evaluated by a licensed plumbing contractor to determine if replacement or repair is necessary. (See Photo 19)
