# Beresheet Probe Crash Report

Based on: <https://davidson.weizmann.ac.il/en/online/sciencepanorama/what-happened-beresheet>

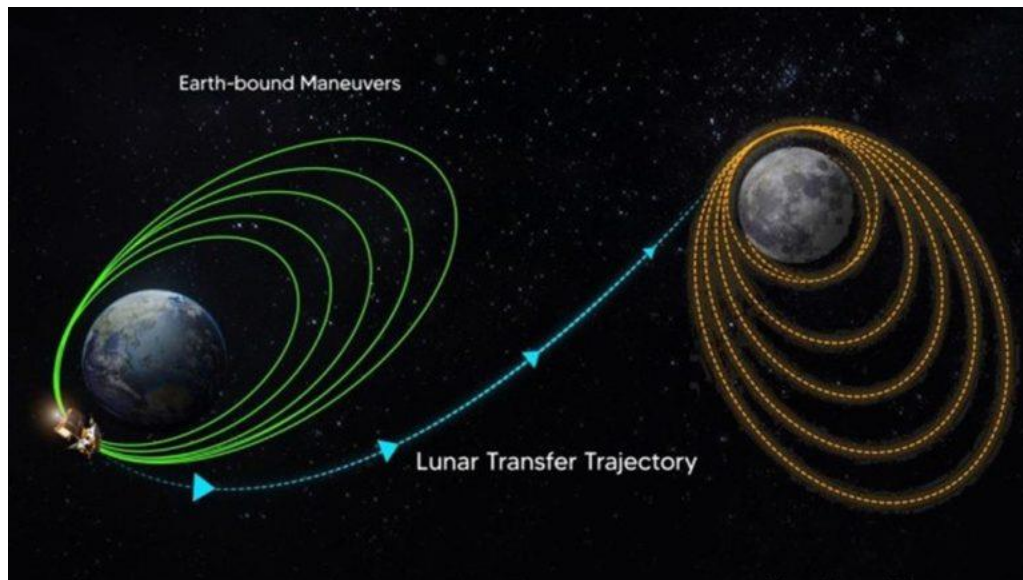
While making its way to the moon, the single onboard computer kept unexpectedly rebooting itself and attempting to cancel planned orbital maneuvers:

Clearly, these maneuvers are critical to the mission and missing even one maneuver could cost the mission. This may have been caused by damage to the craft's electrical box by radiation exposure or other external factors. It has also been revealed that the electrical box has not been tested for space.

- Single onboard computer introduced another single point of failure.
- Star trackers could have incorporated better shielding.
- Spacecraft had minimal radiation protection due to budget, which caused issues with the single onboard computer.

- The onboard electronic box was never tested in space. It should have been tested and certified for space condition.
