Simulation : False
Vessel : Ranform Atlas
Date : Tue May 16 21:27:10 2017
Author : Berenguer Yoann
Version : beta 1.01

Wings Condition monitoring

Wing QC checks

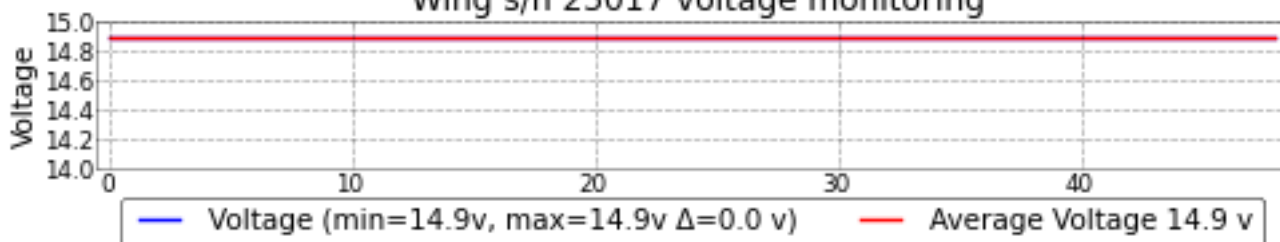
Wing s/n 23017 voltage monitoring

Cannot be used in production.

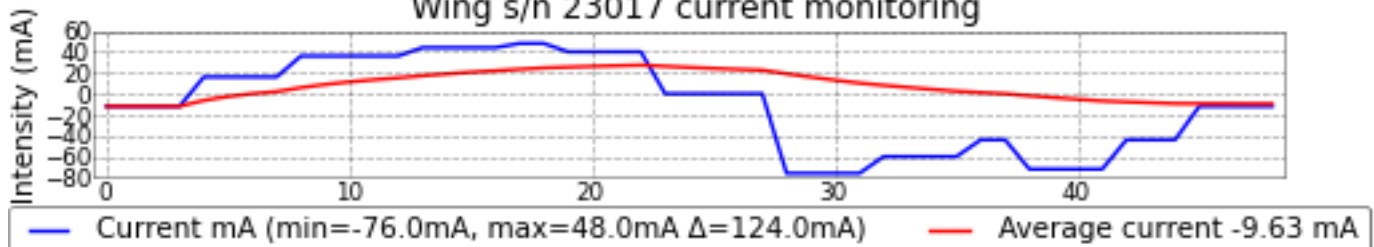
Wing s/n 23017 current monitoring

Wing is depleting. Investigate flags and duty cycle

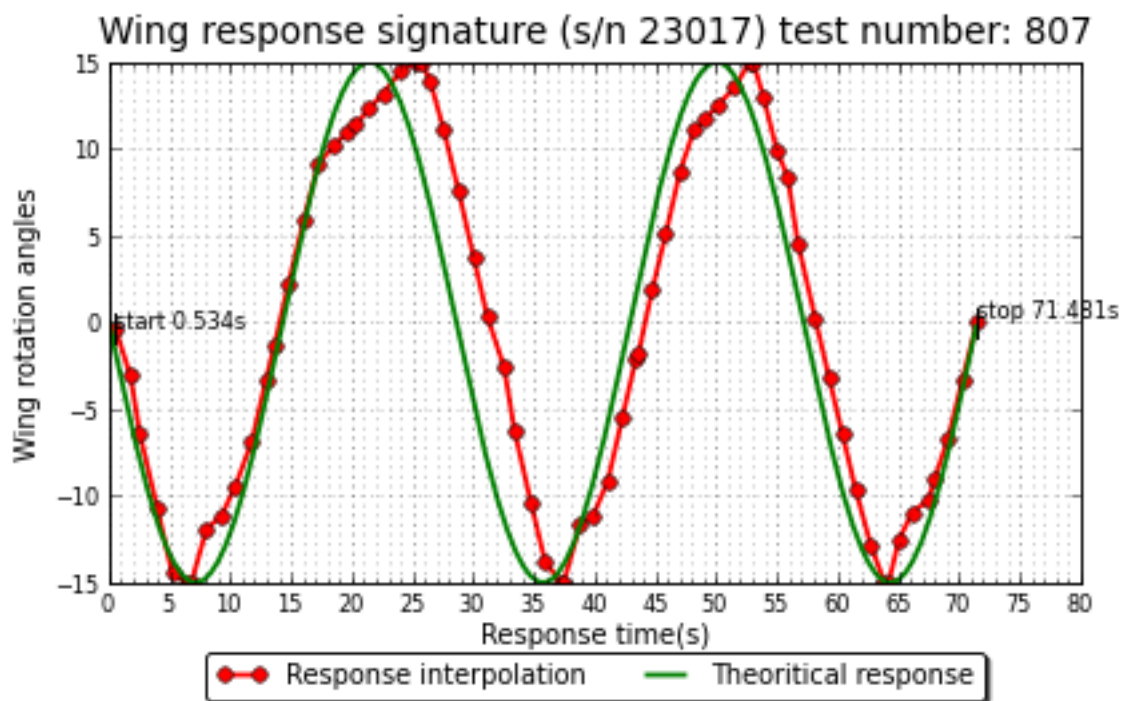
Speed (this test) : 71.481 seconds

Warning! motor speed is lower than average

Pool classement : 99/102
