Body port : 3
Simulation : OFF
Vessel : Ranform ATLAS
Date : Tue May 30 16:14:02 2017
Author : ATLAS seismic crew
Version : beta 1.01
Test DB : ReportDB_Tue May 30 16:13:59 2017.sq3

Wings Condition monitoring

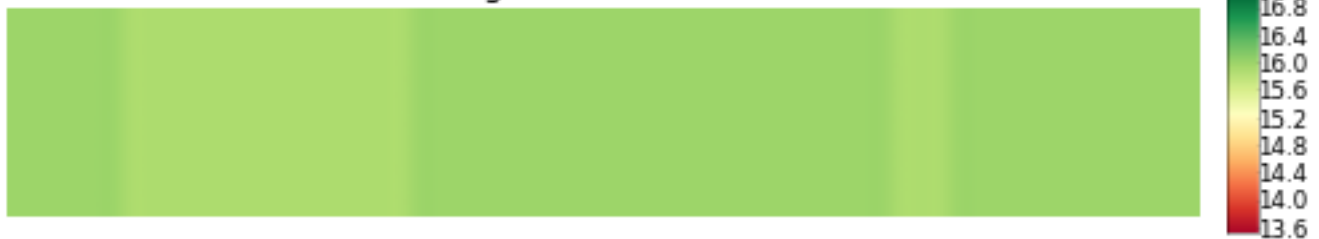
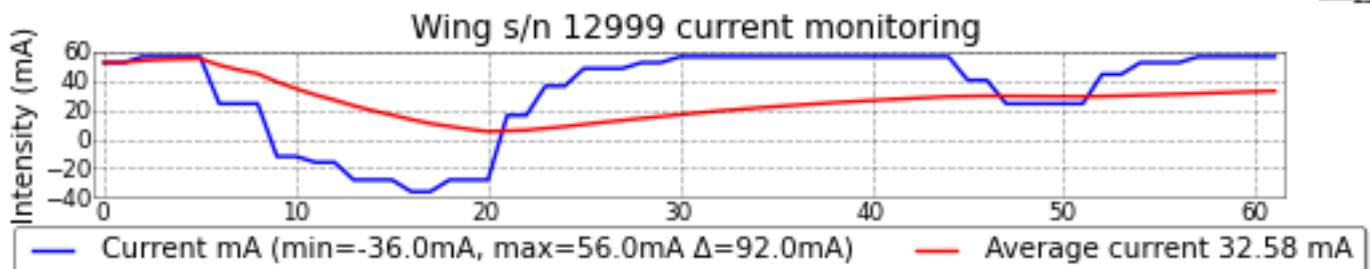
Voltage variation matrice

| Average voltage: 15.97 v | | Need charging, operator to decide if suitable for production. |
