Body port : 1
Simulation : OFF
Vessel : Ranform ATLAS
Date : Tue May 30 15:32:24 2017
Author : ATLAS seismic crew
Version : beta 1.01
Test DB : ReportDB_Tue May 30 15:32:20 2017.sq3

Wings Condition monitoring

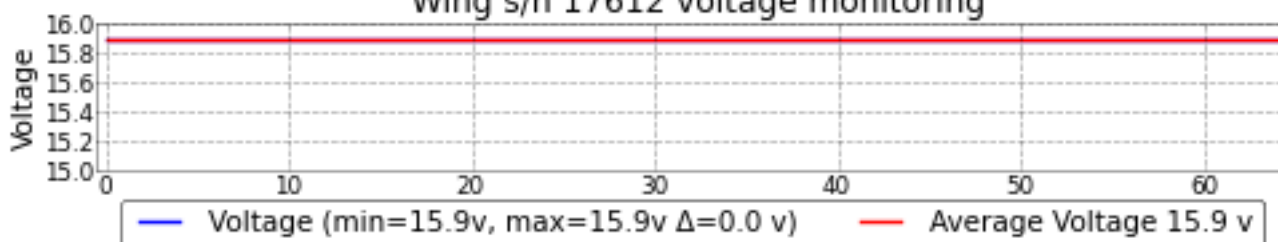
Wing s/n 17612 voltage monitoring

Maximum voltage: 15.9 v		
Minimum voltage: 15.9 v		
Average voltage: 15.9 v		Need charging, operator to decide if suitable for production.
Voltage variation: 0.0 v

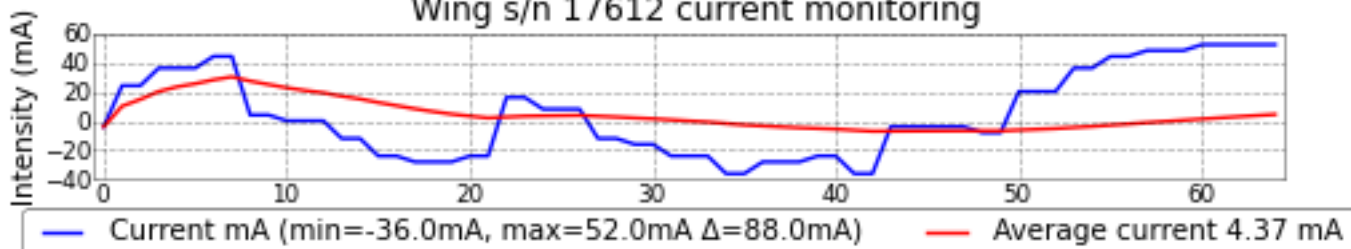
Wing s/n 17612 current monitoring

Maximum current: 52.0 mA		Wing has been charging
Minimum current: -36.0 mA		
Average current: 4.37 mA		
Current variation: 88.0 mA		
Charging capacity: 60.51 mA/H		Wing charging.

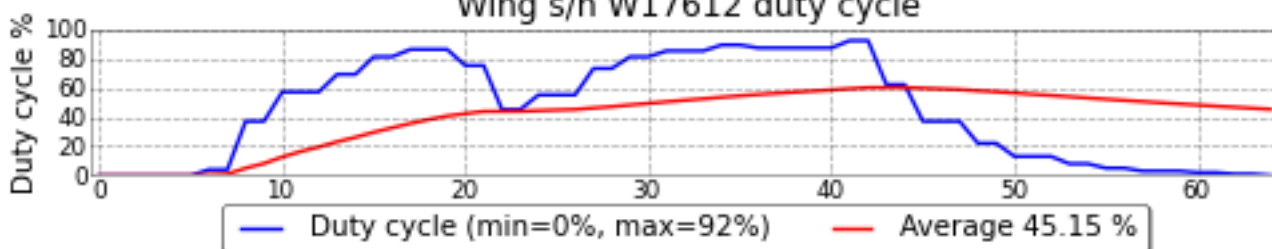
Wing s/n W17612 duty cycle

Maximum duty cycle: 92 %	
Minimum duty cycle: 0 %	
Average duty cycle: 45.15 %

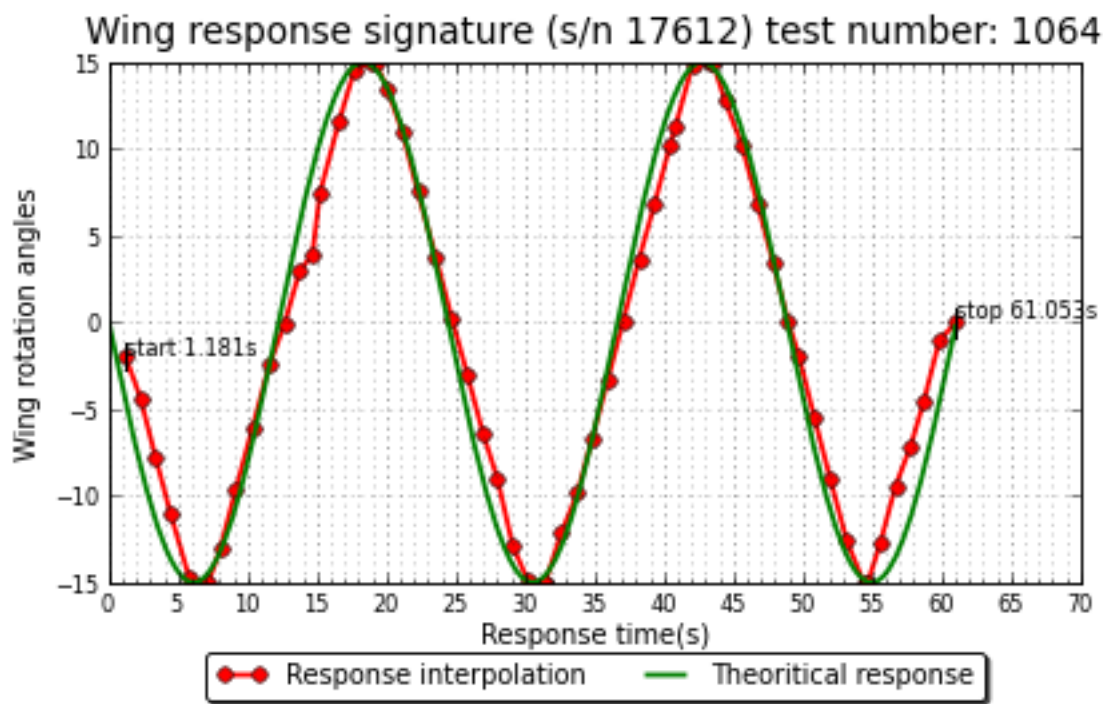
Best performance	Result average	Worst performance
61.053s	61.053s	61.053s

Pool average speed : 60.135 seconds

Speed (this test) : 61.053 seconds

Warning! motor speed is lower than average

Pool classement : 113/150

Recommendation: A test should always be followed by a wing cover inspection and a manual wing rotational test to detect loose mechanism.
