Simulation : False  
Vessel : Ranform Atlas  
Date : Wed May 3 23:36:39 2017  
Author : Berenguer Yoann  
Version : beta 1.01

## Body Condition monitoring

## Body QC checks

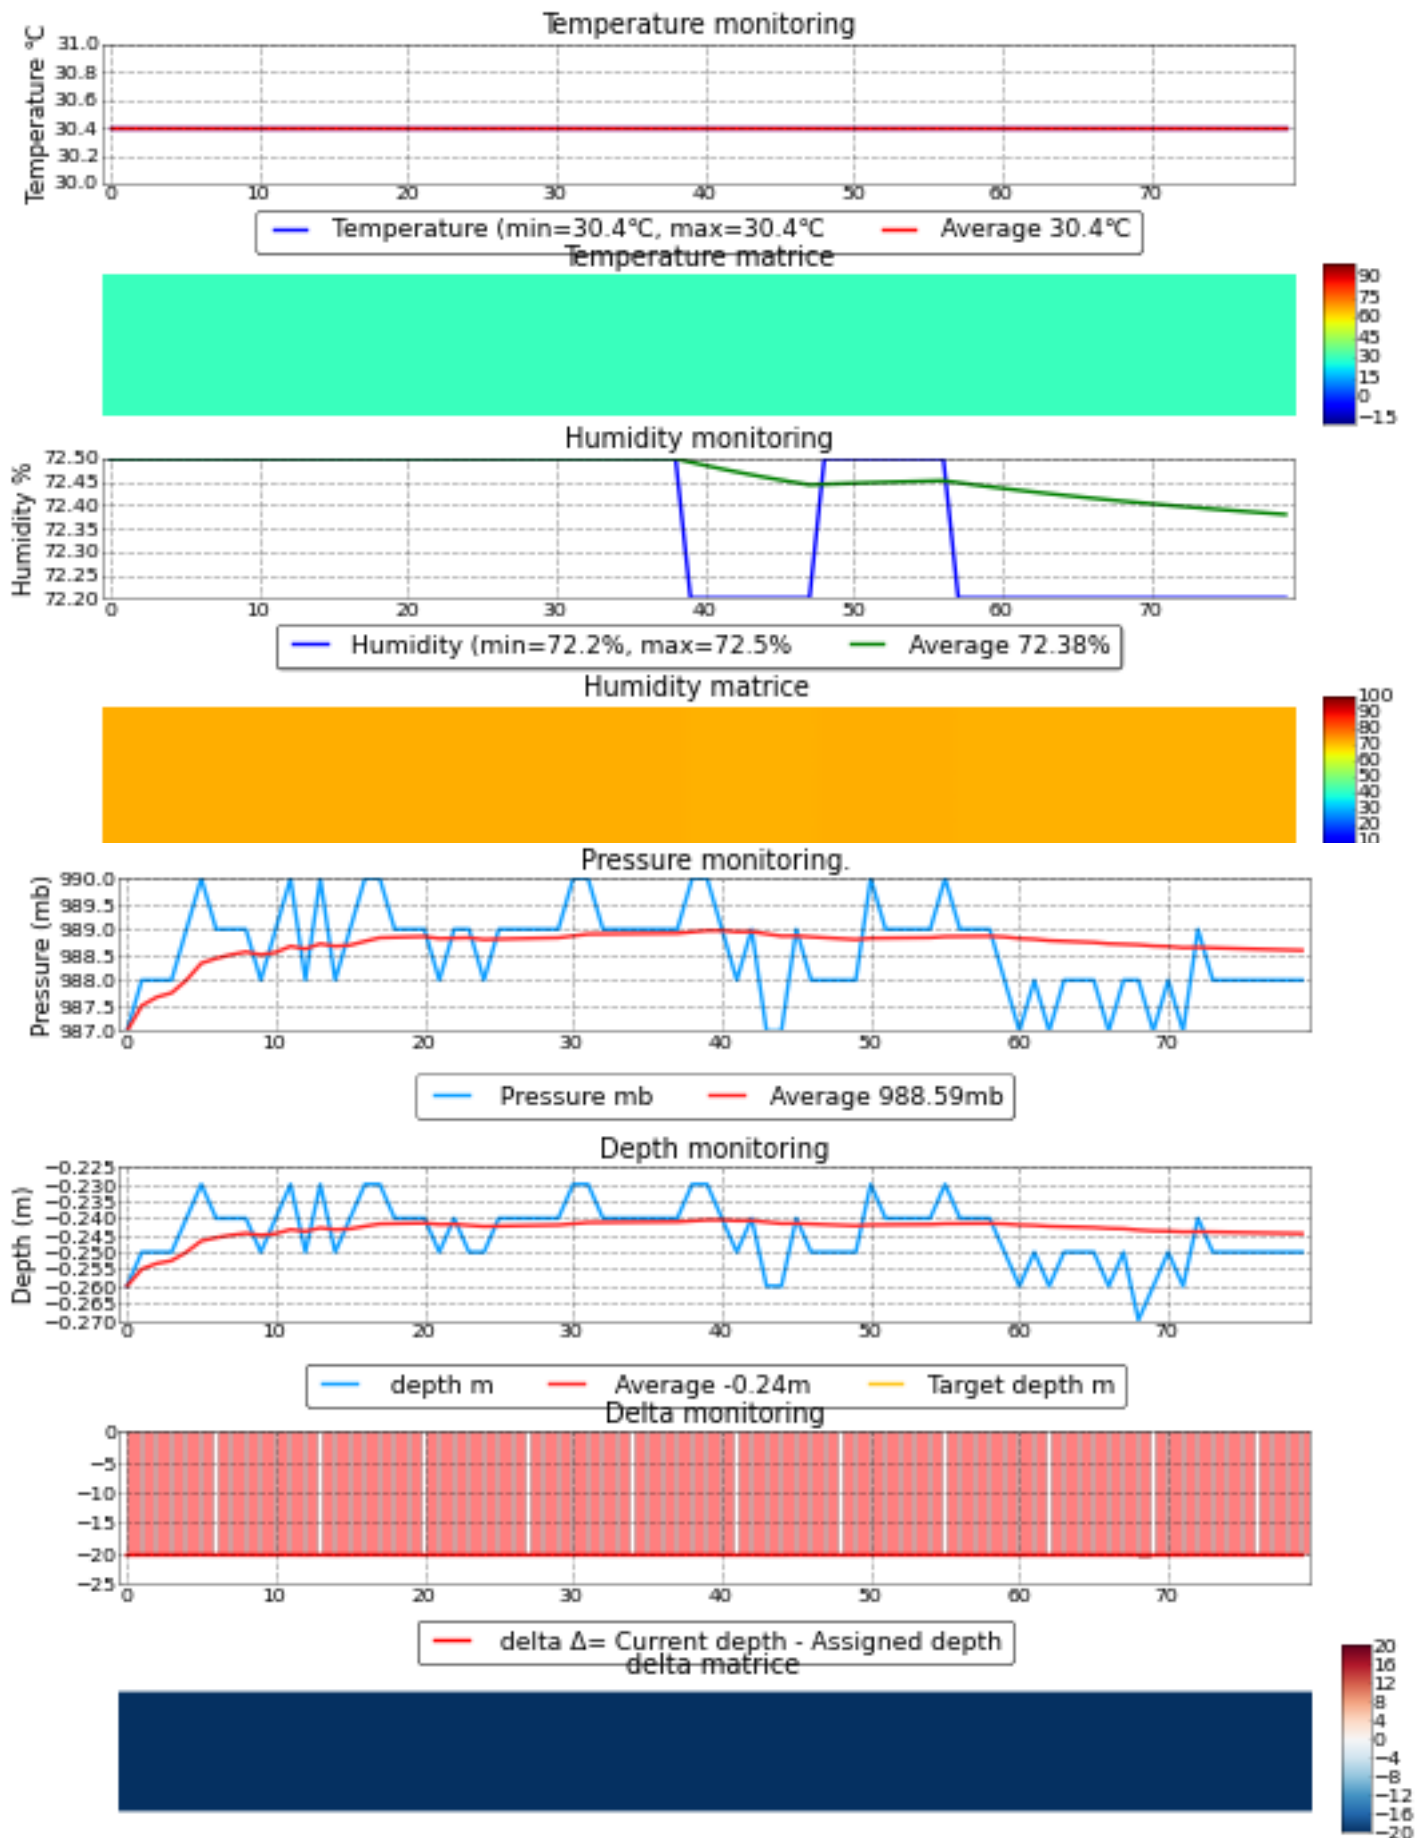
## Body temperature, humidity, pressure & depth

Humidity is high

High humidity, need investigation

DT needs recalibration

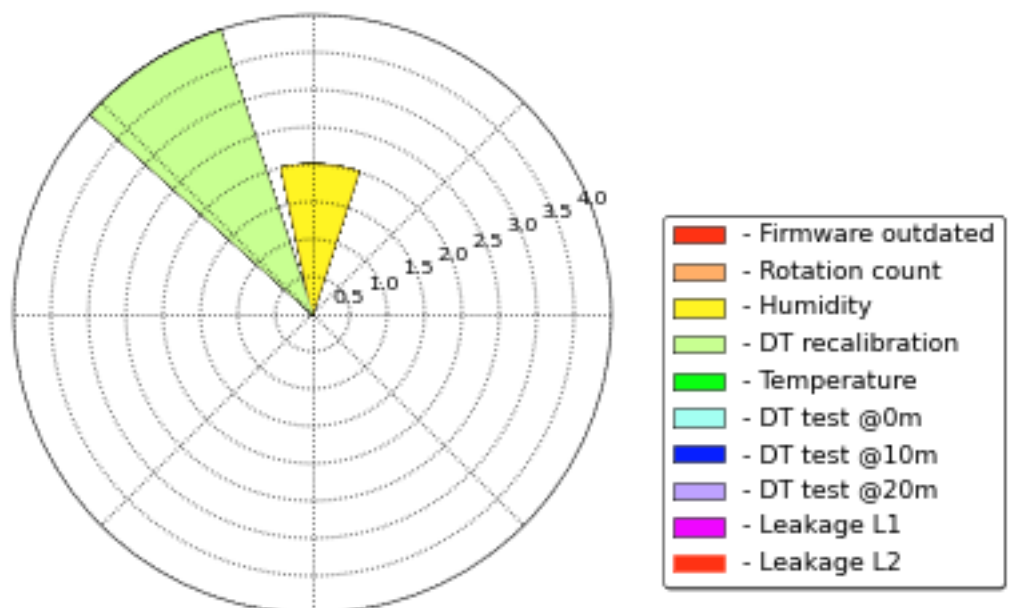
Element : - Firmware outdated	Severity: 0	Pass
Element : - Rotation count	Severity: 0	Pass
Element : - Humidity	Severity: 2	Warning
Element : - DT recalibration	Severity: 4	Fail
Element : - Temperature	Severity: 0	Pass
Element : - DT test @0m	Severity: 0	Pass
Element : - DT test @10m	Severity: 0	Pass
Element : - DT test @20m	Severity: 0	Pass
Element : - Leakage L1	Severity: 0	Pass
Element : - Leakage L2	Severity: 0	Pass

# Fail
