Inspection Form

Score	85.71%	Flagged items	1	Actions	0
Customer Name					
Mobile:					
Email:					
Address:					
Property Age (In years):					
Property Type:				Flat	
Floors:				11	
Previous Structural audit done				No	
Previous Repair work done				No	
Inspection Date and Time:				27.09.2022 14:28 IST	
Inspected By:				Krushna & Mahesh

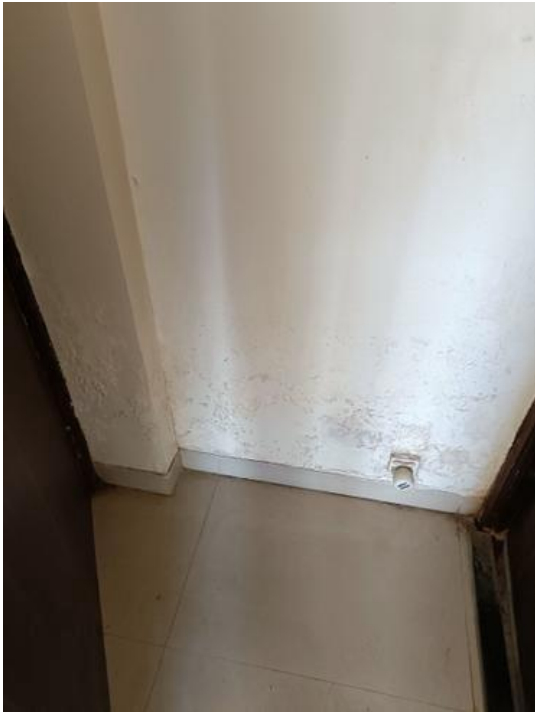
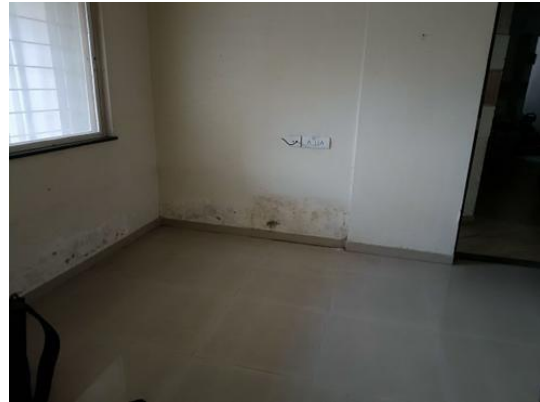
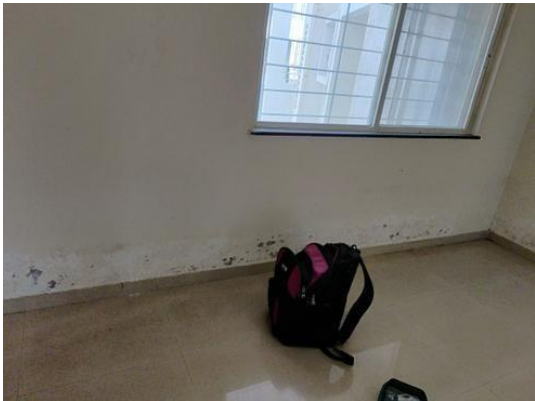
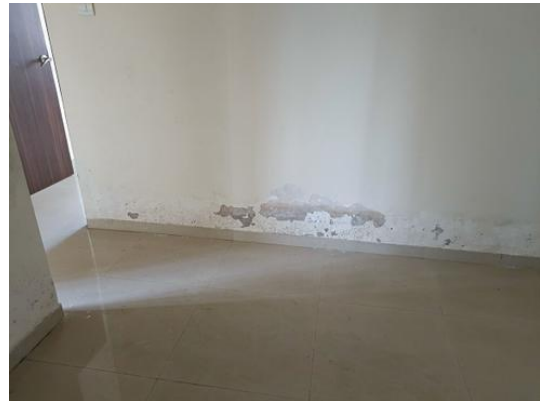
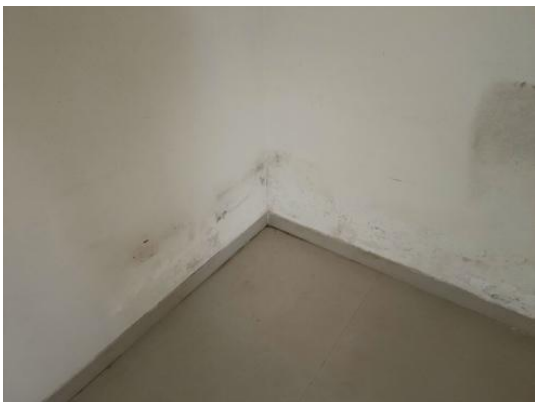
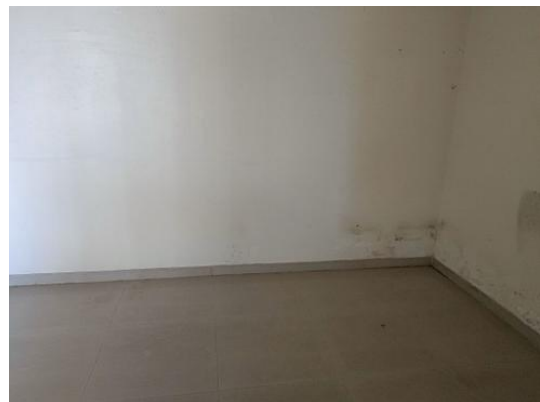
Hall Skirting level Dampness

Point No	Impacted area (-ve side)	Point No	Exposed area (+ve side)
1	Observed dampness at the skirting level of Hall of Flat No. 103	1.1	Observed gaps between the tile joints of Common Bathroom of Flat No. 103
2	Observed dampness at the skirting level of the Common Bedroom of Flat No. 103	2.1	Observed gaps between the tile joints of Common Bathroom of Flat No. 103
3	Observed dampness at the skirting level of Master Bedroom of Flat No. 103	3.1	Observed gaps between the tile joints of Master Bedroom Bathroom of Flat No. 103
4	Observed dampness at the skirting level of Kitchen of Flat No. 103	4.1	Observed gaps between the tile joints of Master Bedroom Bathroom of Flat No. 103
5	Observed dampness & efflorescence on the wall surface of Master Bedroom of Flat No. 103	5.1	Observed cracks on the External wall of building near Master Bedroom of Flat No. 103
6	Observed leakage at the Parking ceiling below Flat No. 103	6.1	Observed plumbing issue & gaps between the tile joints of Common Bathroom of Flat No. 103

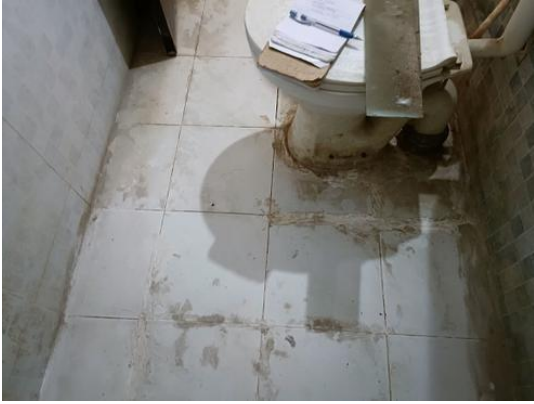
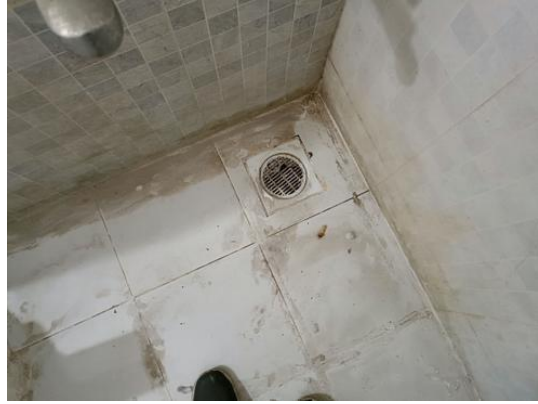
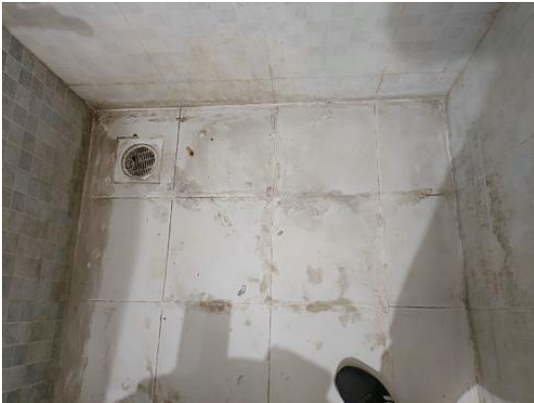
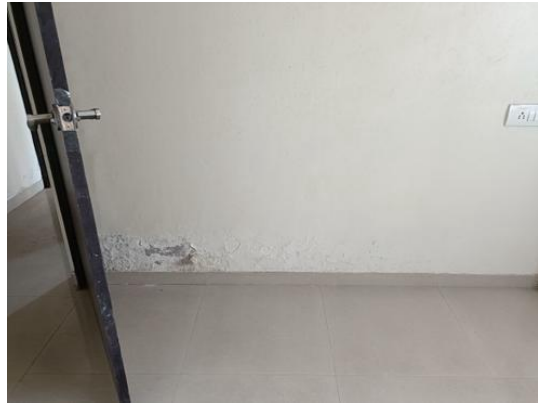
Common Bathroom tile
hollowness

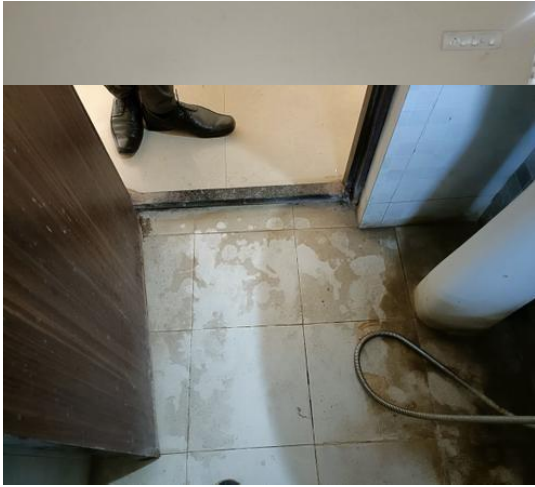
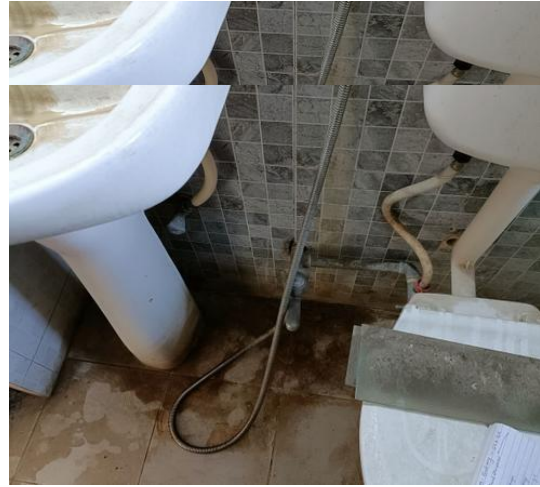
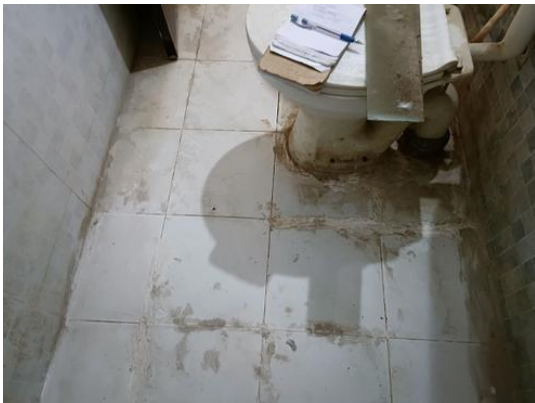
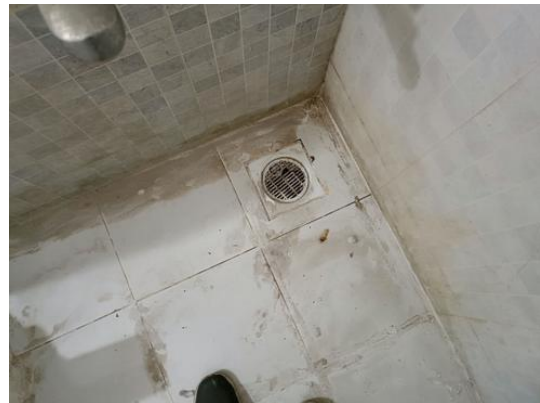
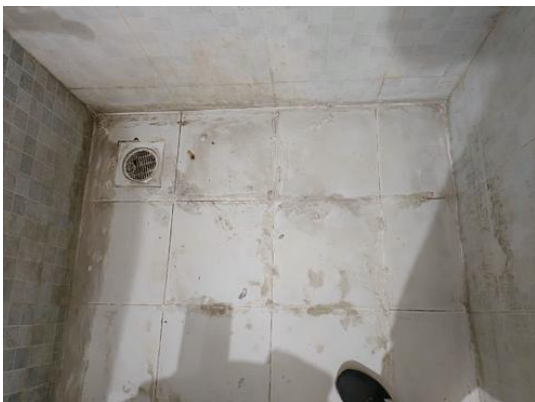
Common Bathroom tile
hollowness

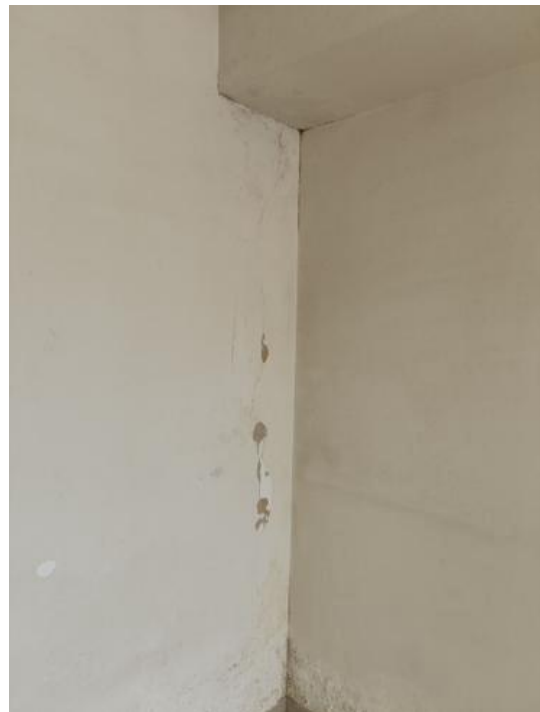
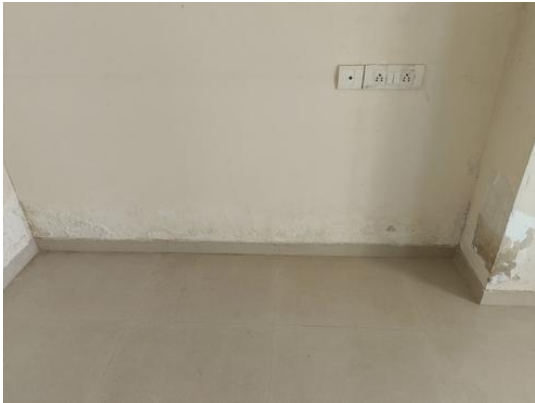
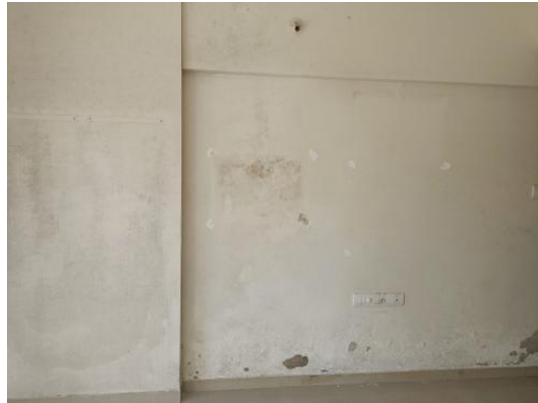
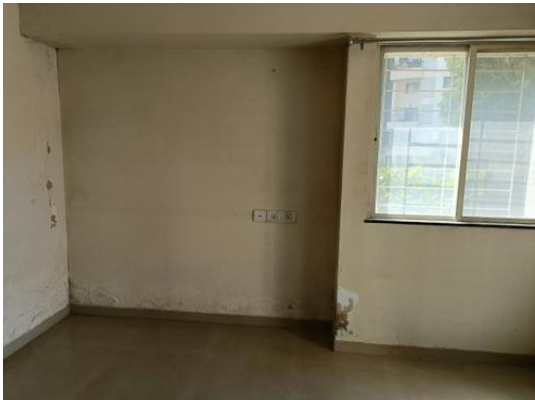
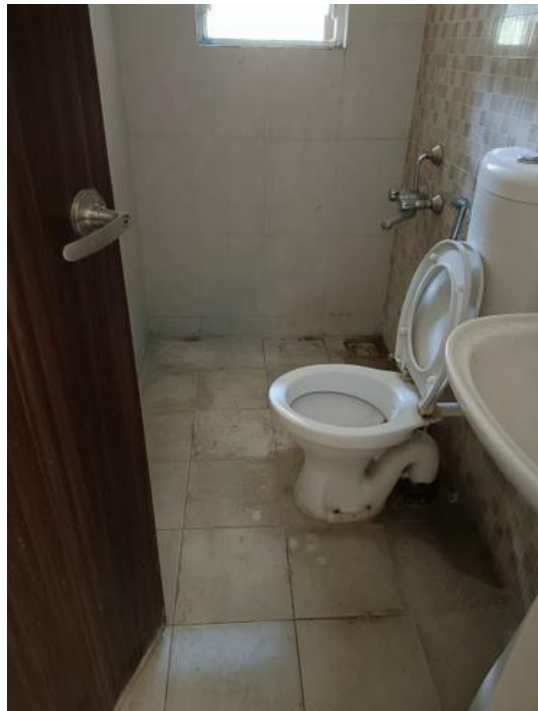
Master bedroom Skirting level
Dampness

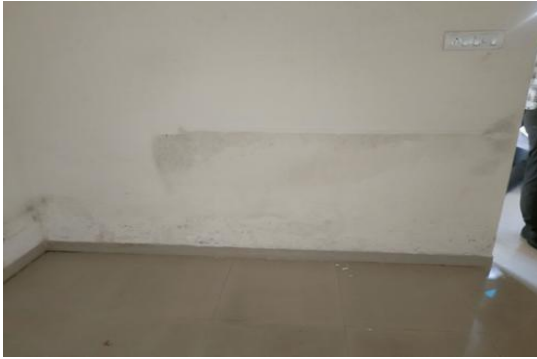
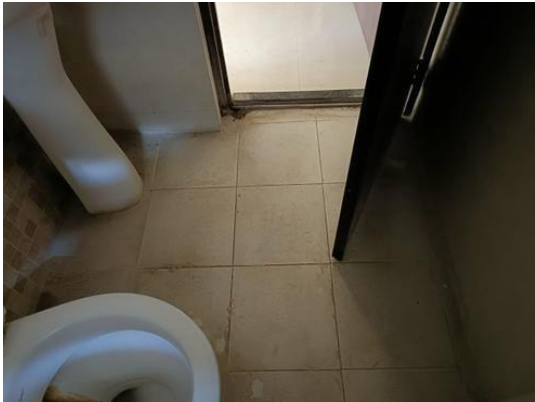
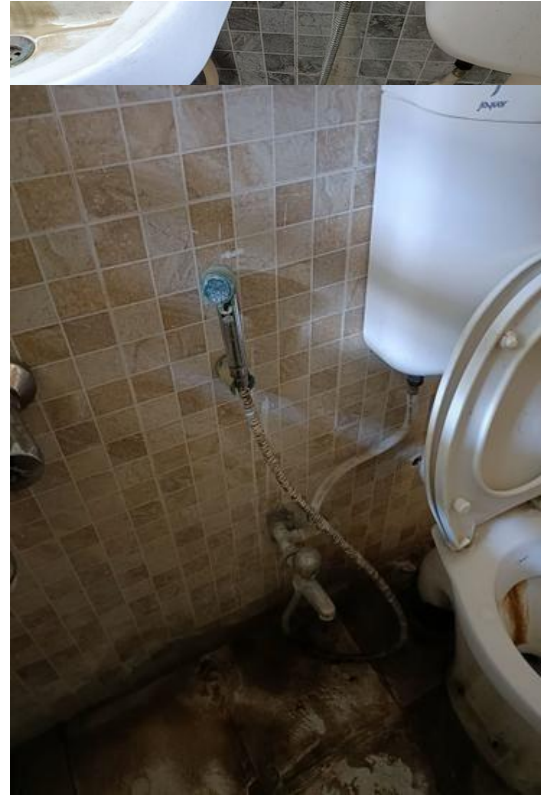
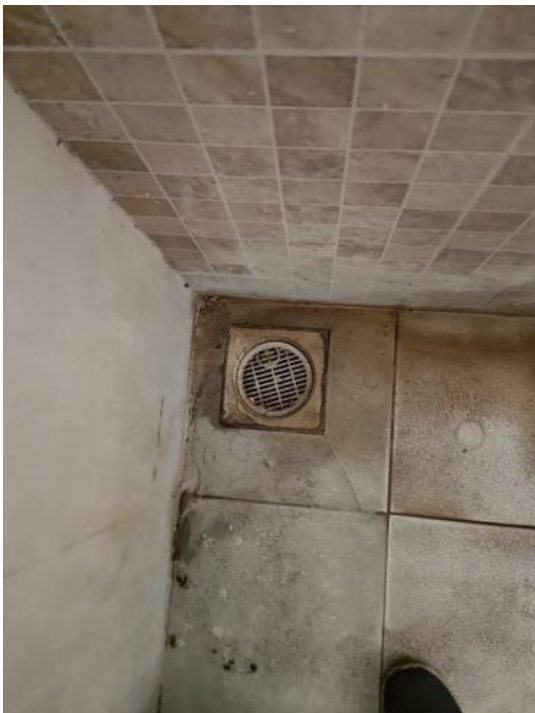
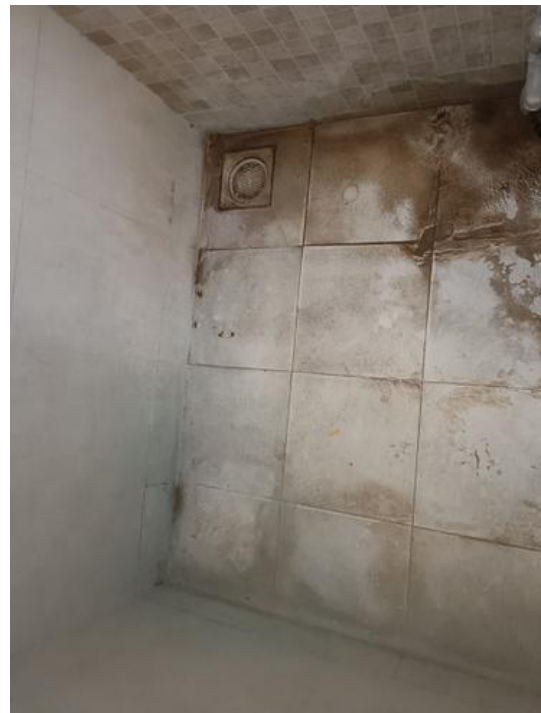
MB Bathroom tile hollowness

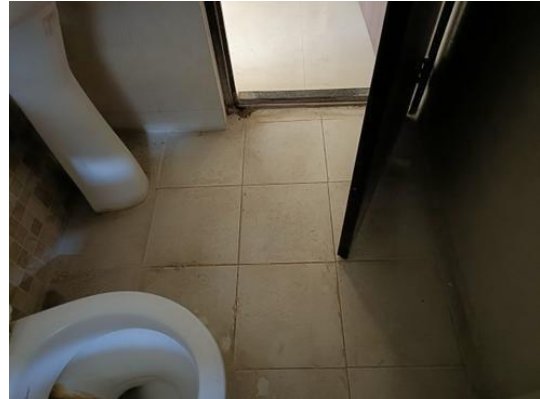
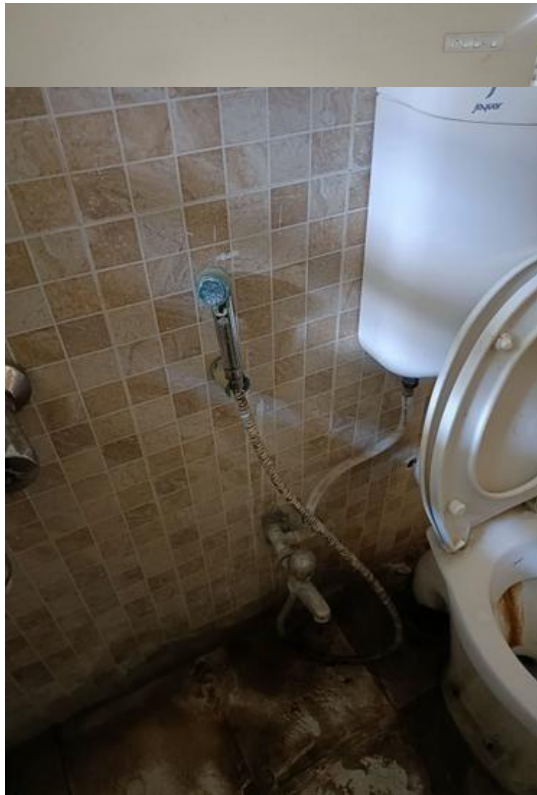
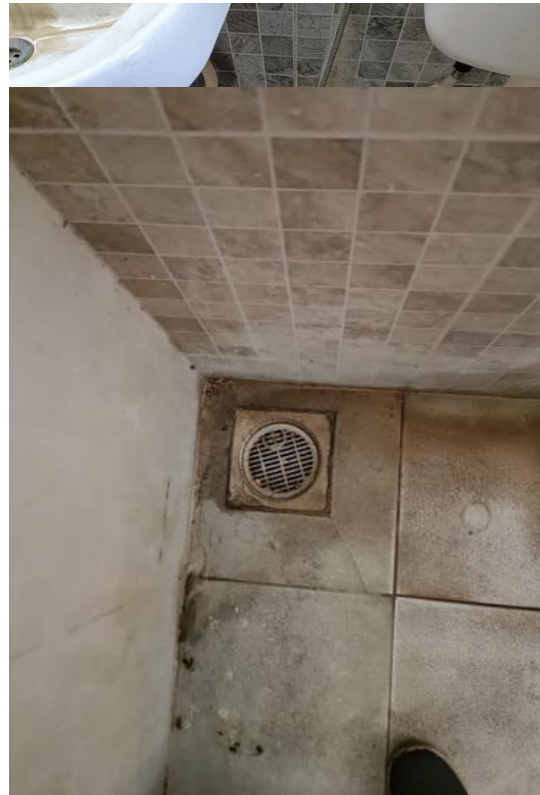
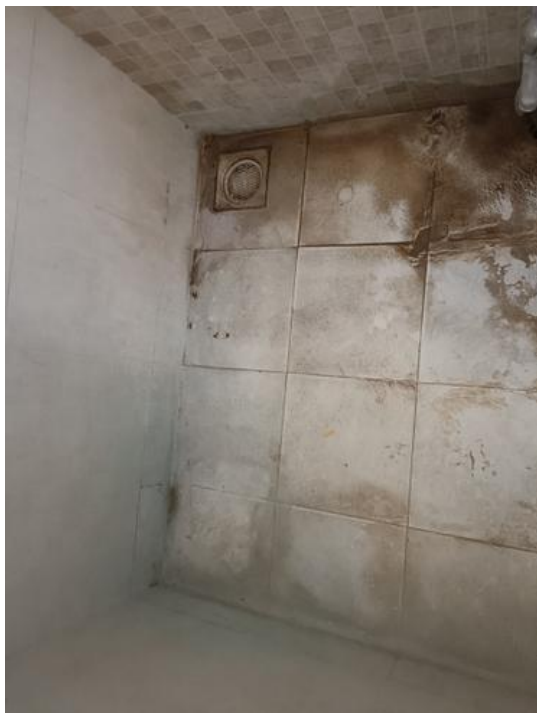
Master bedroom bathroom

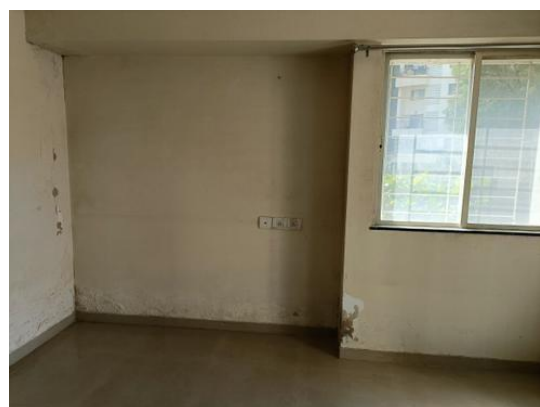
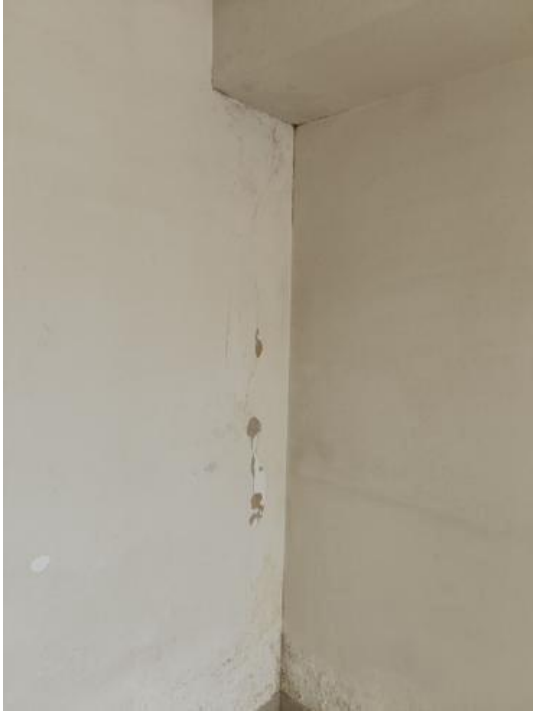
Master bedroom wall damness

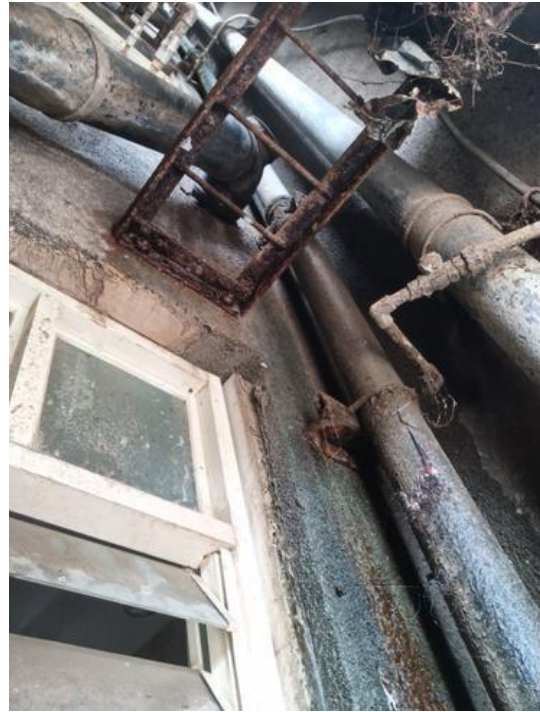
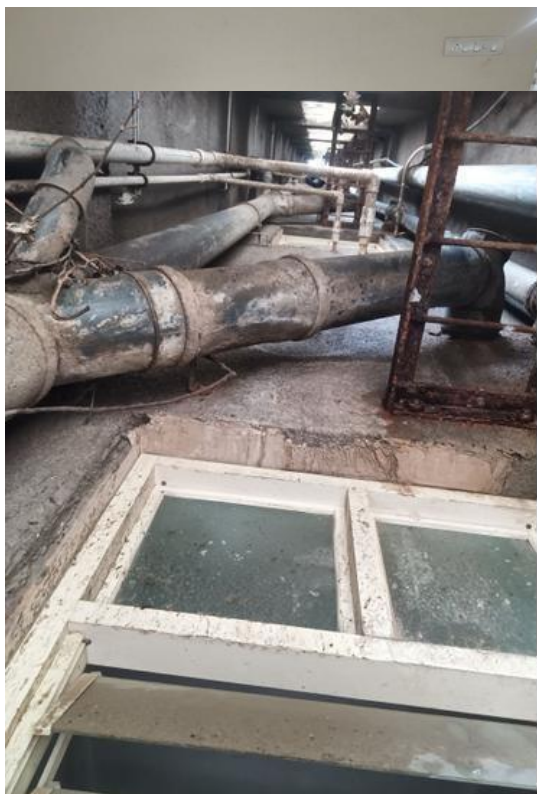
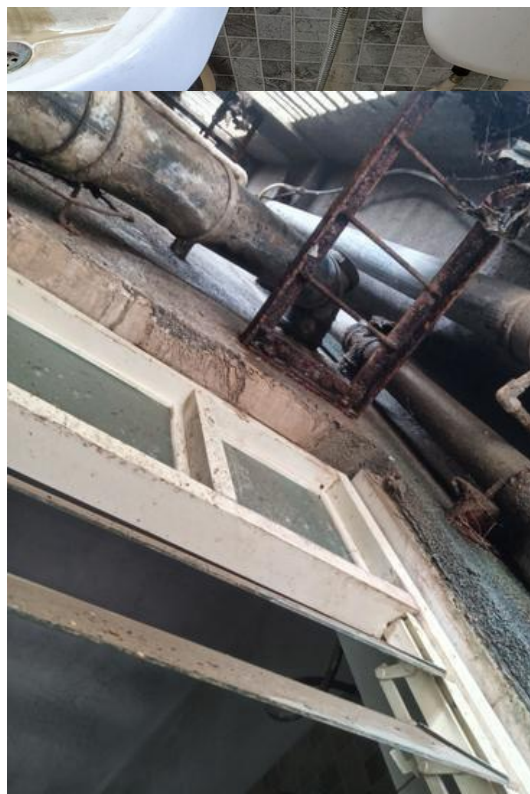
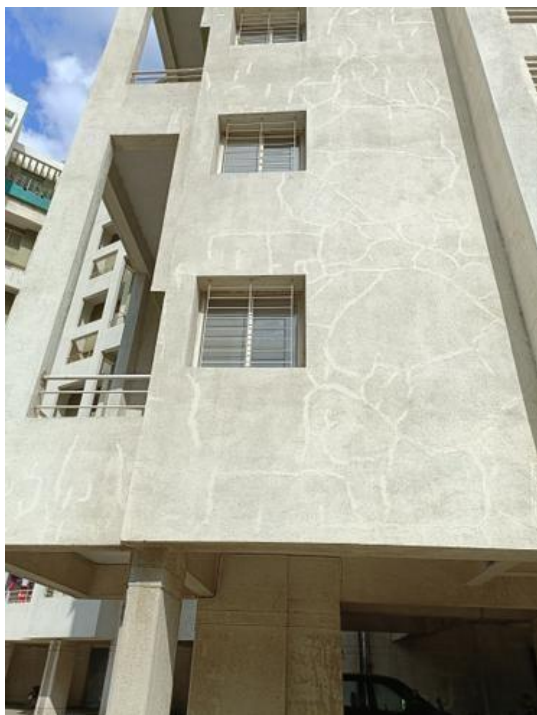
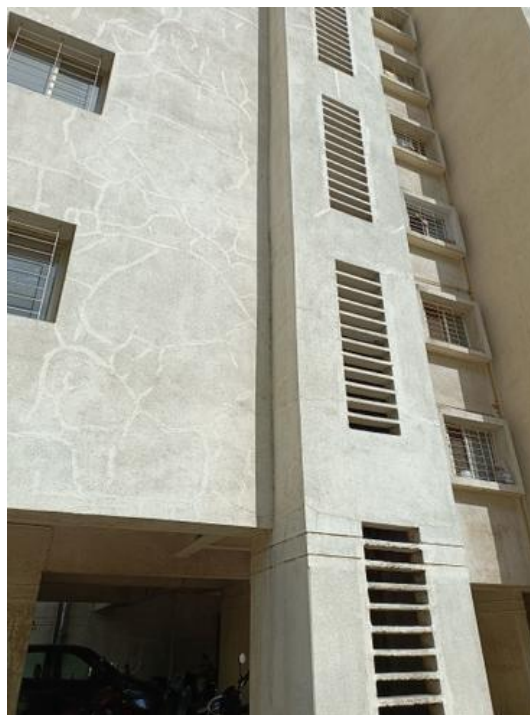
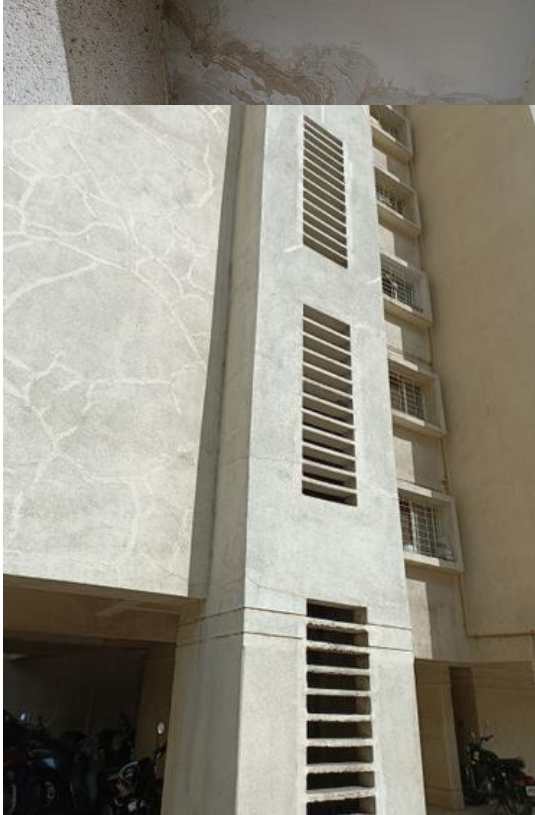
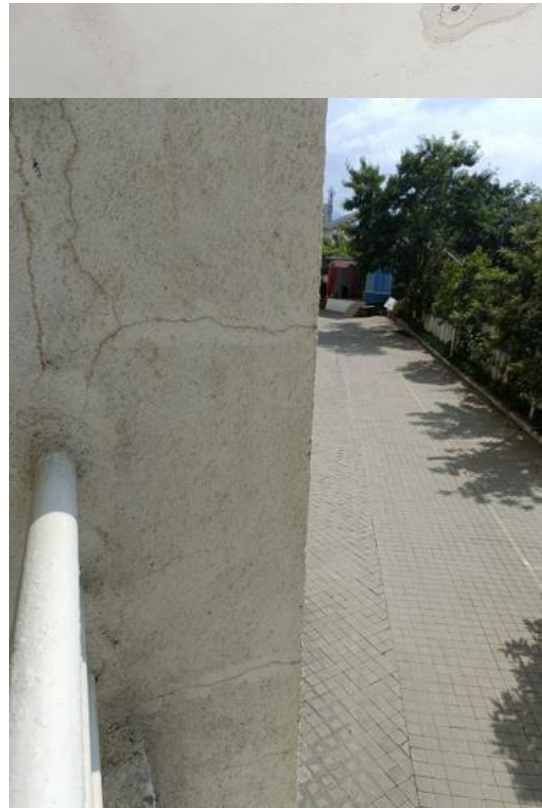
External wall crack and Duct
Issue

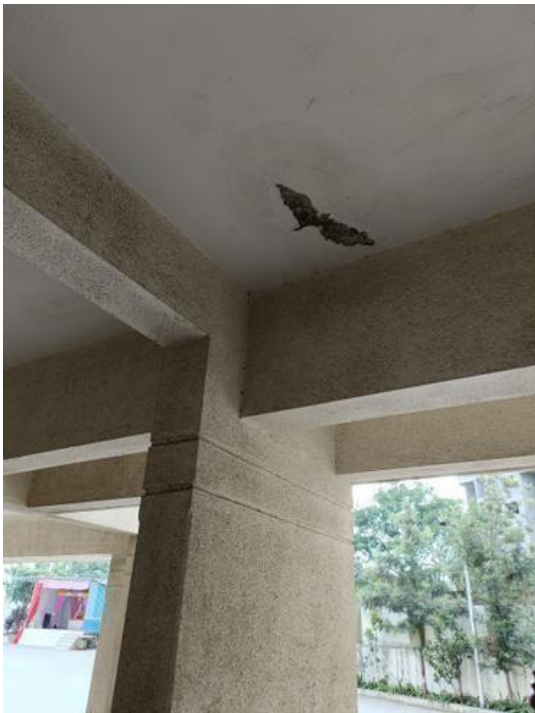
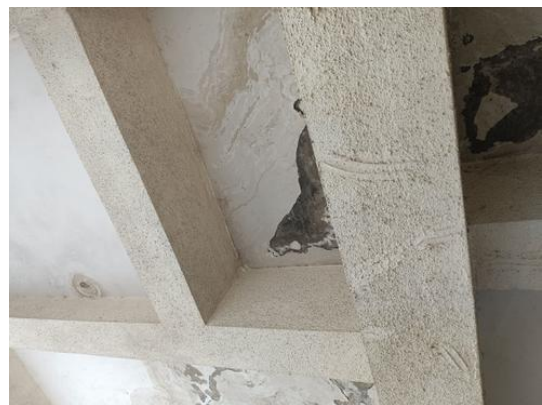
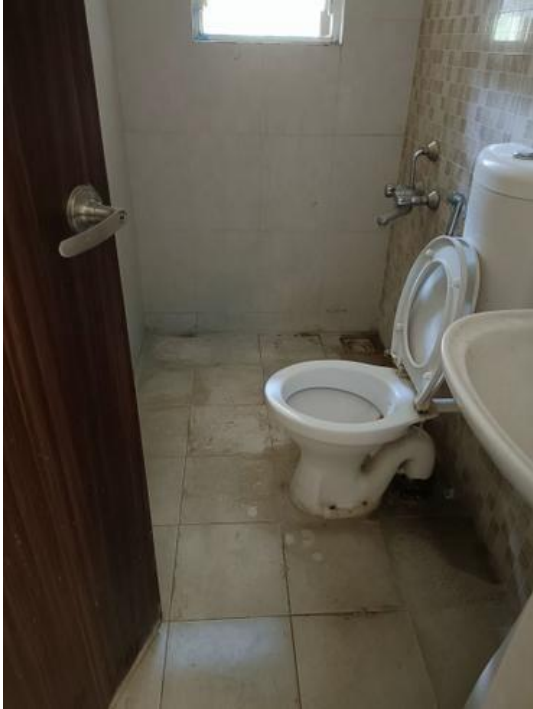
Parking Area seepage

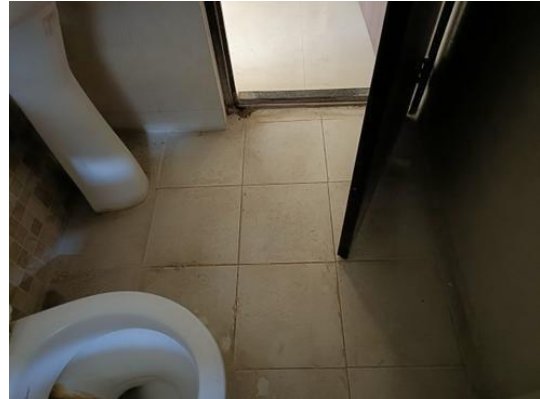
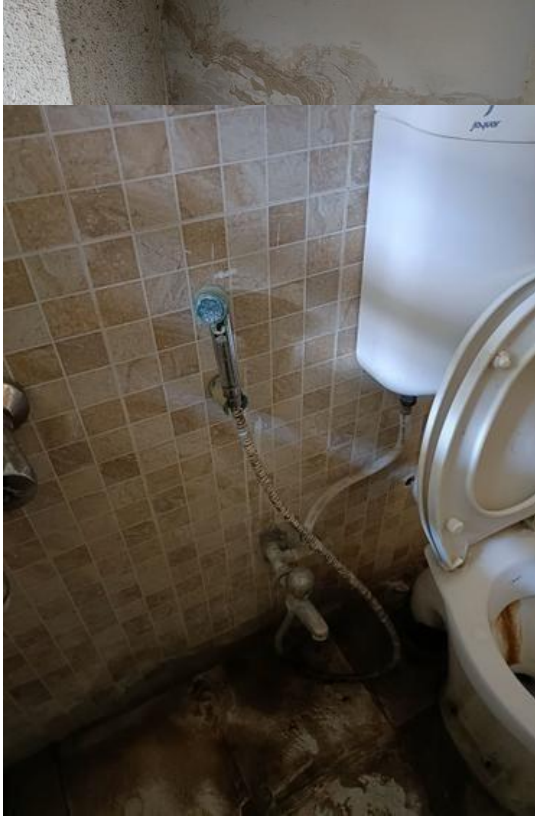
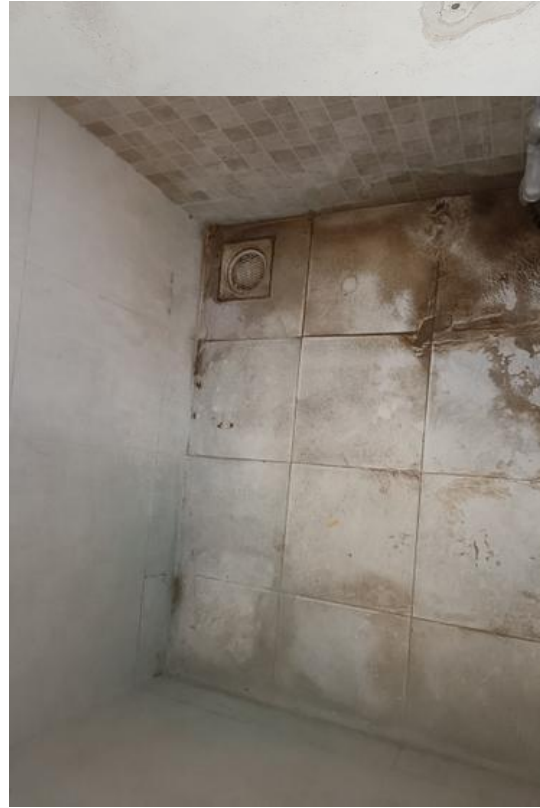
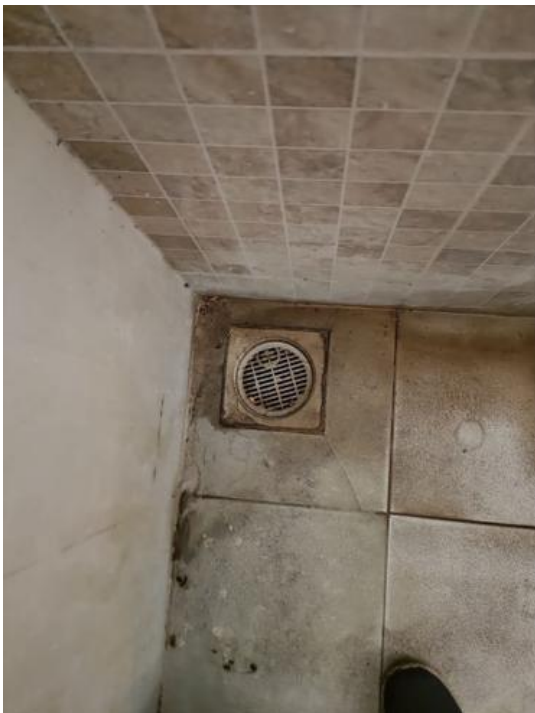
Common Bathroom tile
hollowness and plumbing issue

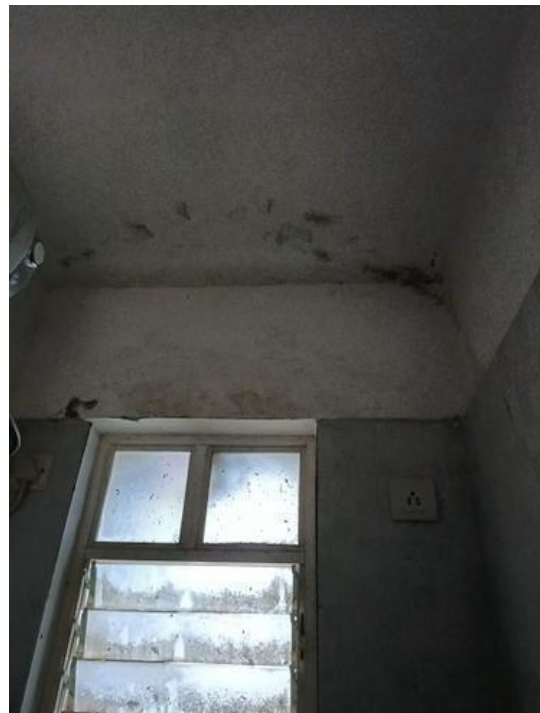
Common Bathroom Ceiling
Dampness

outlet Leakage

7	Observed mild dampness at the ceiling of Common Bathroom of Flat No. 103	7.1	Observed gap between tile joints of Common & Master Bedroom Bathrooms of Flat No. 203.

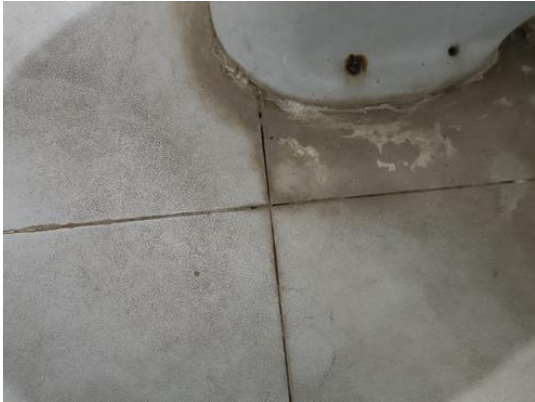
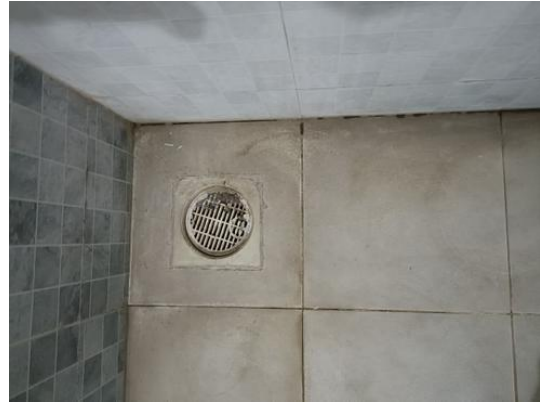
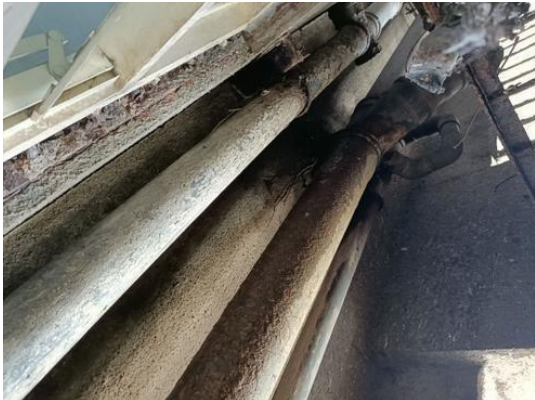
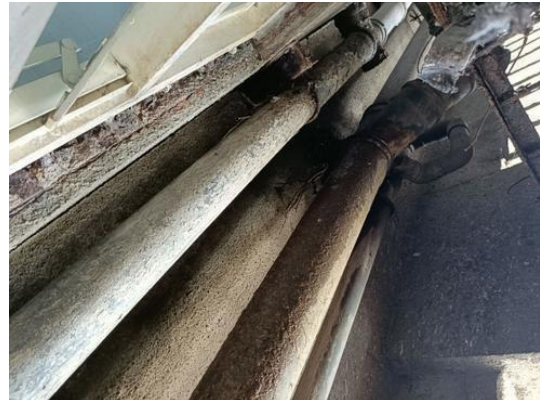
Flat no 203 tile joint open and
