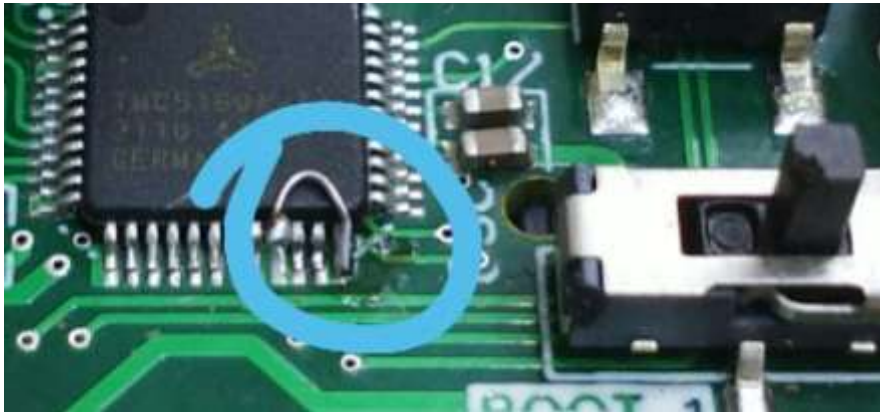
Work around the Stepper Driver Mode change issue: SD_MODE pin was lifted up and connected manually with GND in order to change the TMC5160 Mode from STEP / DIR Mode to Internal Ramp Mode.

Correction: Increase connecting header by two pins to allow the stepper motor mode to be changed from the STM32.

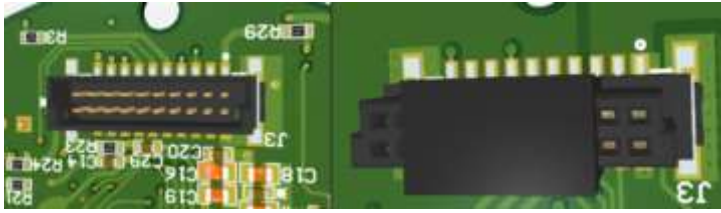
Connector on bottom PCB reversed

Reason : One problem that I see is that during Soldering Assembly the connector is rotated.

Design change: I have checked this Little Dot Overlay, created this issue.

Correction : The issue can be resolved if we resolder the connector. (Needs to be rotated)
