# **CX32L003 Application Note 1**

## **LXT Failure Issue and Workaround Solution**

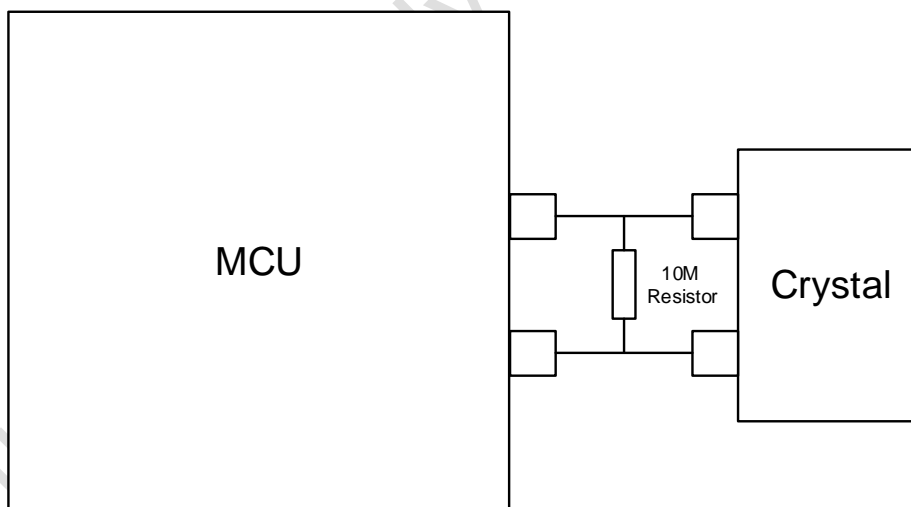
LXT can not start up normally at 85 degree temperature and 2.6 / 3.3 Voltage. The failure rate is 100% so that customer must follow the workaround solution if LXT has to be used.

The workaound solution for this issue is to connect a 10MΩ resistor between two ends of the external crystal.

Test results with this workaround solution show that LXT failure issue can be avoided.
