Sitara™ AM335x ARM® Cortex™-A8 Microprocessors (MPUs) Silicon Revisions 2.1, 2.0, 1.0

Silicon Errata

Literature Number: SPRZ360E
October 2011 – Revised April 2013

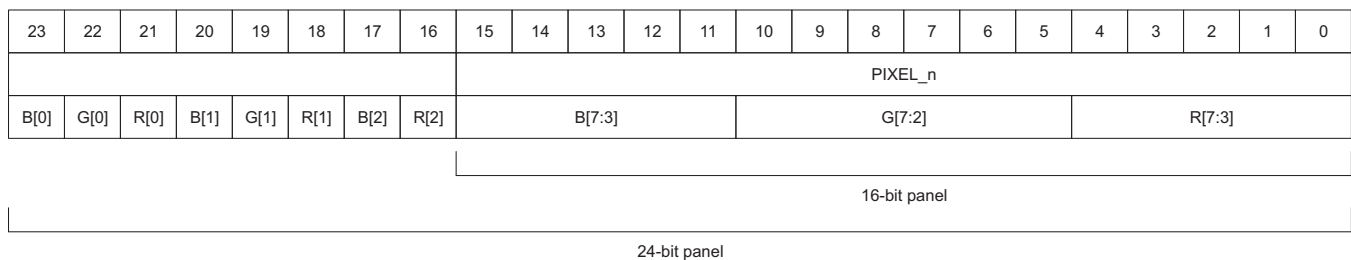
Figure 2. RGB888 Mode LCD Controller Output Pin Mapping (LCD_DATA[23:0])

The blue and red color assignments to the LCD data pins are reversed when operating in RGB888 (24bpp) mode compared to RGB565 (16bpp) mode. In order to correctly display RGB888 data from the SGX, or any source formatted as RGB in memory, it is necessary to connect the LCD panel as shown in [Figure 2](#). Using the LCD Controller with this connection scheme limits the use of RGB565 mode. Any data generated for the RGB565 mode requires the red and blue color data values be swapped in order to display the correct color.

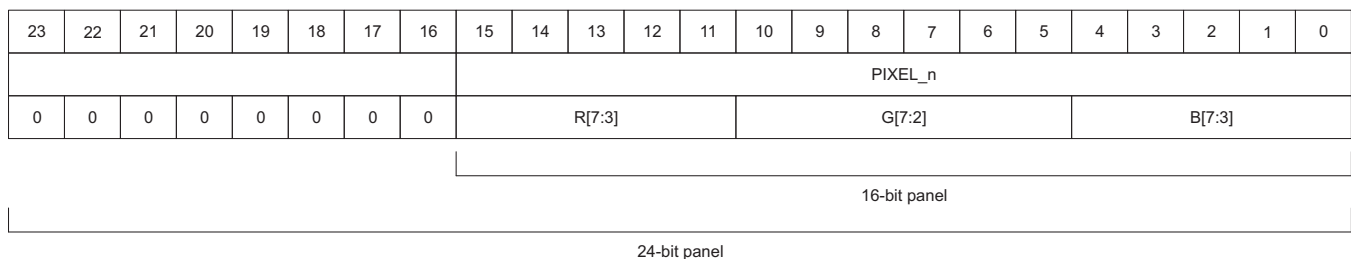
Figure 3. RGB565 Mode LCD Controller Output Pin Mapping (LCD_DATA[23:0])

When operating the LCD Controller in RGB565 mode the LCD panel should be connected as shown in [Figure 3](#). Using the LCD Controller with this connection scheme limits the use of RGB888 mode. Any data generated for the RGB888 mode requires the red and blue color data values be swapped in order to display the correct color.
