PROJECT SAFETY OBSERVATION REPORT

PROJECT LIDAR

Date of Site Survey	March 19, 2024	Time of Site Survey	5:00 a.m.
Risk Control Specialist	Joe Rickson	Project Location	Anaheim, CA 92802
Project Contact	Whiting-Turner: Dave Conyers Superintendent Disney: Sara Simon, Kellen Dengler, James Duarte, Dale Chandler, Quinn Hollaway		
# Subcontractors	10	# Workers on Site	30+
Facility Asset Management Project Night/Day Work			Yes

Purpose of Service Visit | Site Safety Assessment

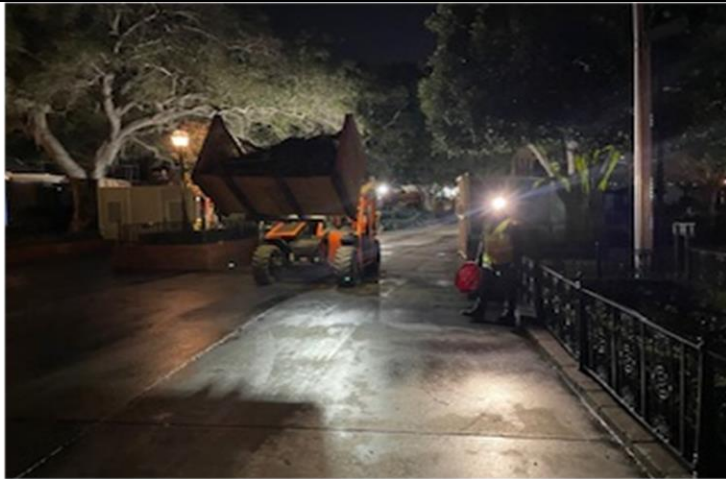
Photo #1: Traffic control provided with slow/stop paddleboard outside project and includes lighting on equipment, reflective vest, and approved travel plan.

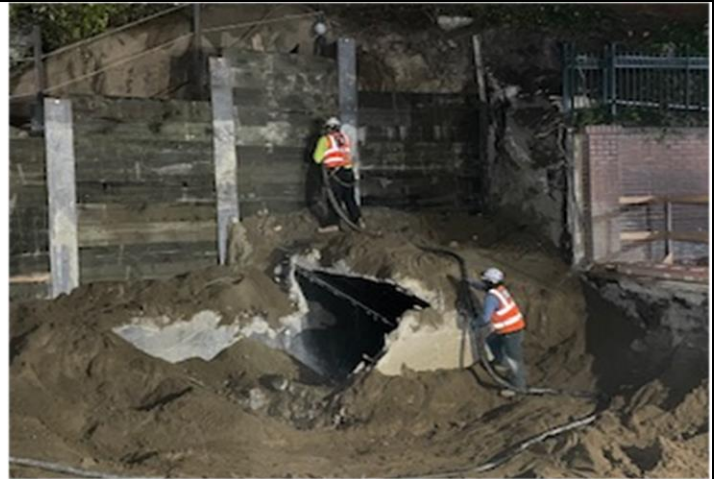
Photo #2: Malcom: Worker tied off with SRL above during slurry operation standing on top of existing basement stairway.

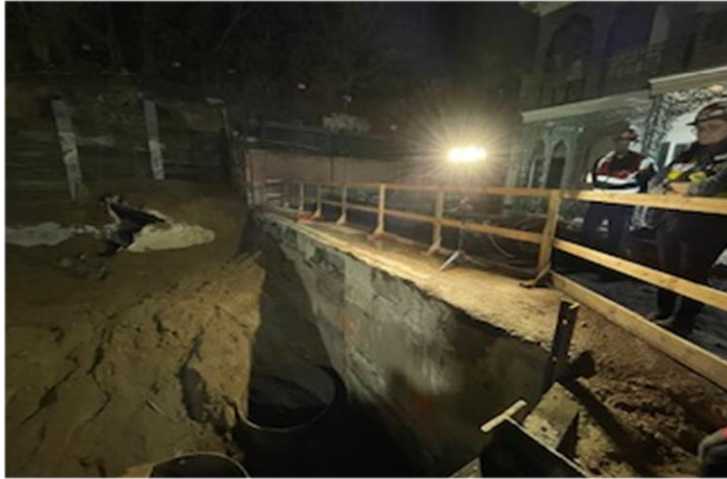
Photo #3: Temporary guardrails in place above basement, adequate lighting provided.

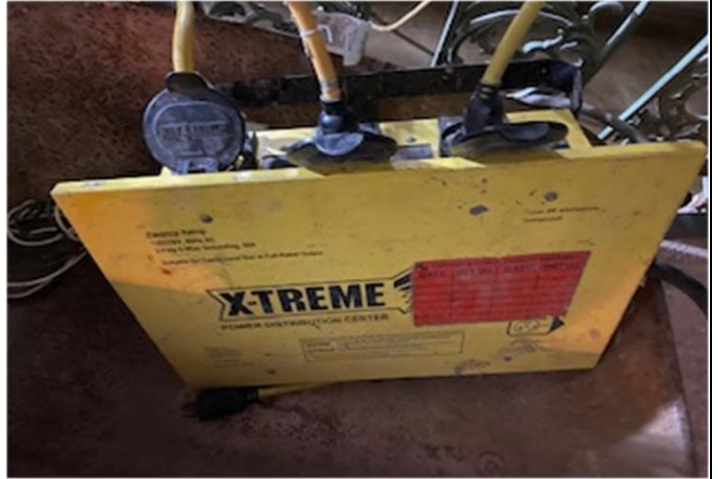
Photo #4: Temporary power inspected through Morrow Meadows, electrical cords inspected through each subcontractor and provided with GFCI protection.

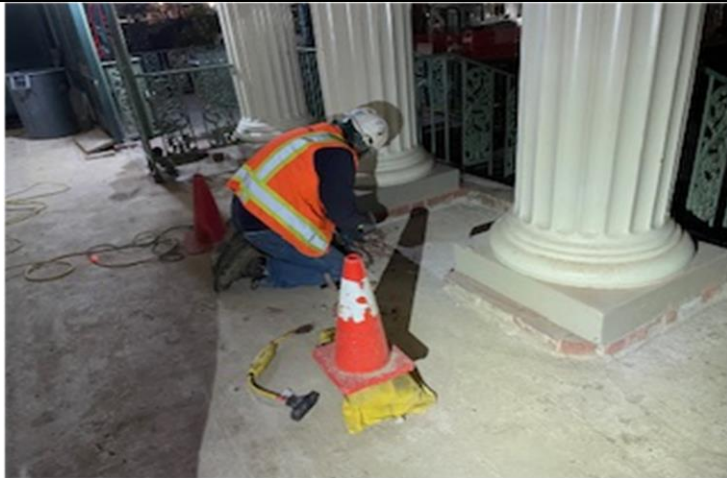
Photo #5: All workers observed wearing required and task specific personal protective equipment.

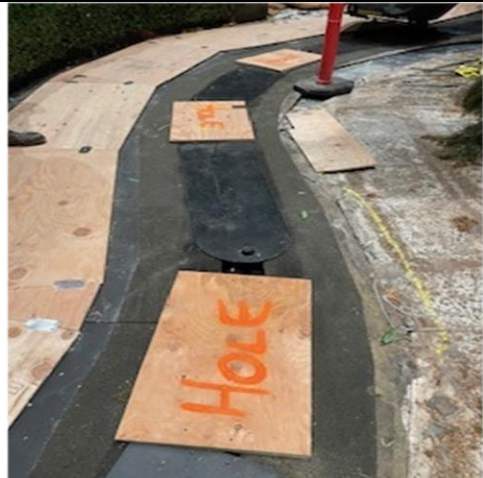
Photo #6: Hole covers marked/cleated along track inside Haunted Mansion.

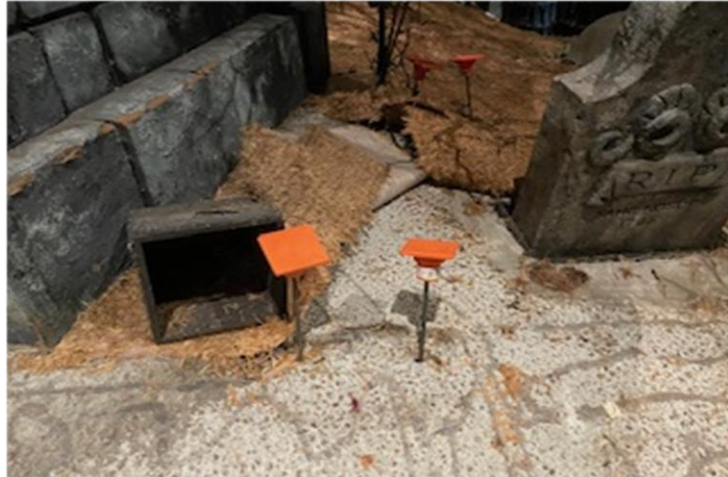
Photo #7: Impalement protective covers in place.

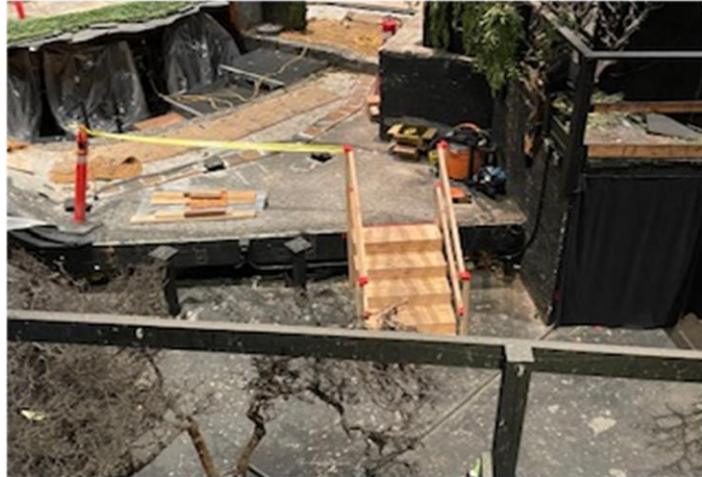
Photo #8: Temporary stairs with handrails.

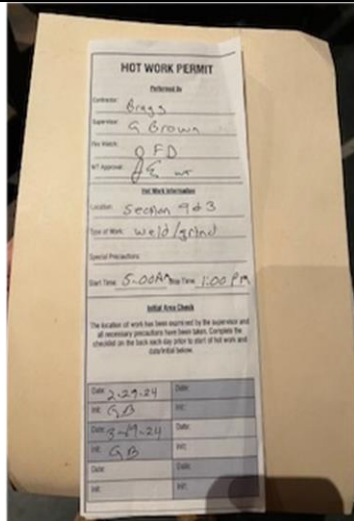
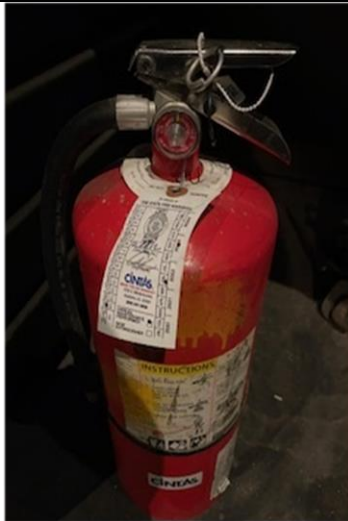
Photo #9: Hot work permit current, charged fire extinguishers at work zone, and DFD onsite during all hot work activities.

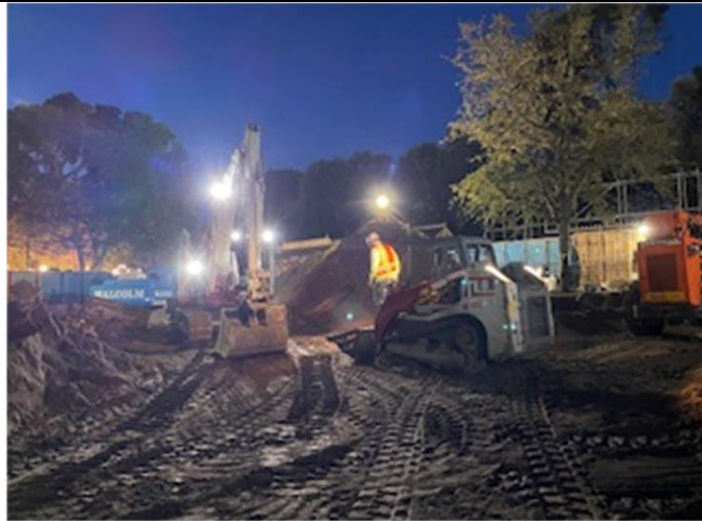
Photo #10: Equipment inspections documented prior to work start from each subcontractor and turned into Whiting-Turner.

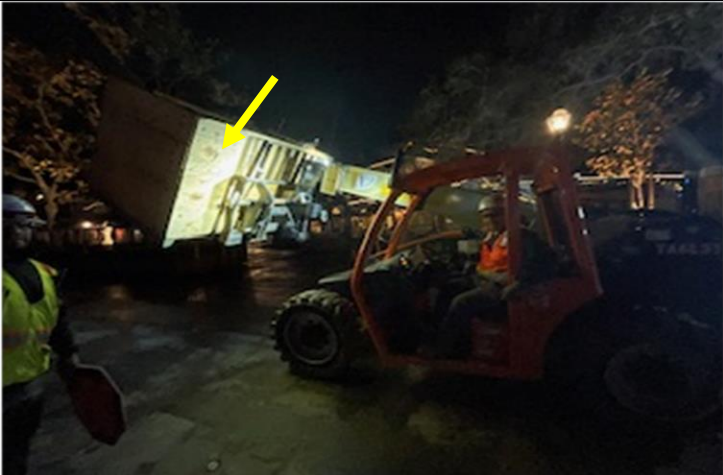
<p>Photo 1: NorthStar: Recommend replacing job made wood debris box with approved engineered container.</p> <p>Photo 2: Basement: Slip, trip, fall identified corrected during visit.</p>

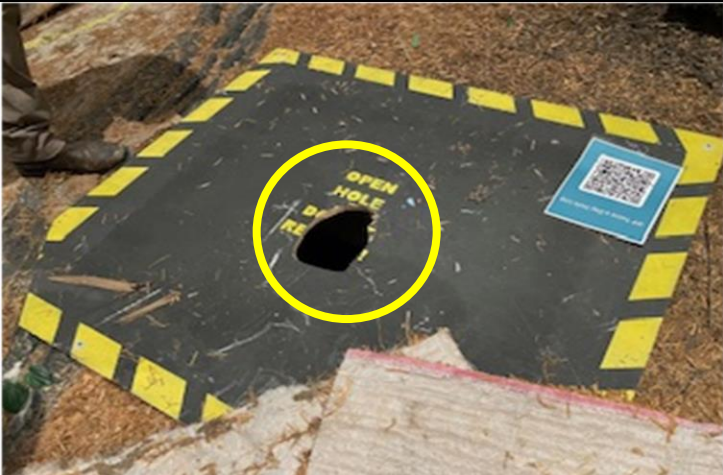
<p>Photo 3: IFP Haunted Mansion: Recommend inspecting all hole covers.</p> <p>Photo 4: IFP Haunted Mansion: Hole cover not secured and missing sign Opening Do Not Remove.</p>
