RE: Risk Engineering Service

Corporate Office Shop/Yard Safety Assessment: 28548 Livingston Ave, Valencia, CA 91355

Site Safety Assessment: The Wallis Annenberg Wildlife Crossing | Agoura Hills California 91301

Site Safety Assessment: State Street Undercrossing | Santa Barbara California 93101

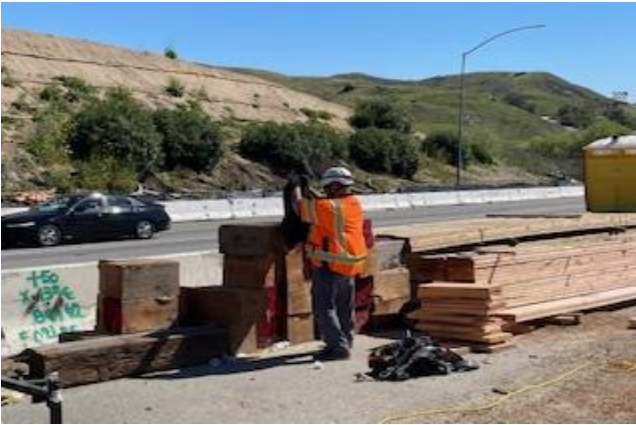
Clothing can blow into active traffic creating visual obstruction. Also discussed building a solid shaded structure in lieu of EZUP during summer months to prevent displacement into active highway traffic.

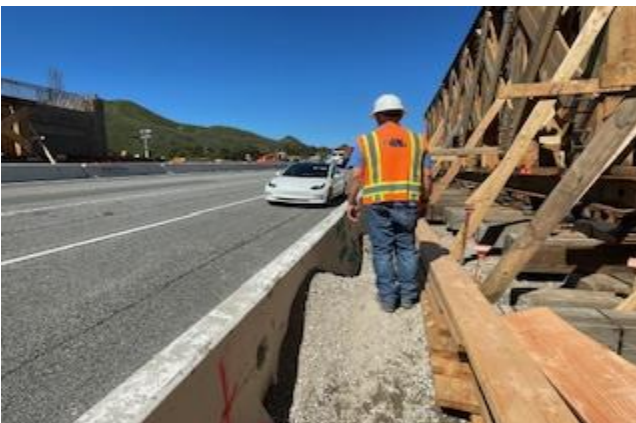
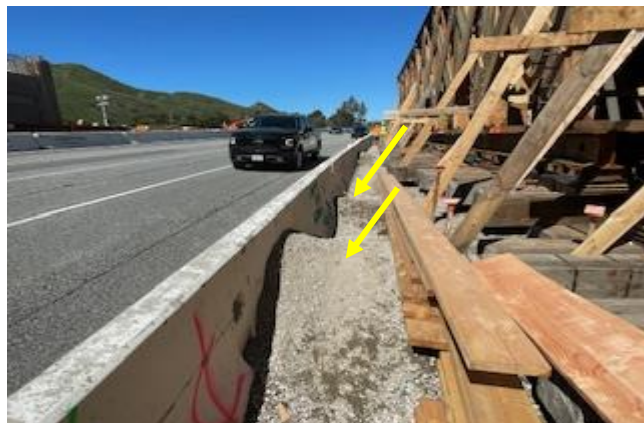
- Middle lane bent walking path of travel places workers above k-rail at a few locations adjacent to Southbound traffic. From my understanding, there is no other means of access/egress. Observation agreed and walking pathway will be leveled. Additional discussion regarding struck-by exposure from vehicles with material sticking out that can extend beyond the k-rail including C.A. Rasmussen material from carpenters that can strike a vehicle.

Walking path Southbound places workers above k-rail adjacent to highway traffic on the 101 freeway, not an effective guardrail barrier. Observation agreed and in the process of correction.

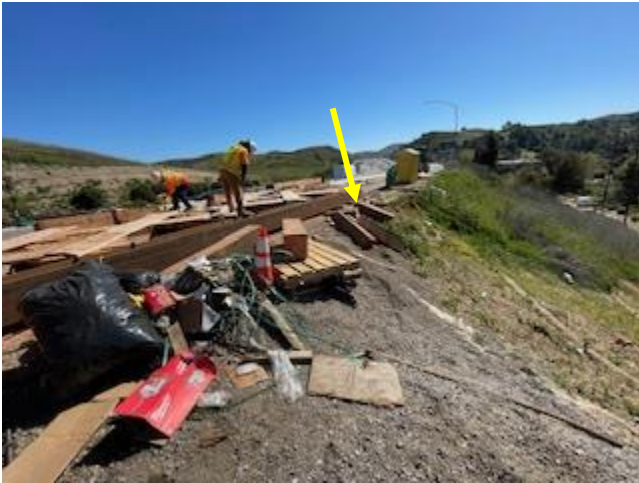
- Exposure (Slip-Trip-Fall / Sprain/Strain) retrieving falsework material on steep hillside. Observation agreed and material retrieval process under review through Site Safety Professional Alfredo Aparicio.

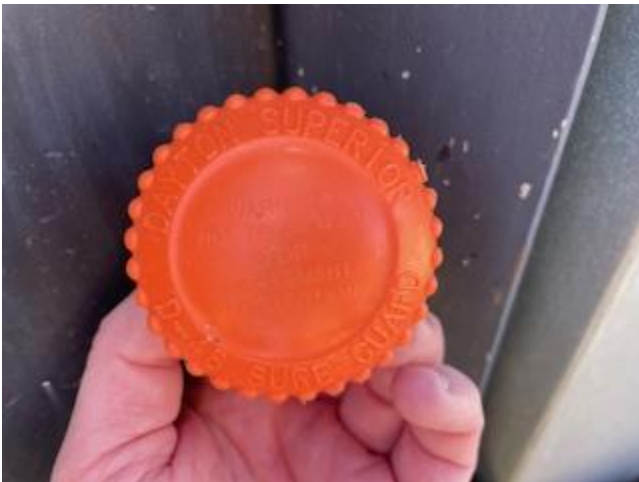
- Dayton Superior Sure Guard are not to be used for impalement protection. Observation agreed and will be removed from the site.

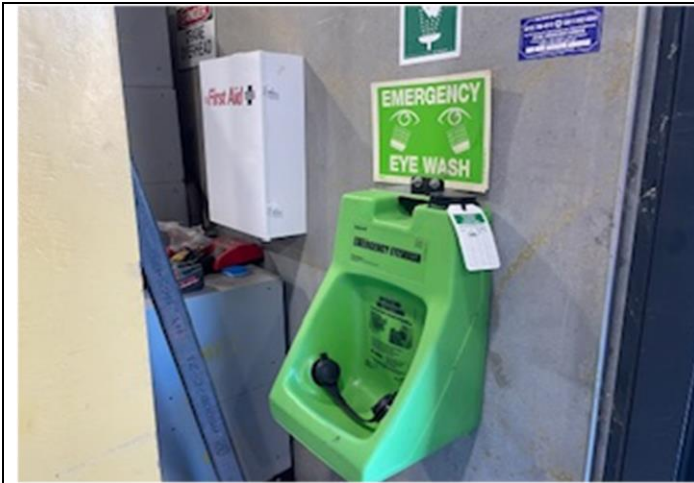
Eyewash station and first aid kit

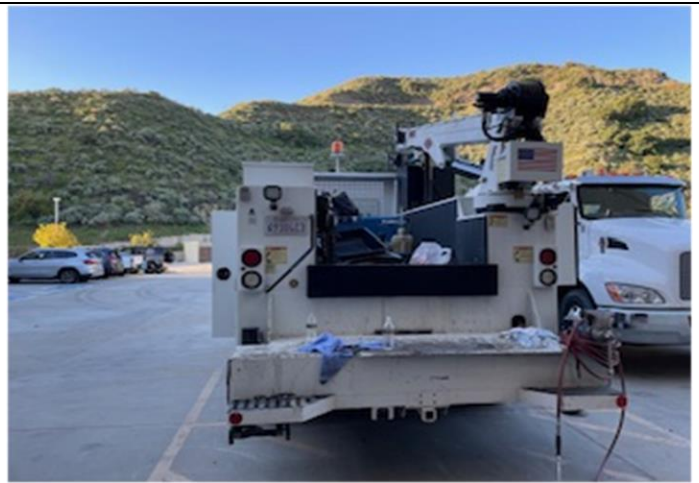
Commercial vehicle provided with hand grab rails

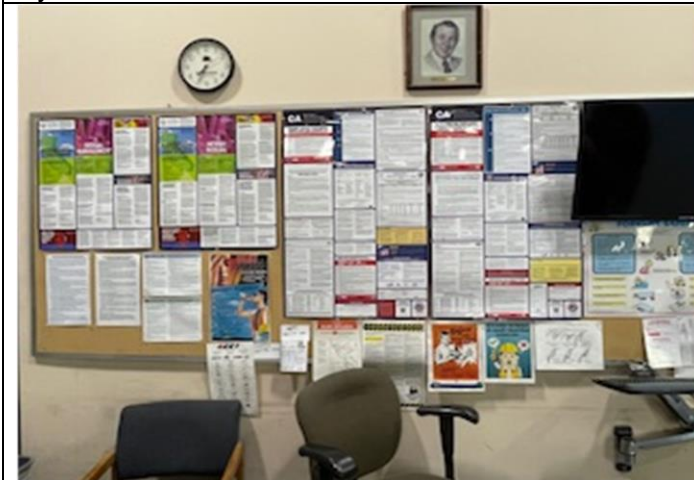
Jobsite postings include industrial rules for forklifts

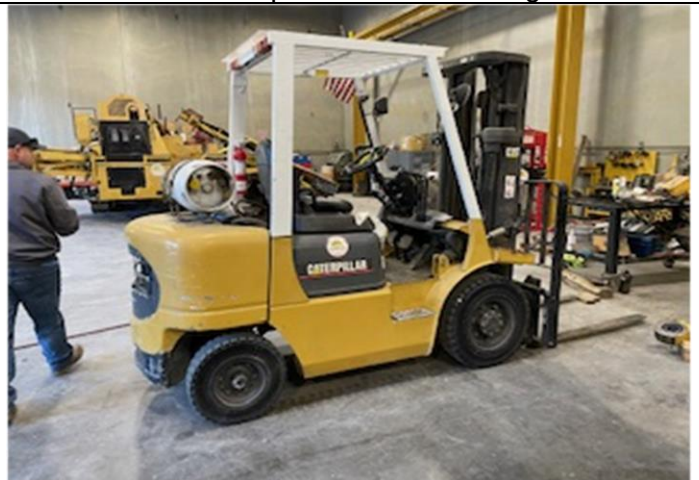
Forklift operators trained/certified

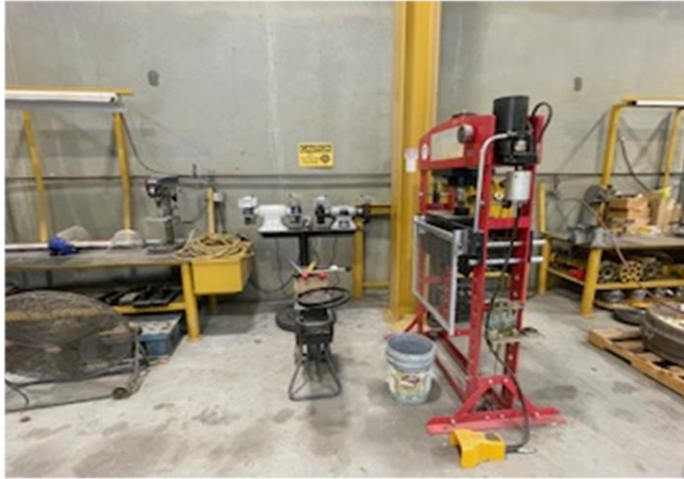
Bench grinder required PPE signage in place

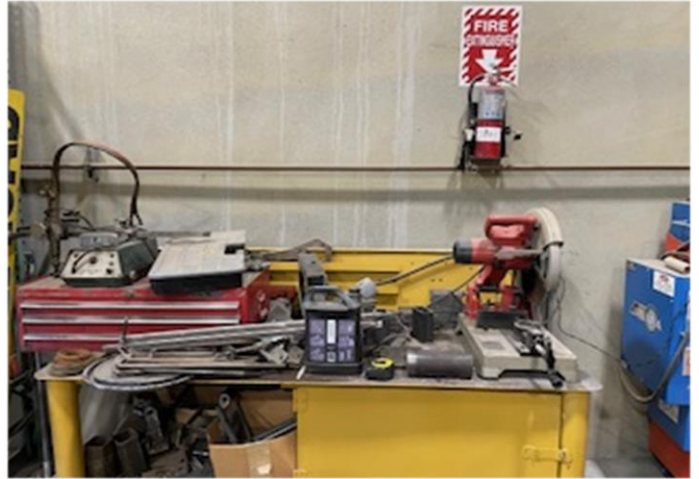
Chop Saw required PPE signage to be provided going forward. Fire extinguishers provided throughout mechanic shop/yard.

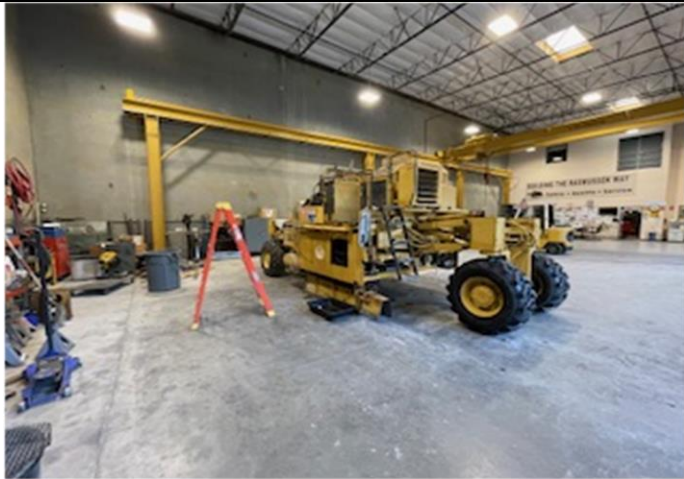
Workers trained on ladder use, selection, and inspections.

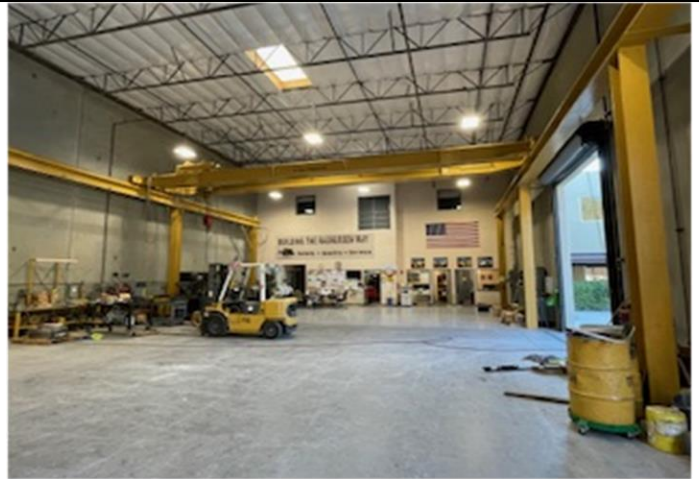
Overhead gantry crane no longer in use. Excellent housekeeping through mechanic shop.

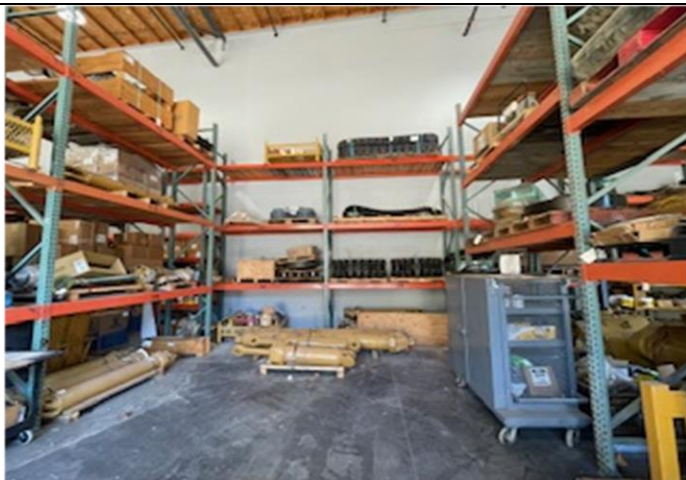
Material placed on wooden pallets and retrieved with forklift.

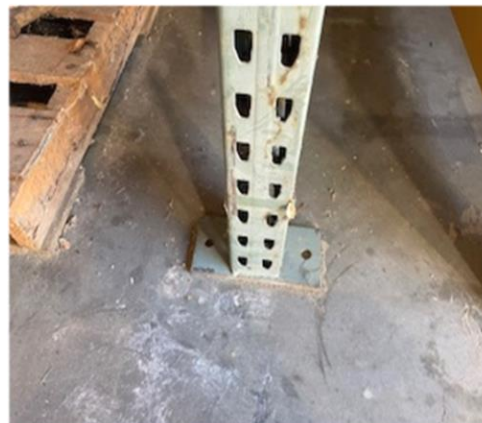
Heavy Duty rack not bolted to ground to prevent displacement, area for improvement.

- Discussion took place to bolt down pallet racks and provide rating load capacity signs. Reference Cal-OSHA General Industry Safety Orders 3241.
- Discussion took place to verify training is completed and documented for the bench press, chop saw, and bench grinder. C.A. Rasmussen will provide personal protective equipment signage at each chop saw location and include face shield required in addition to safety glasses while using the bench grinder.

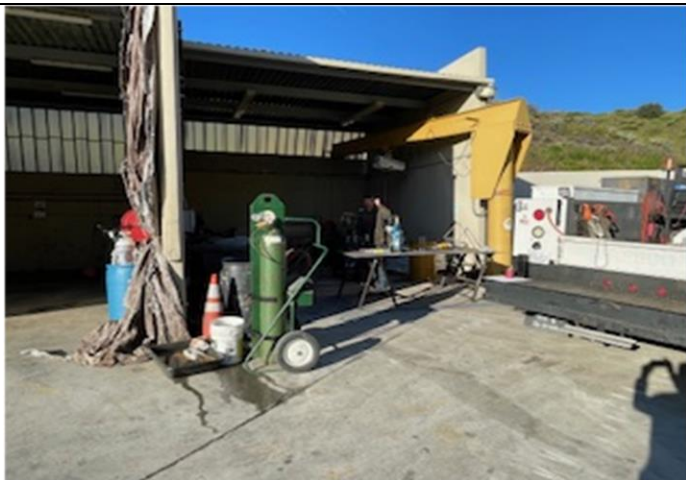
Work taking place off elevated workbench fabricating brackets. Safety glasses worn while operating handheld grinder with guard. Cylinders secured and provided with flashback arrestors. Fire extinguisher provided during hot work activities. Good housekeeping observed within outdoor bay.

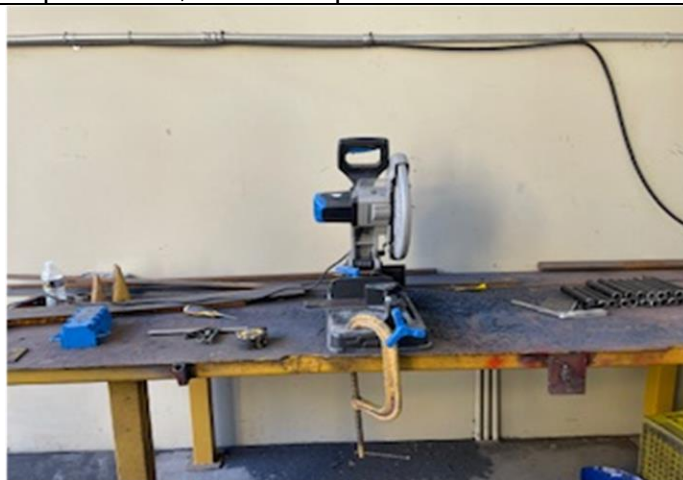
Chop Saw in outdoor bay missing required PPE signage. Best practice to secure chop saw with bolts to table in lieu of vise.

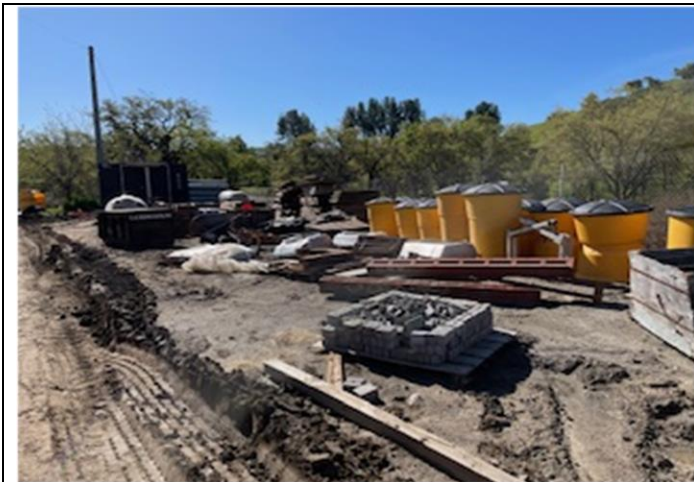
Workers wear gaiters while moving material in laydown yard due to high volume of rattlesnakes in the area.

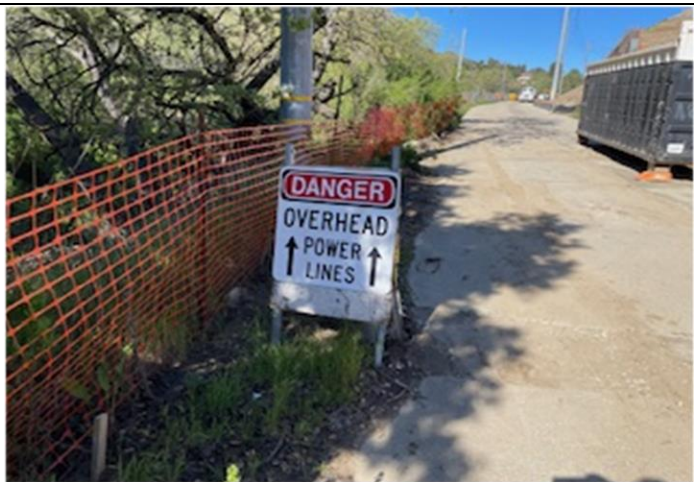
Danger overhead power line signs in place.

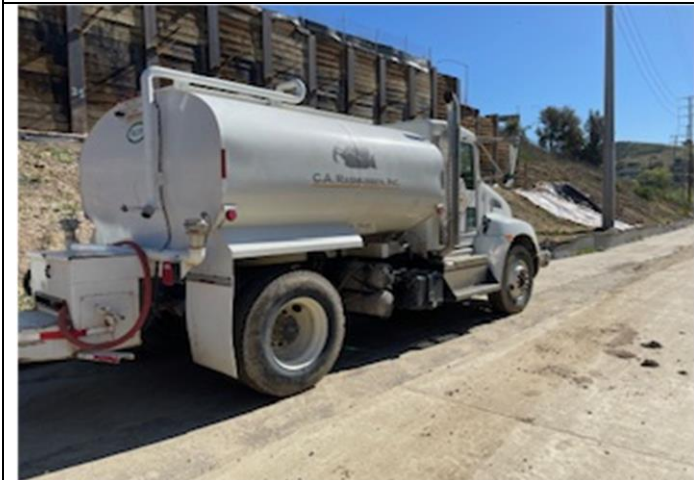
Best practice to use wheel chocks

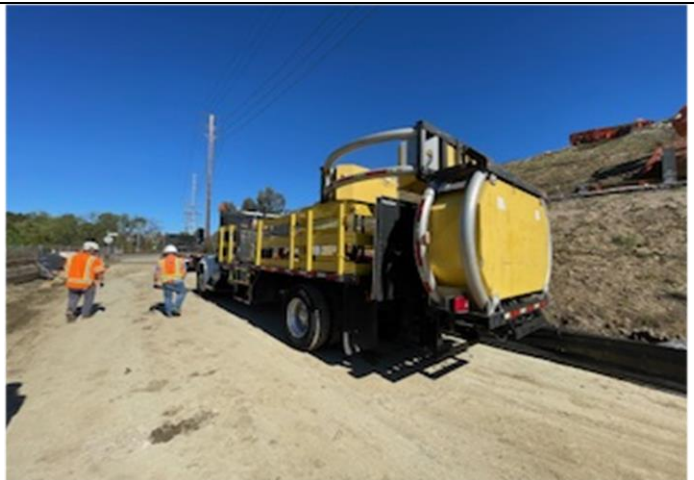
Approved traffic control plan through Cal-Trans
Crash attenuator trucks in place during lane closure.

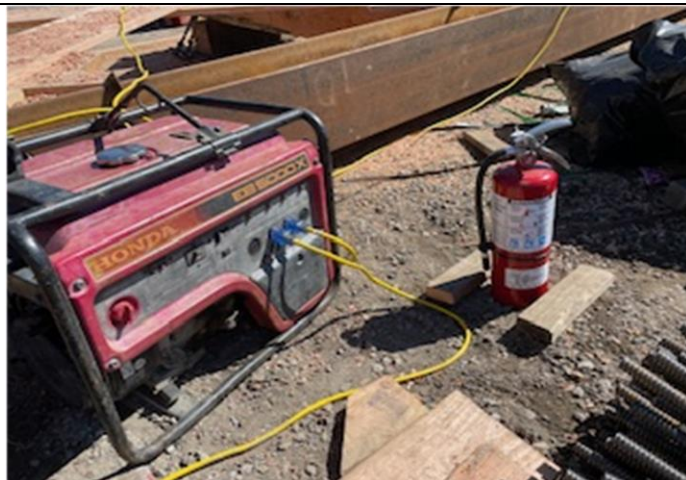
Generator provided with fire extinguisher during fueling.

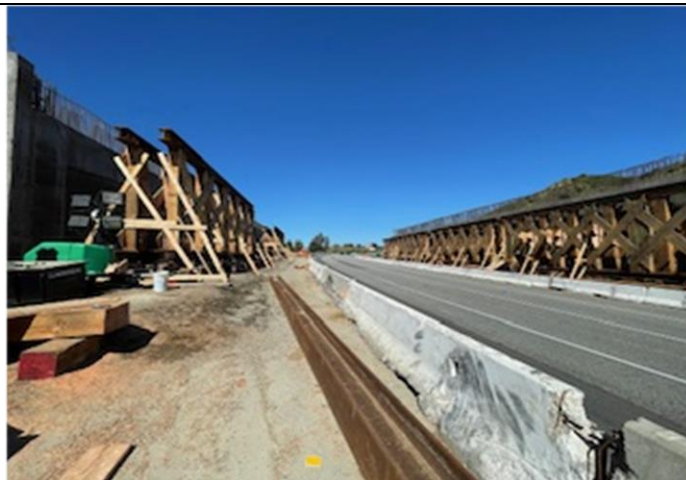
Abutment 1, middle lane bent, and abutment 3 protected with k-rail barriers.

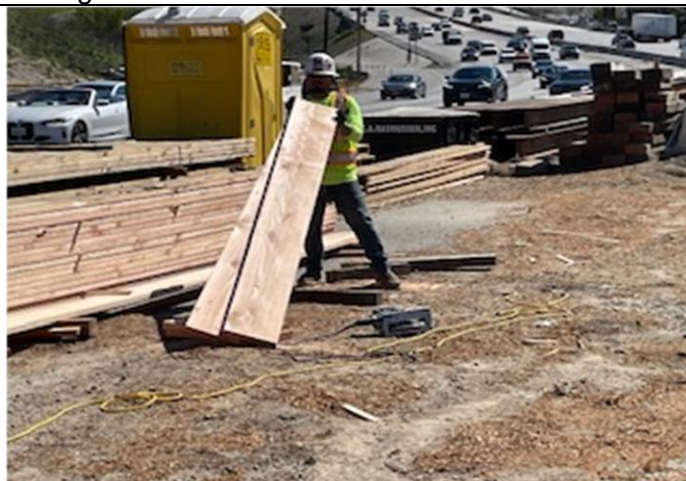
Task specific personal protective equipment in use. Skill Saw guard in place and electrical cord grounded.

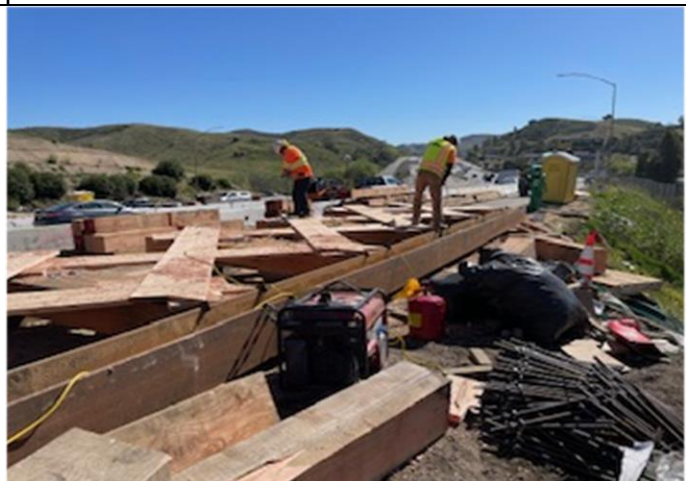
Uneven surfaces identified on daily pre-task plan while carpenters build falsework.

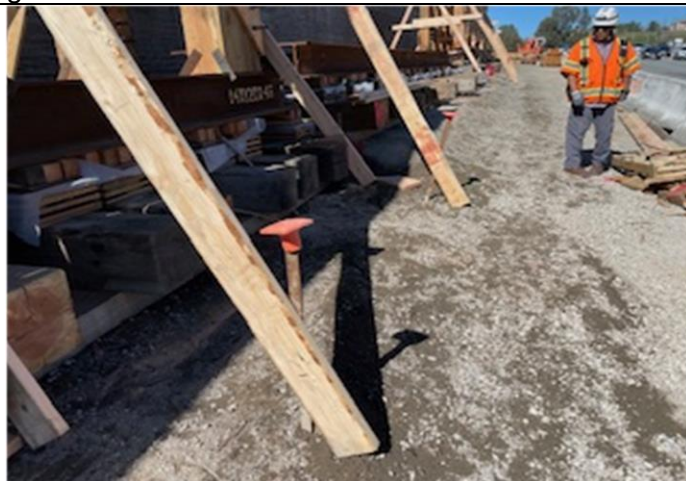
Impalement protective covers in place.

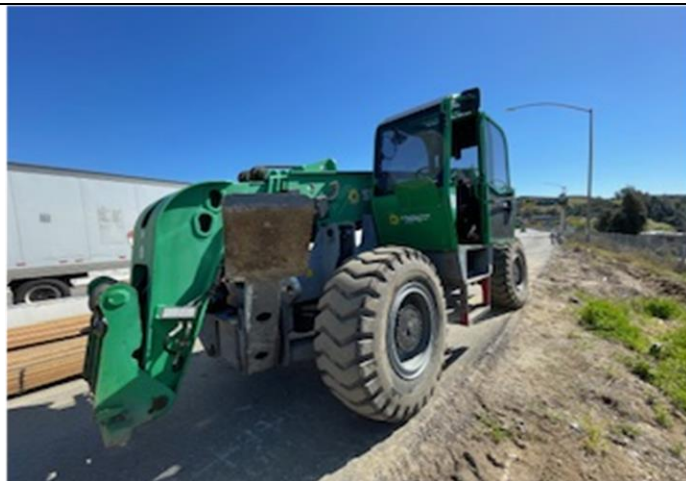
Forklift operators certified; inspections documented.

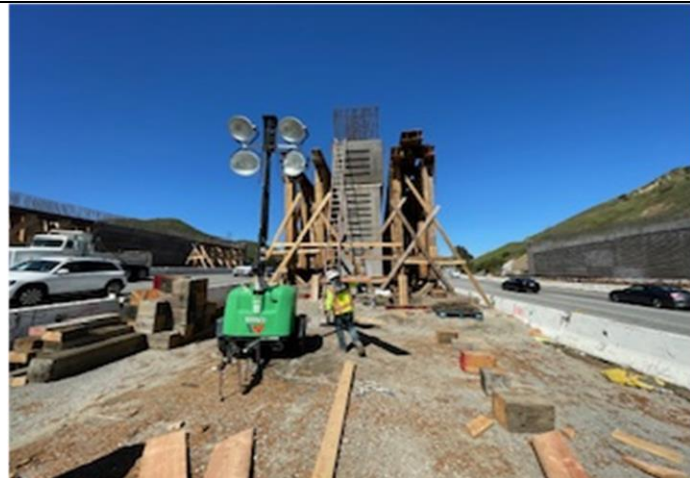
Light tower provided during night work.

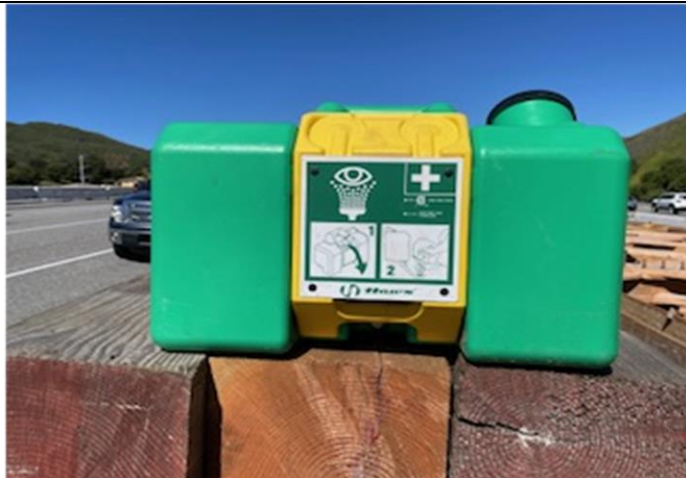
Eyewash station readily available and inspected.

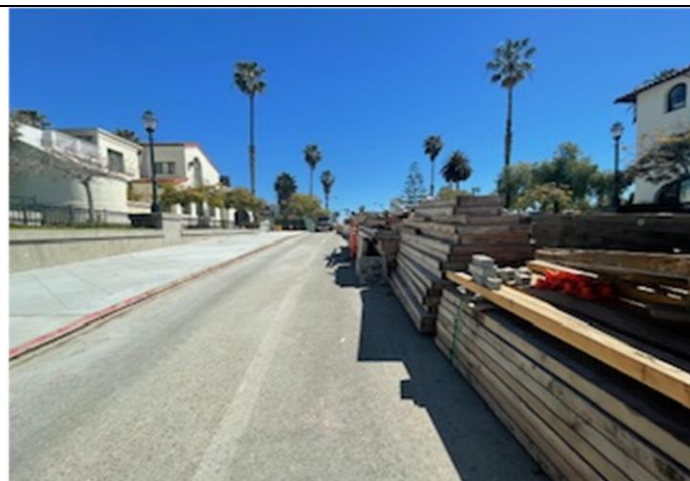
Good housekeeping observed with material stacked and secured out of path of travel.

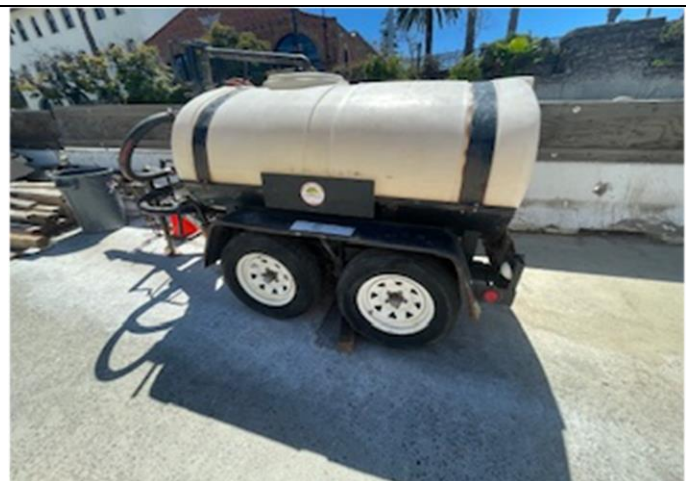
Water buffalo wheel chock in place.

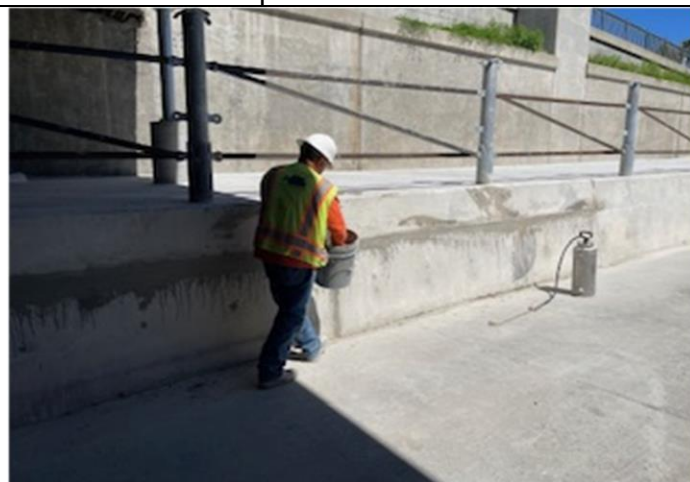
Company required PPE in use.

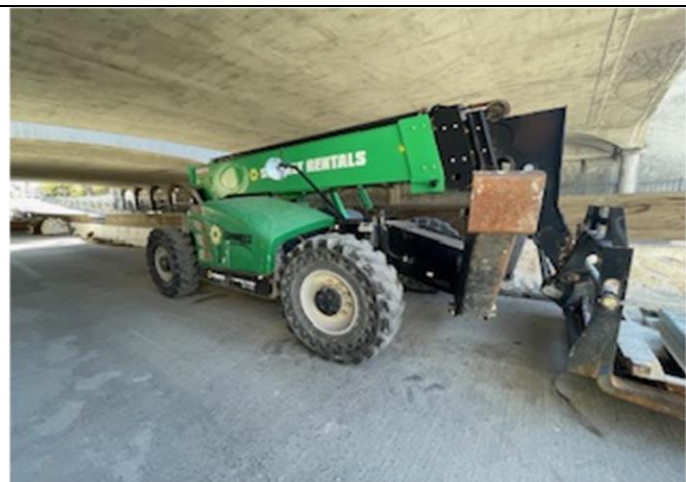
Forklift operators certified.

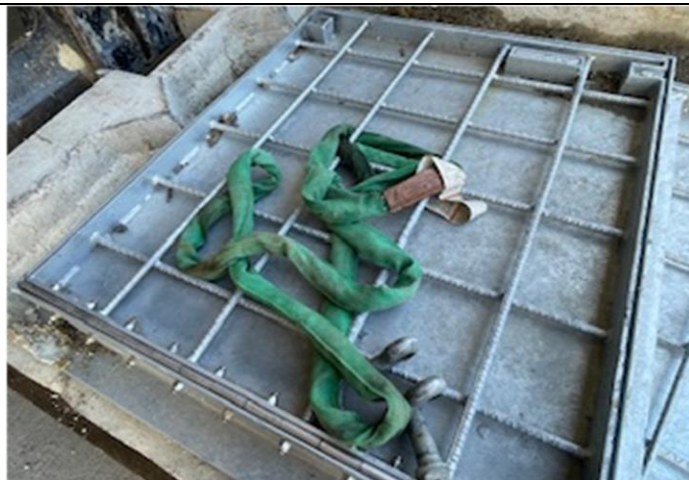
Rigging in good condition, inspected prior to each use.

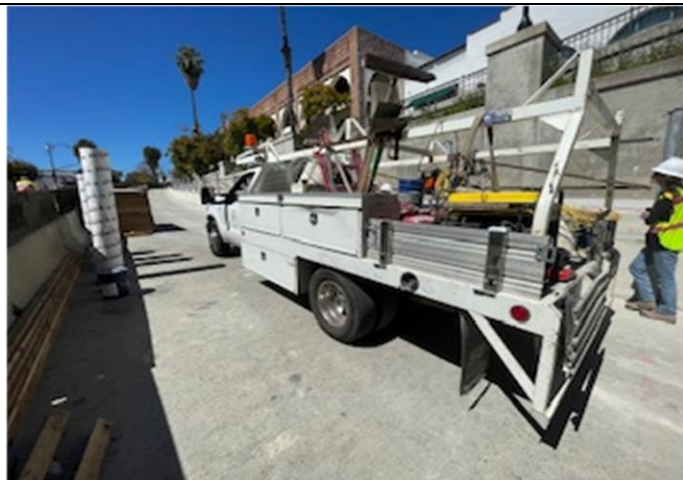
Company vehicle in good condition with material secured to prevent displacement. Wheel chocks to be provided going forward.

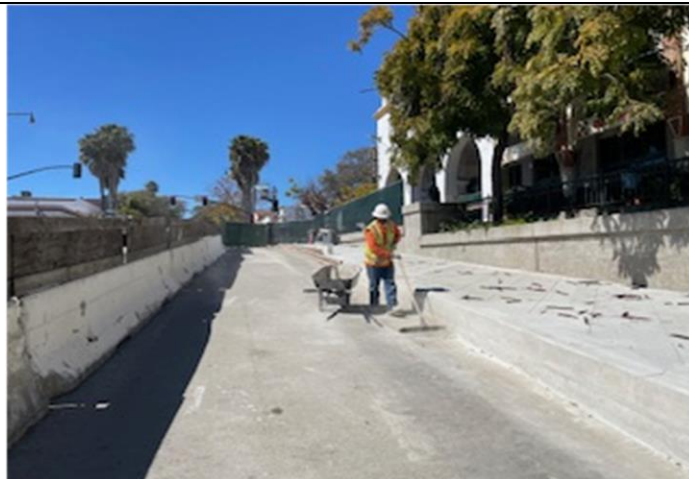
C.A. Rasmussen worker wearing required PPE
Wheelbarrow and broom in good condition.

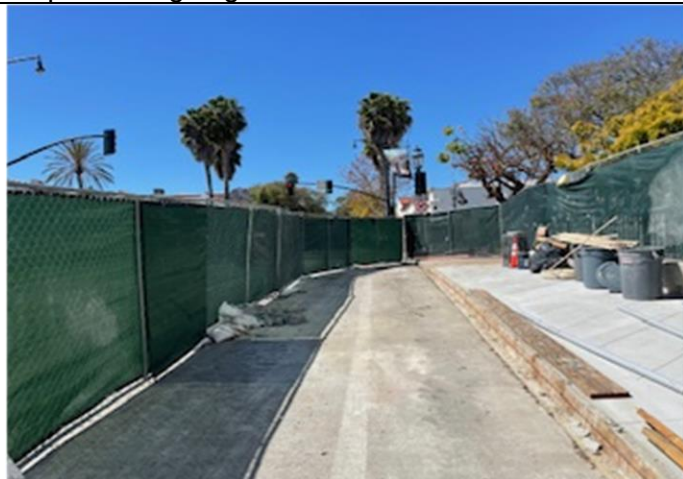
Jobsite perimeter fencing secured and locked.
Recommend inspecting fencing for gaps and panels to prevent tip over into pedestrians and vehicles.
