PROJECT SAFETY OBSERVATION REPORT

PROJECT NAME: POO – Maritime Projects – Inner Harbor Berths 55-59 Wharf Upgrades

GENERAL CONTRACTOR: California Engineering Contractors, Inc.

Date of Site Survey	June 24, 2024	Time of Site Survey	9:30 am
Risk Control Specialist	Doug Jenkins	Project Location	Inner Harbor Berth 55 - 59
Project Contact(s)	Desmond DeMoss, Port of Oakland, Safety and Emergency Management. Sarah Corso, Port of Oakland, EH&S Specialist Chuck Wells, Superintendent, CEC Jim Healy, Safety Manager, CEC Luis Torres, Alliant Insurance Services, Inc., Sr. Loss Control Consultant		
# Subcontractors on site	0	# Workers on Site	12

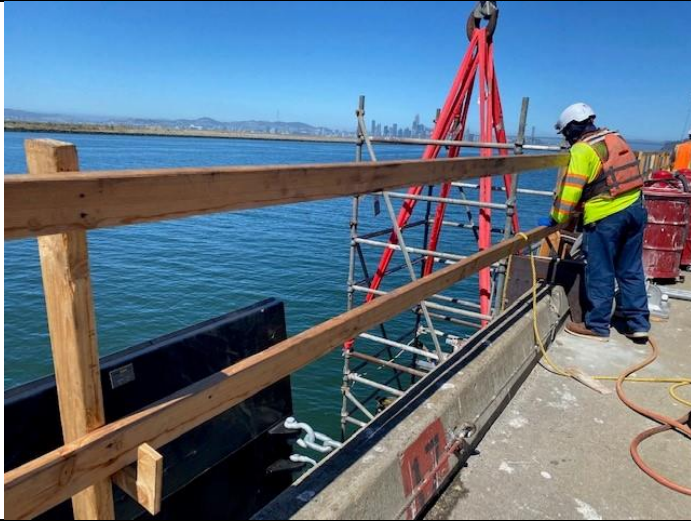
Photo #	Positive Observations: <i>The following positive observations were identified:</i>
1	✓ Employees working near or over water were wearing PFD. Good housekeeping and use of other general PPE including glasses, gloves, hard hats.
2	✓ Crane in use was on all 4 outriggers and CCO certified operator.
	✓ Construction work area is well delineated and separated with k- rail barricades from other port traffic.
3	✓ Emergency Eyewash station is in place along with other first aid supplies and a stokes basket is available.

Photo 1: Ladder did not extend at least “36” over the landing and a swinging gate or other method to provide unobstructed access to the ladder.

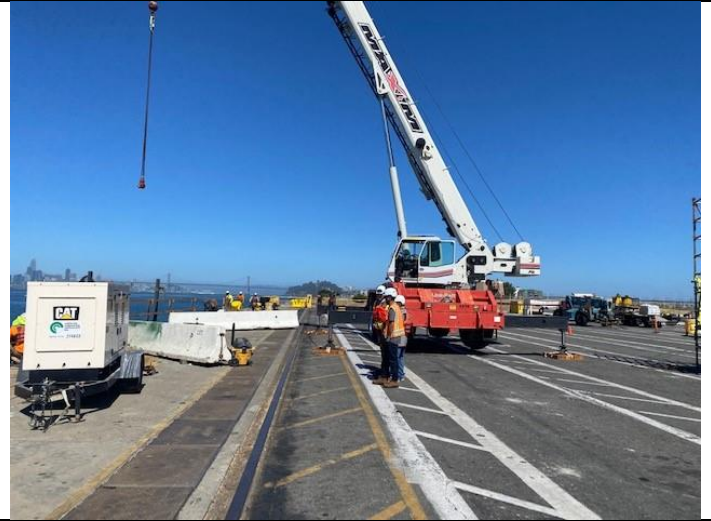
Photo 2: Crane in use was on all 4 outriggers and CCO certified operator.

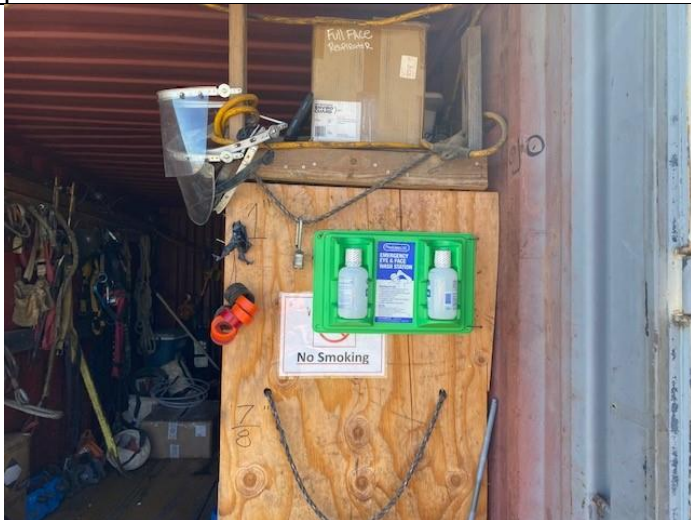
Photo 3: Emergency Eyewash station is in place along with other first aid supplies and a stokes basket is available.

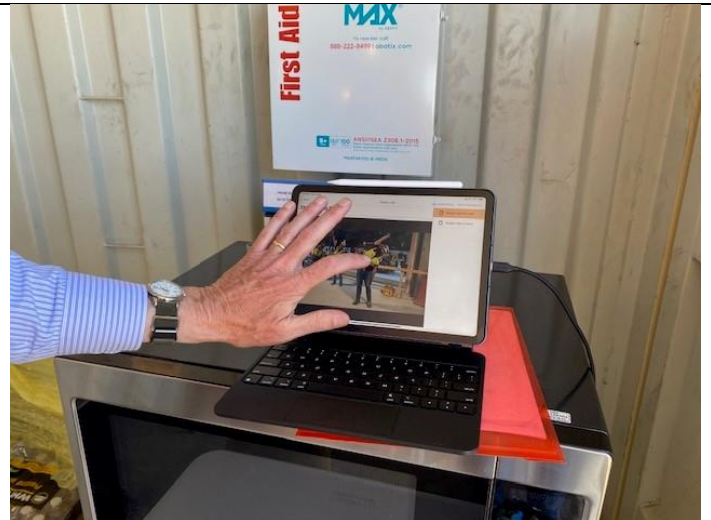
Photo #	Positive Observations: <i>The following positive observations were identified:</i>
4	<ul style="list-style-type: none"> ✓ Daily Pre-task planning and stretching activity are completed daily and reviewed with the crew. This is documented in the E- Mod digital platform.
	<ul style="list-style-type: none"> ✓ Site Safety Representative was onsite during working times and performs daily training and planning activities with the crew.
5, 6	<ul style="list-style-type: none"> ✓ EAP training recently performed on 6/15/24 and updated as needed to identify rescue boat and rigging practices.

Photo 4: Verify Engineering for Metal Platforms - Daily Pre-task planning and stretching activity are completed daily and reviewed with the crew. This is documented in the E- Mod digital platform.

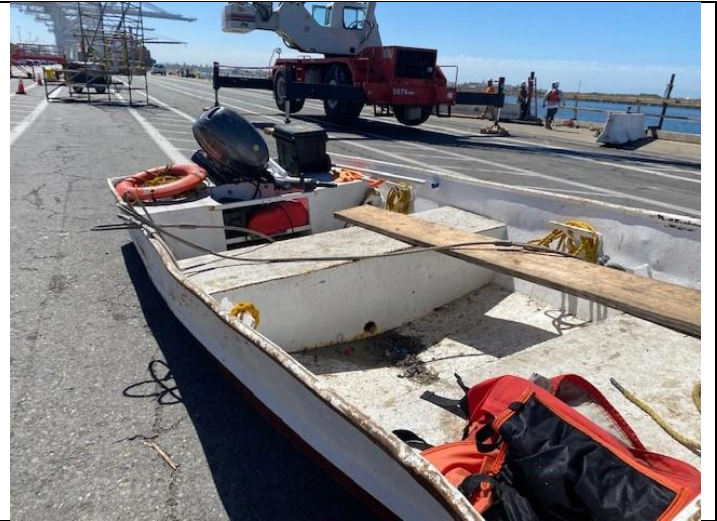
Photo 5: EAP training recently performed on 6/15/24 and updated as needed to identify rescue boat and rigging practices.

Photo 6: EAP training recently performed on 6/15/24 and updated as needed to identify rescue boat and rigging practices.

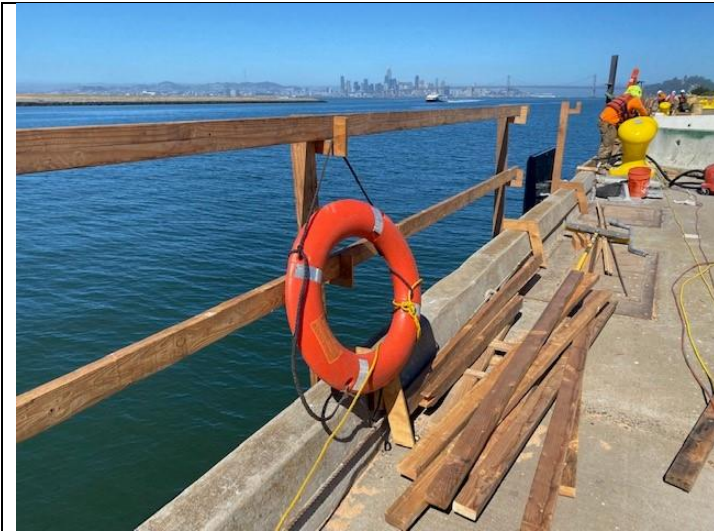
Photo #	Corrective Observations: <i>The following observations required corrective actions to be taken or were identified as an improvement opportunity.</i>
7	<p>Fall Protection – Review personal fall protection requirements for employees working at the edge of the wharf engaged in construction activities without the use of guardrails. Reviewed with Jim Healy.</p> <p>Barricading and Delineation of areas not protected by Guardrails. – We found a couple of areas where guardrails have been removed to engage in concrete activities on the wharf edge. We discussed the importance of barricading and restricting access to these areas. Reviewed with Jim Healy.</p>
7	<p>Work in Pairs – We observed an employee working on the edge of the wharf alone for a brief period of time. We discussed the "Buddy System" and Jim verified it was part of the emergency notification system and he would refresh the crew on that topic.</p>

Photo 7: Fall Protection Requirement and Barricading. Use of Buddy System needs review.

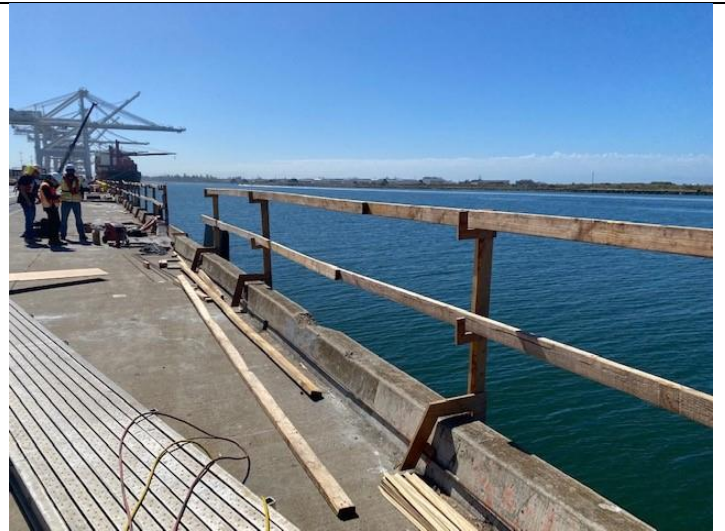
8	<p>Guardrail Construction and Maintenance – We observed a couple different areas where the guardrail span between uprights exceeded 8 feet or the wood rails were spliced together in the center of a span and not at an upright location. Reviewed with Jim Healy.</p>
9, 10	<p>Verify Metal Platform Set Up Matches Engineering Specifications- We observed the Angel Wing access platform installed and in use with the use of concrete ballast places on top of the baseplates. The engineered drawing provided calls for a concrete screw anchor. Please have the competent person review the set up and erection. . Reviewed with Jim Healy.</p>

Photo 8: Guardrail construction spans over 8' and splicing.

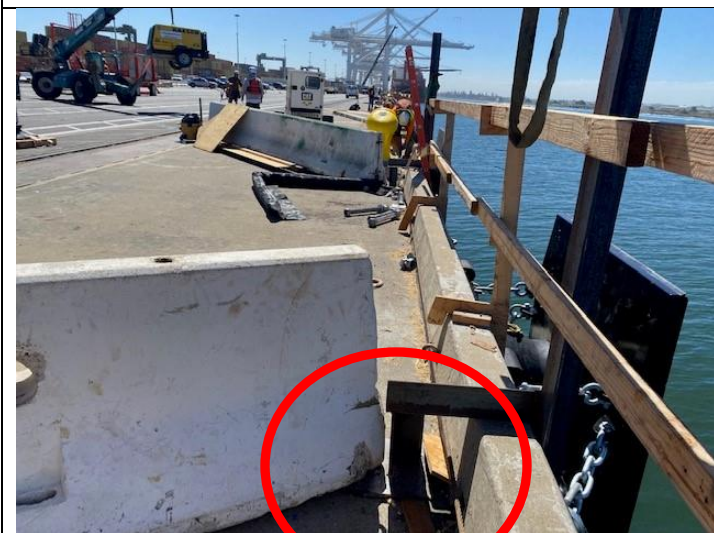
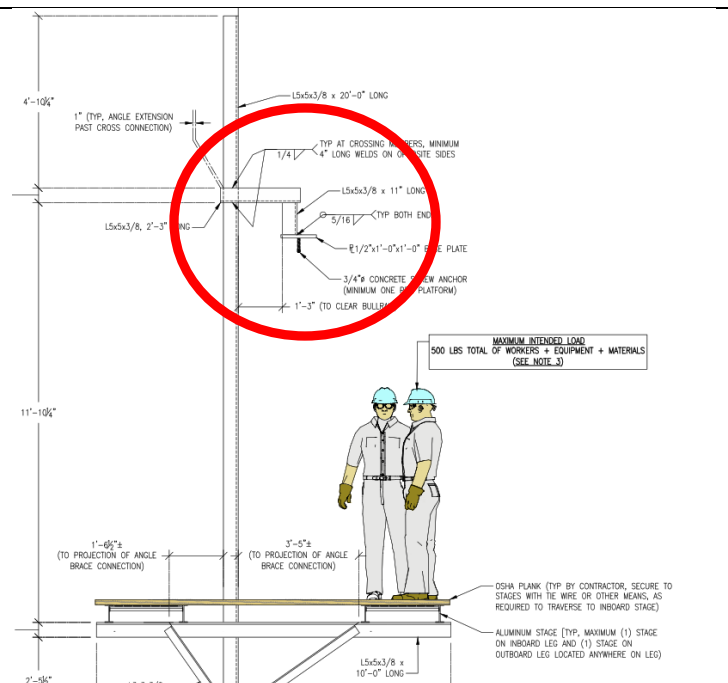
Photo 9: We observed the Angel Wing access platform installed and in use with the use of concrete ballast places on top of the baseplates. The engineered drawing provided calls for a concrete screw anchor.

Photo 10: We observed the Angel Wing access platform installed and in use with the use of concrete ballast places on top of the baseplates. The engineered drawing provided calls for a concrete screw anchor.
