RE: Risk Engineering Service Activity

Site Safety Assessment | The Park Ward Village | 333 Ward Ave | Honolulu, HI 96814
Service Date: February 1, 2024

Site Safety Assessment | The Park Ward Village

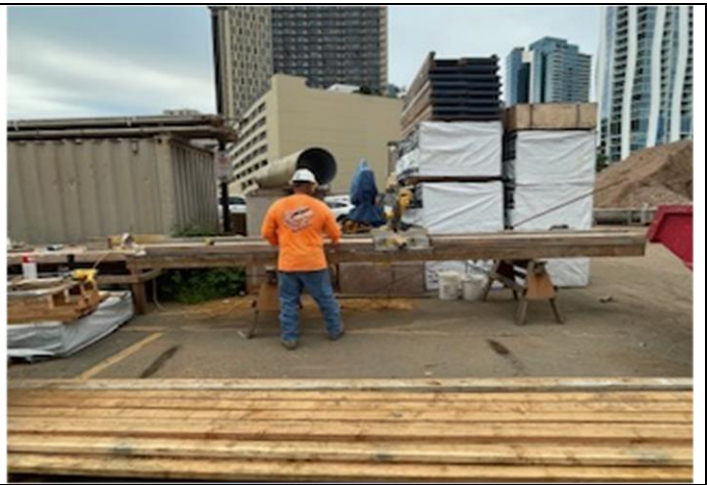
McClone: Laydown fabrication yard provided with elevated workbench, secured saw with blade guard in place and electrical cords in good condition and grounded.

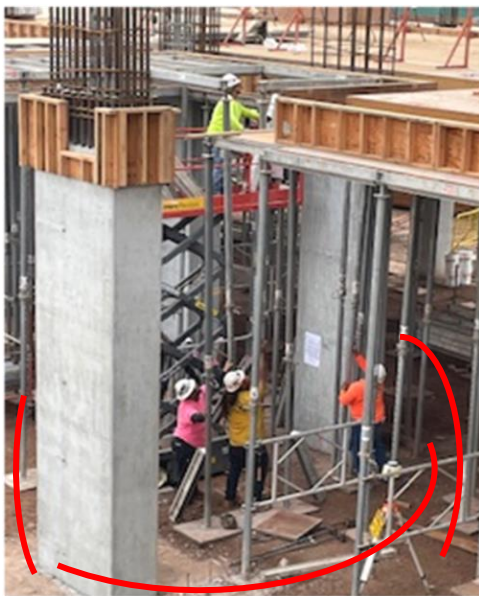
Rented scissor lift inspections completed daily
Overall depiction of formwork installation.

Barricade added at ground level (Red Danger tape and signage) to keep others out of overhead work, prevent struck-by incident fallen objects.

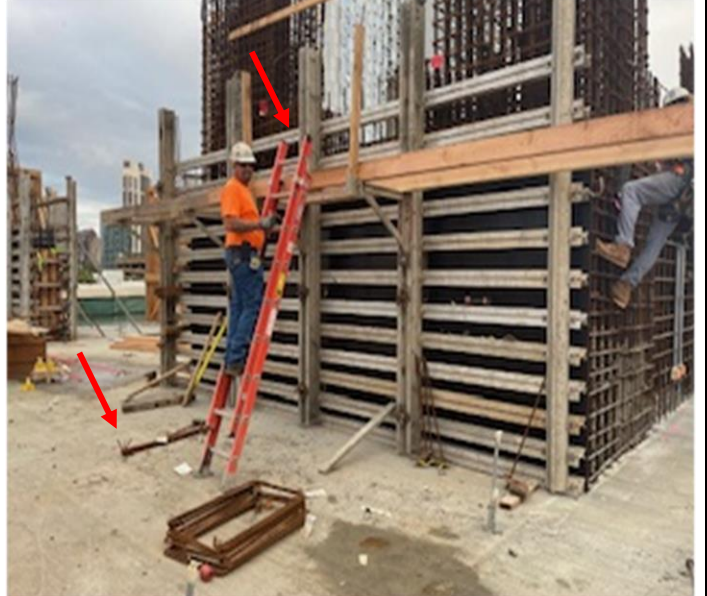
Formwork tasks off extension ladder:

Rebar near extension ladder (other trade material CMC Rebar) relocated and ladder extended above landing 36" and secured to prevent displacement.

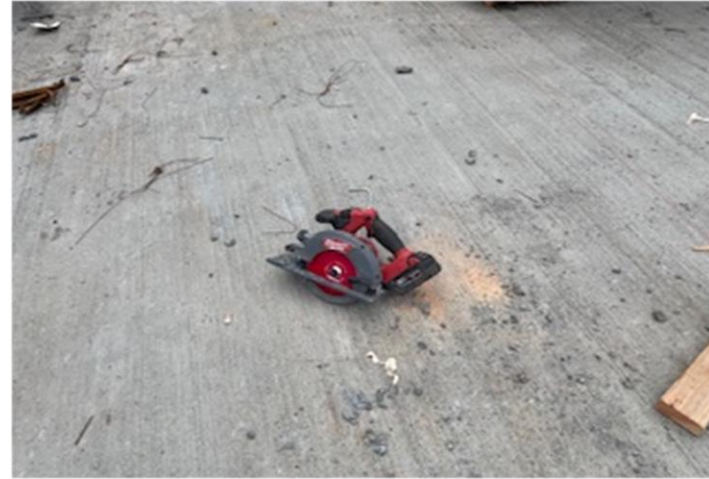
Skil Saw blade guard in place, battery operated.

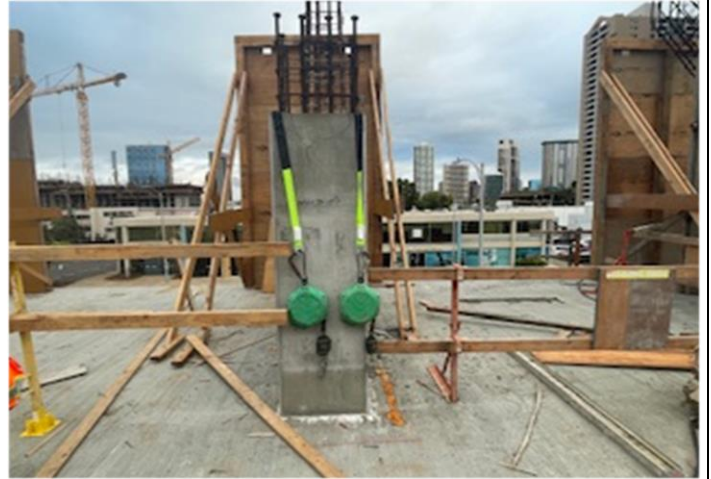
MSA leading edge fall protection while working outside guardrail system with embedded concrete column approved anchors.

Fall protection rescue plan will be reviewed with Safety Coordinator Joey Galariada and General Contractor Kobayashi.

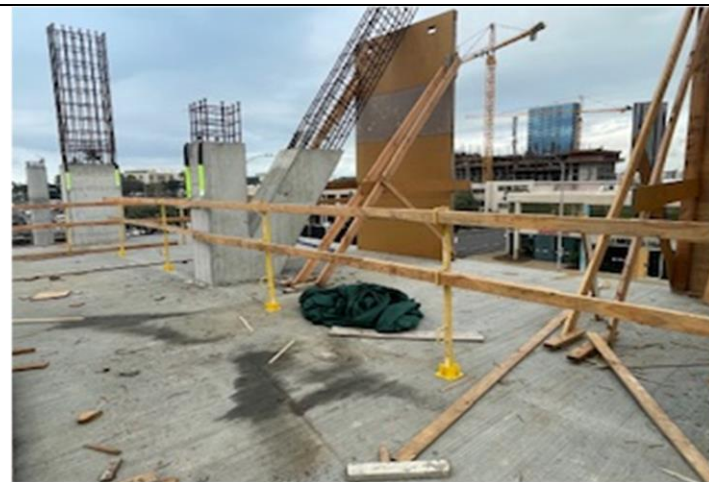
Temporary guardrails installed and inspected along leading edges through general contractor Kobayashi.

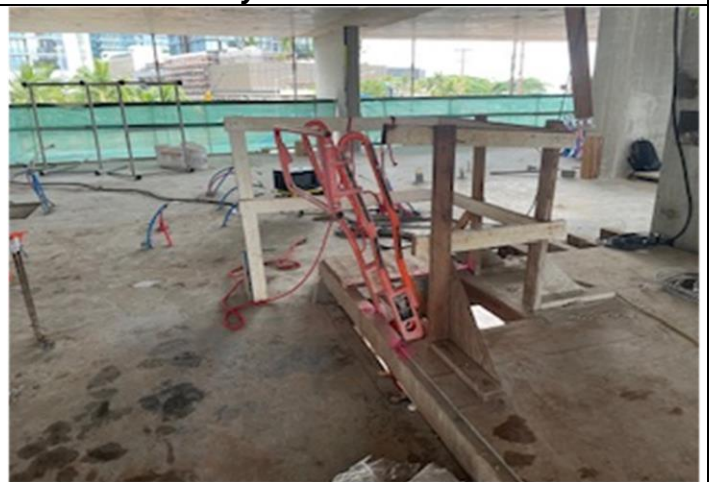
Extension ladder access secured at the top and bottom with extension handles and guardrail offset.
