PROJECT SAFETY OBSERVATION REPORT

PROJECT NAME: Project Radius

Date of Site Survey	December 20, 2024	Time of Site Survey	10:30 AM
Risk Control Specialist	Tim Rossi	Project Address	Avenue of the Stars, Lake Buena Vista, FL
Project Contact(s)	Scott McCullough , Disney Safety		Graham Johnson, Disney
# Subcontractors on Site	4	# Workers on Site	55
Estimated Project Completion			%

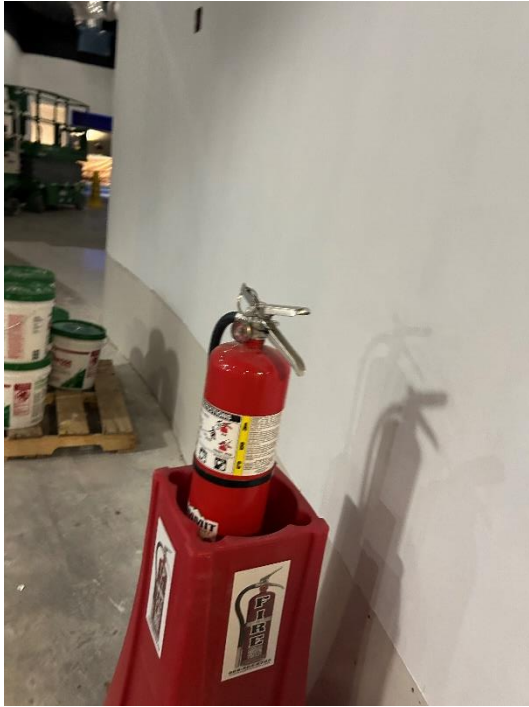
Photo #1: Fire extinguishers were readily available throughout the project.

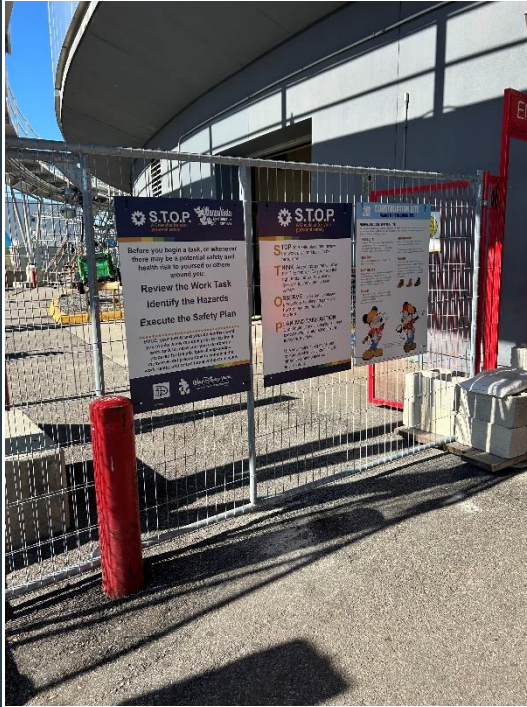
Photo #2: Safety signage was posted at the project entrance.

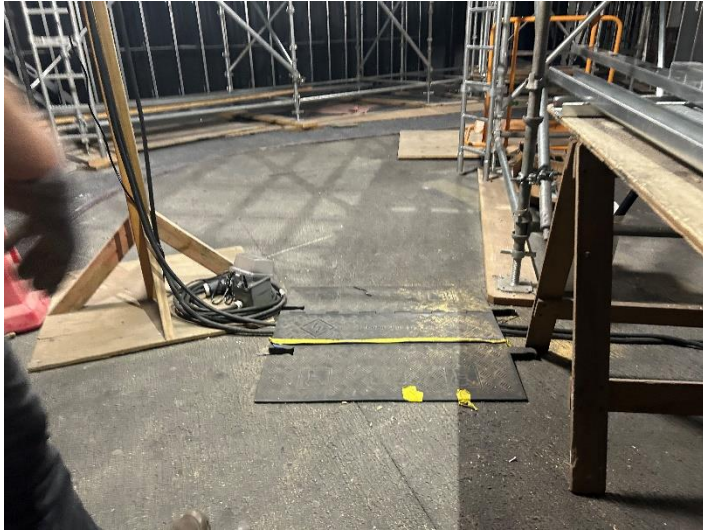
Photo #3: Cords were covered at pathway crossings to prevent trip hazards.

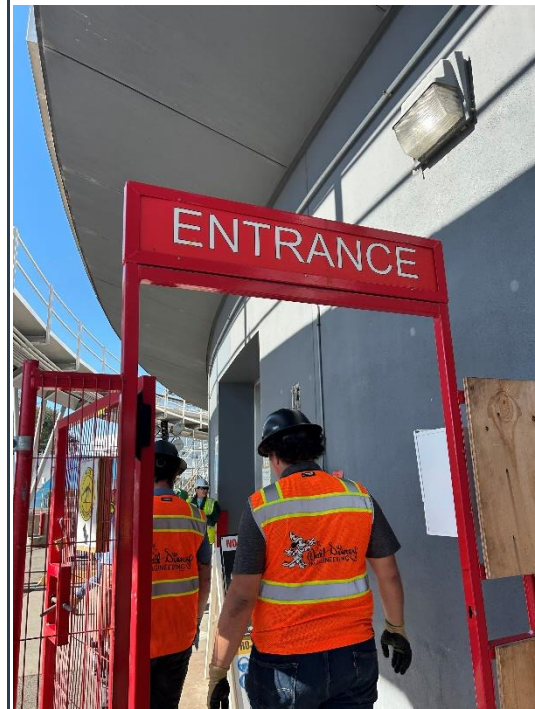
Photo #4: Fencing was in place around the entire project. Workers onsite were wearing the appropriate PPE for their task.

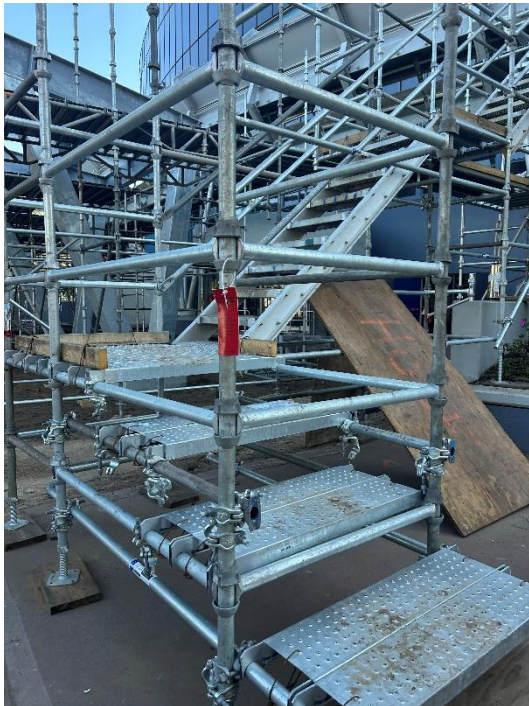
Photo #5: Scaffolding that was currently still being erected had red tags in place with railing setup to prevent access.

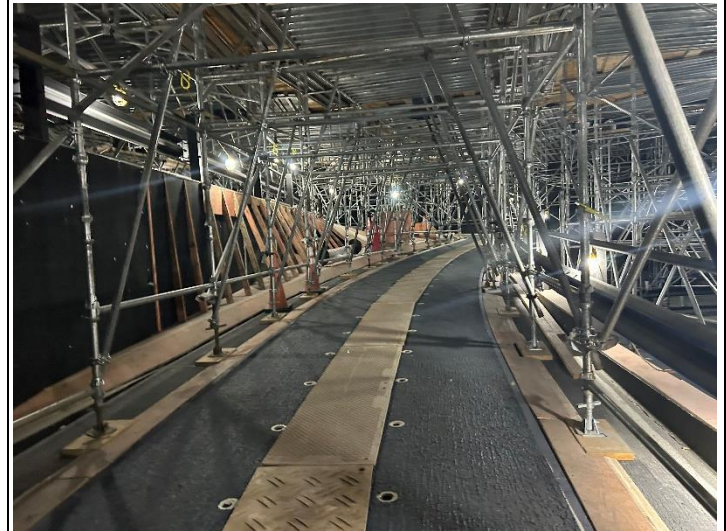
Photo #6: Lighting conditions inside of the building were adequate.

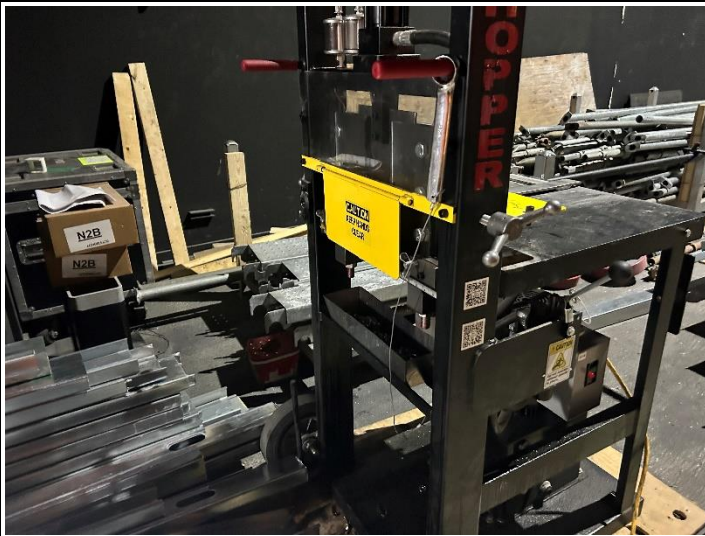
Photo #7: The carpenters had a drywall stud cutting machine onsite that performed sparkless cuts that machine guarding in place around the point of operation.

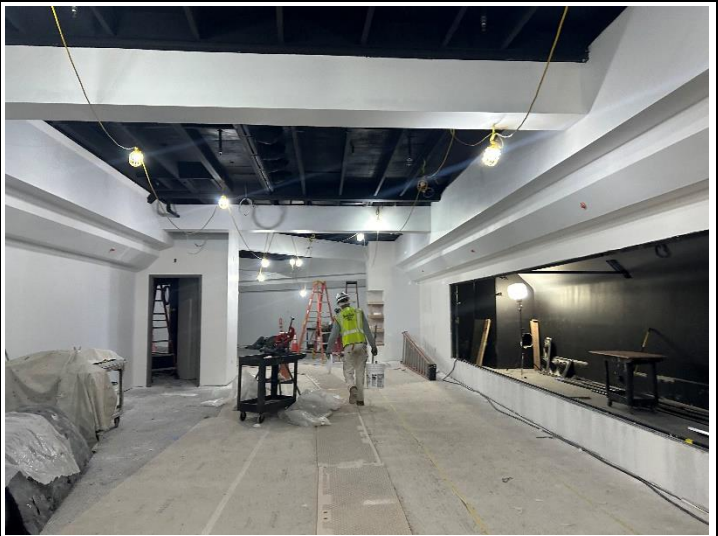
Photo #8: Workers were wearing the appropriate PPE for their task.

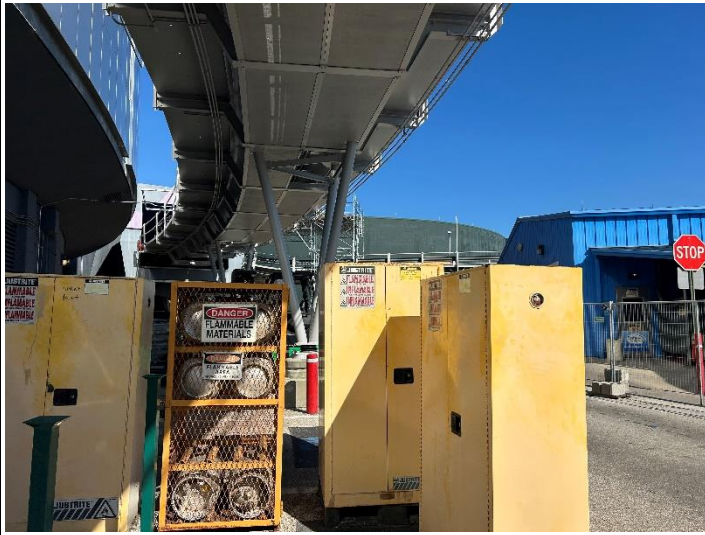
Photo #9: Flammables were stored in approved storage lockers.

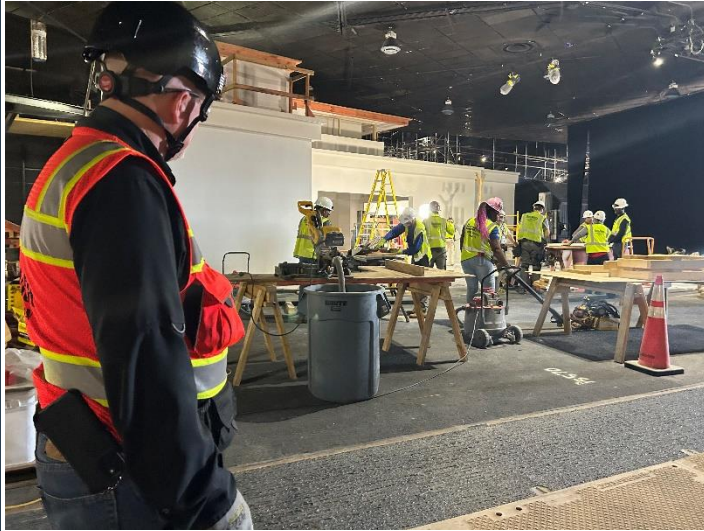
Photo #10: A worker was cutting wood on a table saw with the guard in the up position. He also did not have a push stick.
Work was stopped and the worker was instructed to lower the guard and use a push tick.

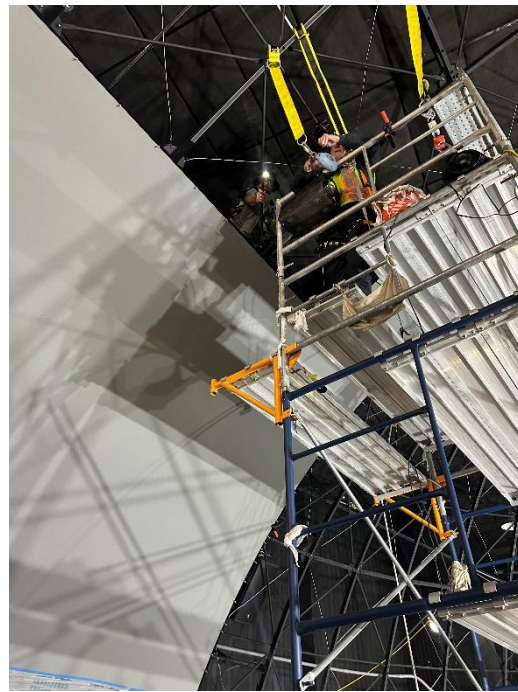
Photo #11: Workers tied off to the dome steel structure. SRLs were hanging too low. Multiple anchorage straps connected to the same steel section.
✓ Corrections were identified to the crew.

10	<p>A worker was cutting wood on a table saw with the guard in the up position. He also did not have a push stick.</p> <p>✓ Work was stopped and the worker was instructed to lower the guard and use a push tick.</p>
11-12	<p>There was a crew from a theming contractor (installing the dome) working off a supported scaffold without guardrails on the front side. One of the workers was not using his fall protection, and the other workers were anchored to the dome steel, which was not the building structure and did not appear to be an OSHA compliant anchorage point. The SRLs in use were also hanging below the workers feet.</p> <p>We discussed the importance of tying off to confirmed OSHA compliant anchorage points and it was recommended that the contractor provide a fall protection plan that identifies proper tie off points for each worker.</p>

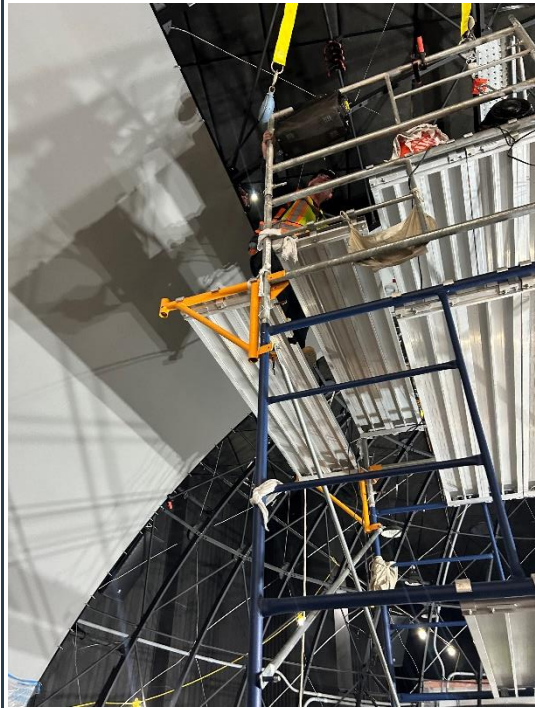
Photo #12: Worker in the front of the scaffold was not connected to his SRL. This was corrected onsite.
