**PROJECT SAFETY OBSERVATION REPORT**  
**PROJECT NAME: Project X Wrap-Up - XXXX**

Date of Site Survey	October 26, 2024		Time of Site Survey		9:30 am - 2:00 pm	
Risk Control Specialist	Doug Jenkins, SVP Risk Control		Project Address		123 ABC Avenue, Anaheim, CA. 90210	
Project Contact(s)	Richard Johnson, Project Superintendent, Build Construction Tom Raines, Project Safety Manager, Build Construction Julie Smith, Owner Representative, Owner					
# Subcontractors on site	14	# Workers on Site	135	Estimated Project Completion %		50%

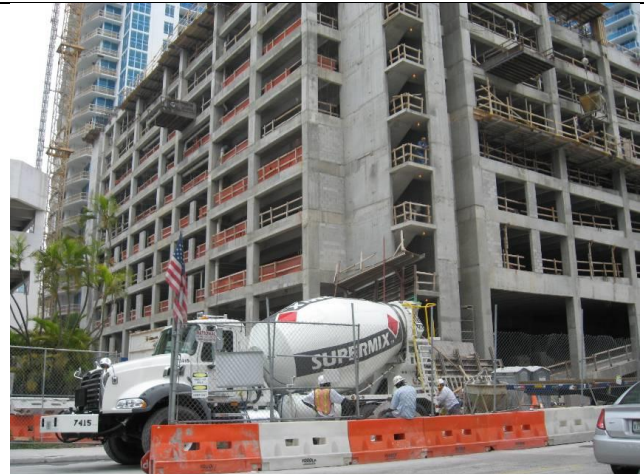
Photo #2: Concrete delivery on the ground floor.

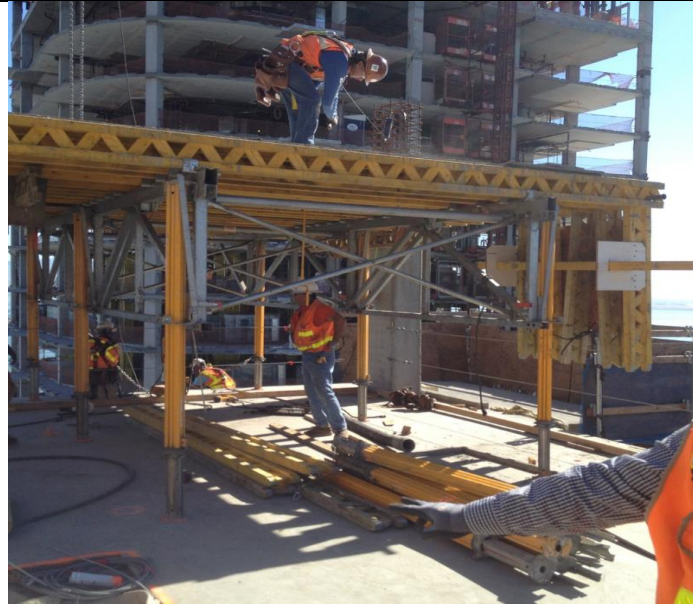
Photo #3: Personal Fall protection was observed at 100%, with all exposed employees properly tied off to appropriate anchorages devices. PPE usage was excellent with all workers observed wearing hard hats, high visibility vests and safety glasses.

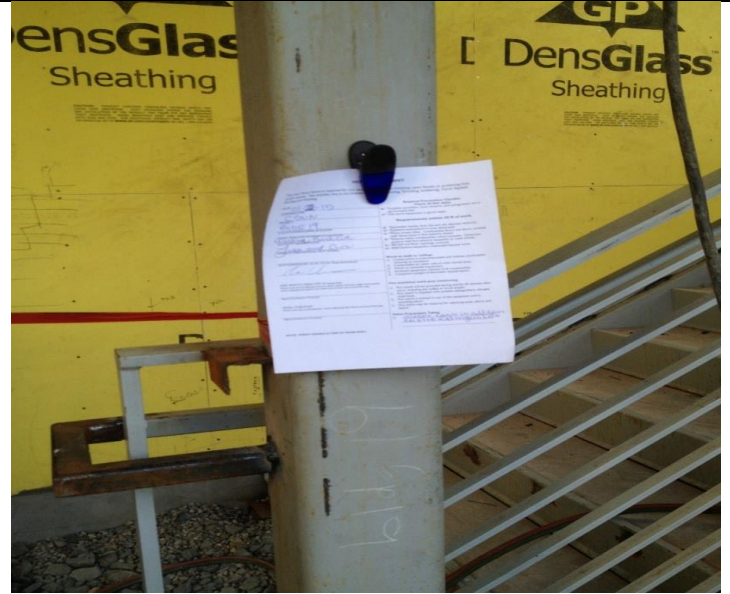
Photo #4: Hot Work Permit process in place and being followed.

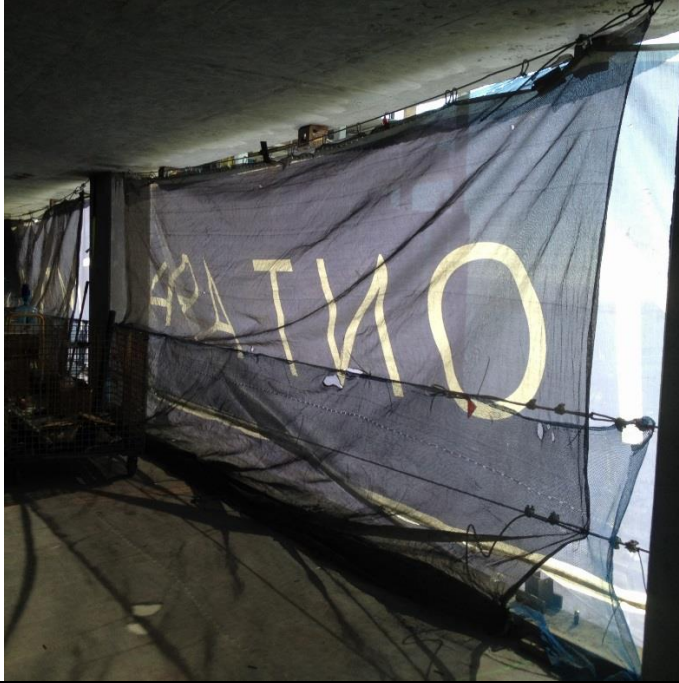
Photo #5: Perimeter fall protection guardrails were in place and well maintained throughout the site.

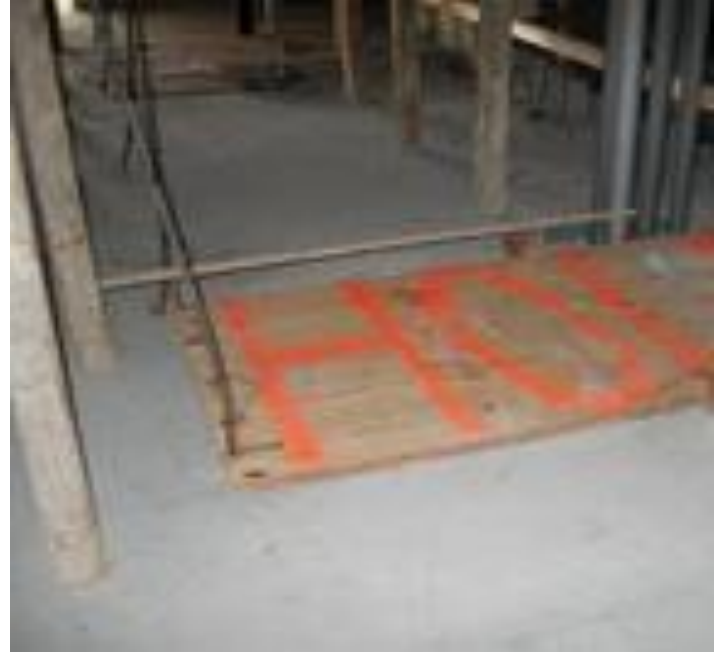
Photo #6: Housekeeping throughout the site was in overall good condition. Floor hole covers were in place where necessary and clearly identified in accordance with OSHA guidelines.

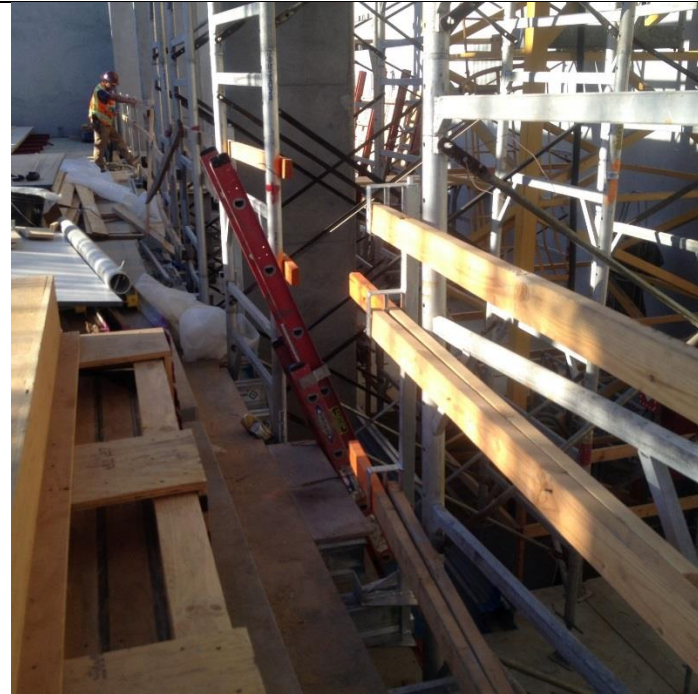
**Photo #7: Build Construction** – Ladder access to pit on level 1, E. Side exterior was blocked by materials.

- ✓ *Tom Raines directed the carpenter foreman to move the materials immediately (Corrected).*

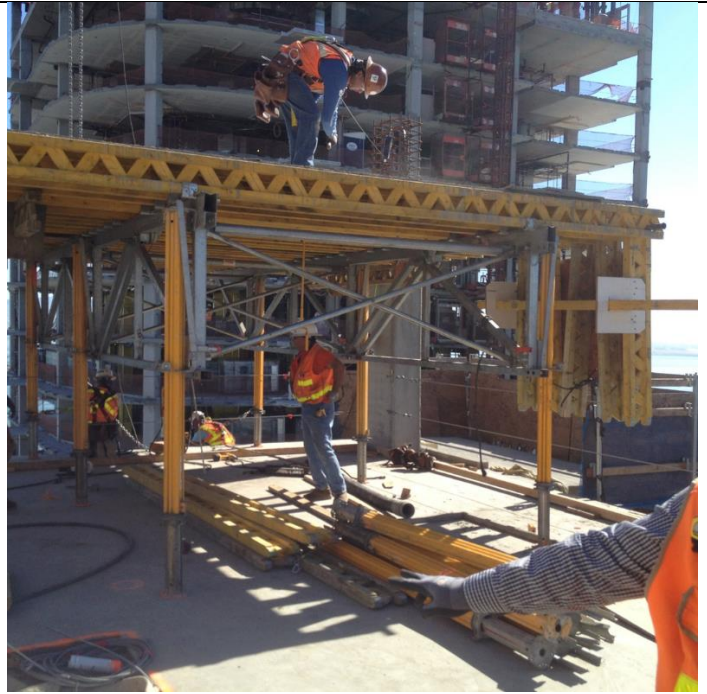
**Photo #8: Pacific Concrete** – On level 17, the table form had been hoisted into place. Employees for Pacific Concrete mounted the form to begin anchoring it into place. Both employees were tied off with self-retracting steel cable lanyards during this process. The location of the self-retracting lanyard created a swing fall hazard to the exterior of the building if an employee was to fall.

- ✓ *Tom Raines discussed this immediately with the crew supervisor. The self-retracting lanyard was relocated to an adjacent column, eliminating the swing fall hazard immediately (item corrected). The supervisor (Juan Gomez) also stopped his crew and reviewed the swing fall hazards and the proper location of the self-retracting lanyards.*
