BASIC INFORMATION

Location: Adjacent to Blocks 15, 16 and 17, Shui Chuen O Estate, Pok Chuen Street, Shatin

SIFT Ref.: 7SE-16B/S 15

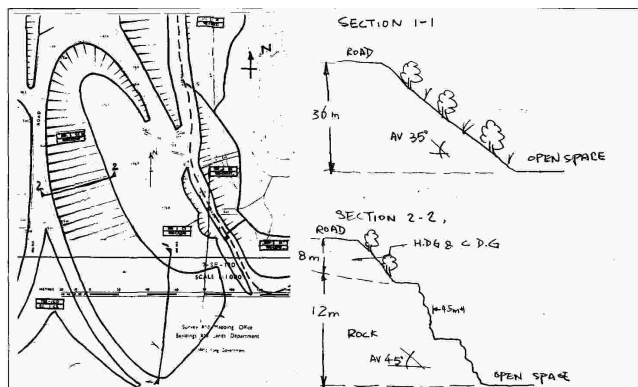
Section No: 1-1

Height(m): H1: 36 H2: 0

Sign of Seepage: Slope: Slight to moderate seepage below mid-height or from isolated rock joints
Wall: N/A

Sign of Distress: Slope: None

Further Study: Y
