高通协议技术期刊 –

2014/09/26

Qualcomm Technologies, Inc.

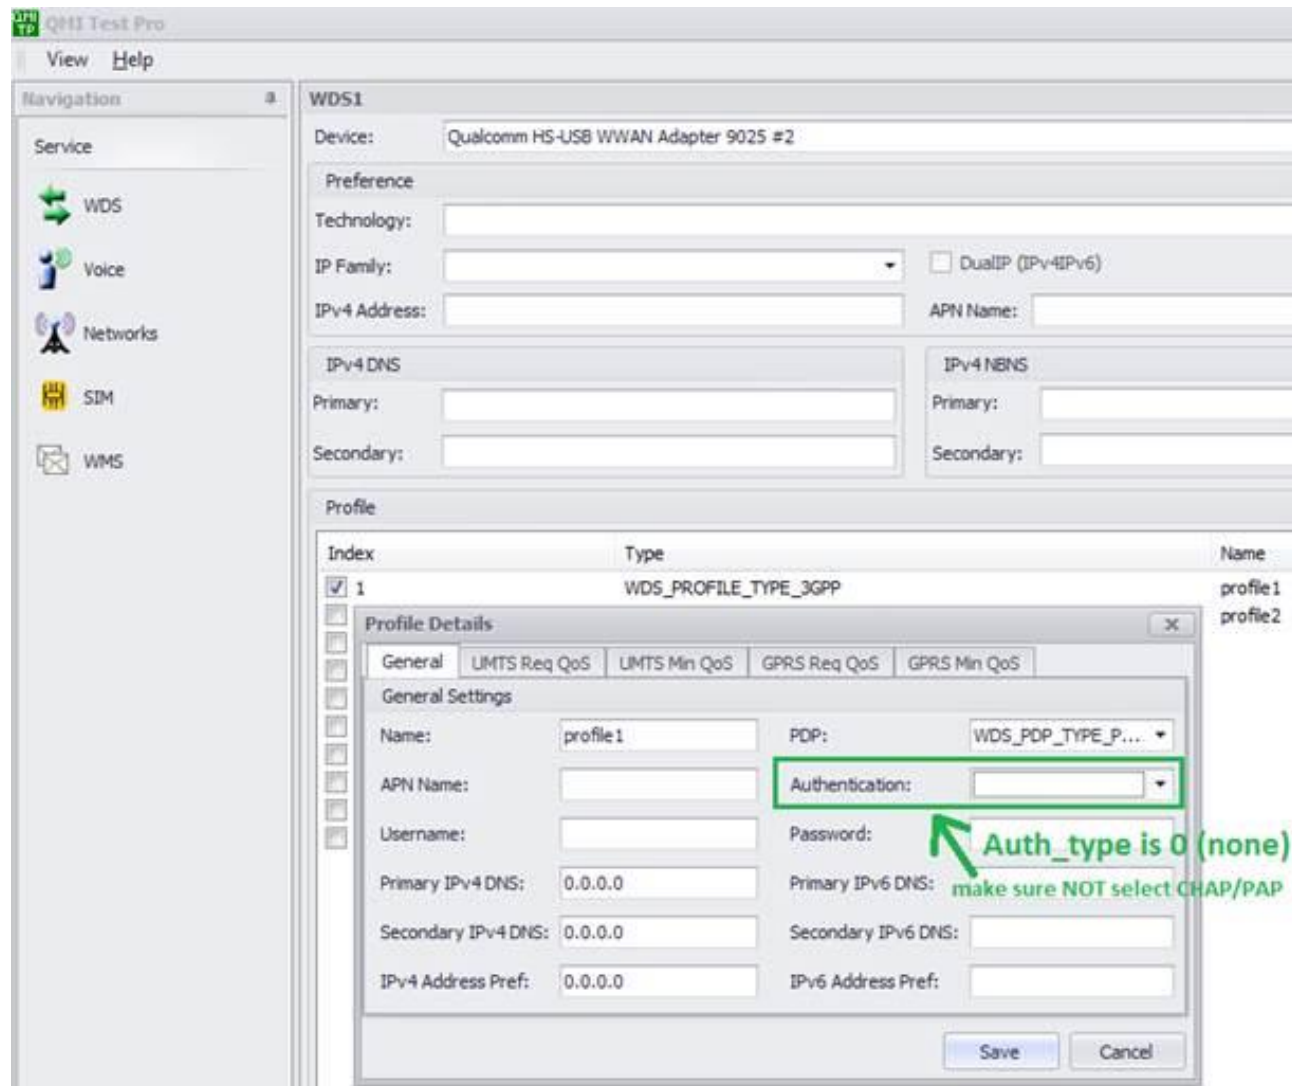
Recently a Testbox compatibility issue is found. During LTE SIM CTA test (3GPP 31.121), UE can't attach to LTE testbox.

- 1) UE configures the LTE Attach Profile with **non-zero authentication type** (e.g., 3:CHAP+PAP; 1: PAP).
- 2) UE LTE Attach OTA message will be set *esm_info_trans_flag* = 1;
- 3) Testbox sends the *ESM information request* Msg, and UE responses with correct authentication Protocol Config Option(PCO);
- 4) Testbox sends *LTE Attach Accept* Msg with “**length=0, Unknown PCO**”;
- 5) Modem decodes this zero length PCO and reports failure. Hence UE rejects it and sends LTE Detach;
- 6) UE attach LTE testbox failed.

Figure: QMI Testpro change profile1's authentication type to "none".

- 1) Contact testbox vendor and see why it sends LTE Attach Accept Msg with “zero length, Unknown PCO”;
- 2) For debug purpose, configure UE LTE Attach Profile's *auth_type* to “none”. In this way, the Testbox will not send “Unknown PCO” in *LTE Attach Accept* Msg.
