高通协议技术期刊 – 2014/10/17

Qualcomm Technologies, Inc.

- 8916/8936/8939系统解决方案
- MBN solution number
- 协议日志分析关键字
- 如何在Salesforce上快速创建Case
- CT doc update
- 一种GSM网络环境下，主叫端在电话接通瞬间听到的噪声问题分析

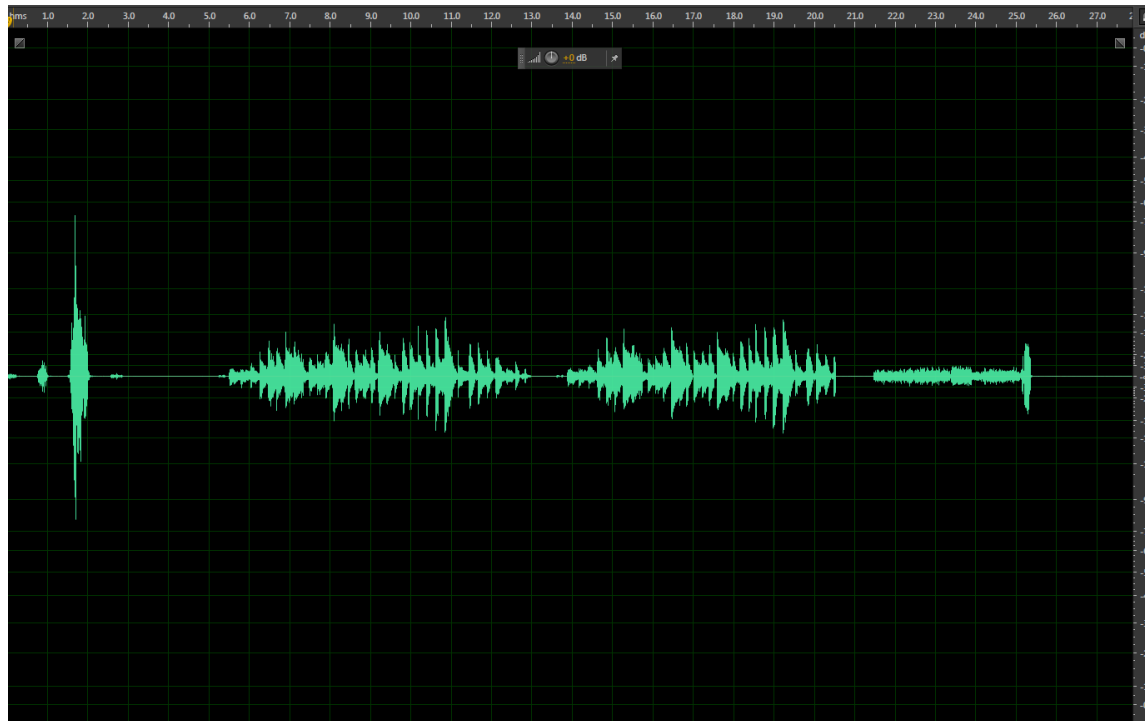
在部分GSM网络环境下使用EFR信源编码方式进行通话，如果被叫端开启彩铃业务，则在电话被接通的瞬间，会在主叫端听到“ZiZi”的噪声，噪声的持续大约在500ms~1000ms，足以引起的通话人的察觉。请注意这是一个网络问题，该问题一般仅在对方开启彩铃业务时才会发生。

噪声产生的原因是，在主叫端呼通被叫端但是被叫端仍未接通的过程中，网络会给主叫端播放定制的彩铃音乐。当被叫接通电话，即网络收到被叫的CONNECT消息之后，网络需要给主叫端也发送CONNECT消息，同时终止进行中的彩铃音乐播放。这个控制环节中，由于本质上有效的双方有效的语音还未被完全激活，在终止音乐到双方说话之间的时间，网络处于DTX状态。理论上，网络必须在彩铃和之后的无声状态中，插入有效的带内信令，保证手机能够识别声音状态的突变。但事实上，部分网络并没有这样实现，导致手机在收到网络在之后DTX下的静音帧之后，产生了较为突兀的舒适噪声，即“ZiZi”声。

参考的音频谱线如下，中间两段重复的波形是彩铃，最后一段幅度较小的密集波形即为“ZiZi”声。

This issue is related to DTX handling in the GSM EFR vocoder. The problem occurs when the MSC does not insert a homing sequence after sending a DTMF or ringback tone into Rx vocoder speech frames. Presenting a homing sequence would reset the decoder state. If this is missed at the end of a DTMF/ringback tone, out-of-sync Rx/Tx DTX results and noise is generated via the following scenario:

若您在测试过程中，遇到此类问题，请仔细甄别是否和上述的场景类似，关键点包括主叫端噪声，EFR编码，彩铃激活，噪声持续时间等。
