高通RF技术期刊2015-11-30

Qualcomm Technologies, Inc.

1. TS14.18.5 EDGE Blocking and spurious response fail
2. Application note for TxM like SKY77916 and RF5216A
3. CDMA 4.3.1 Time Reference test failure

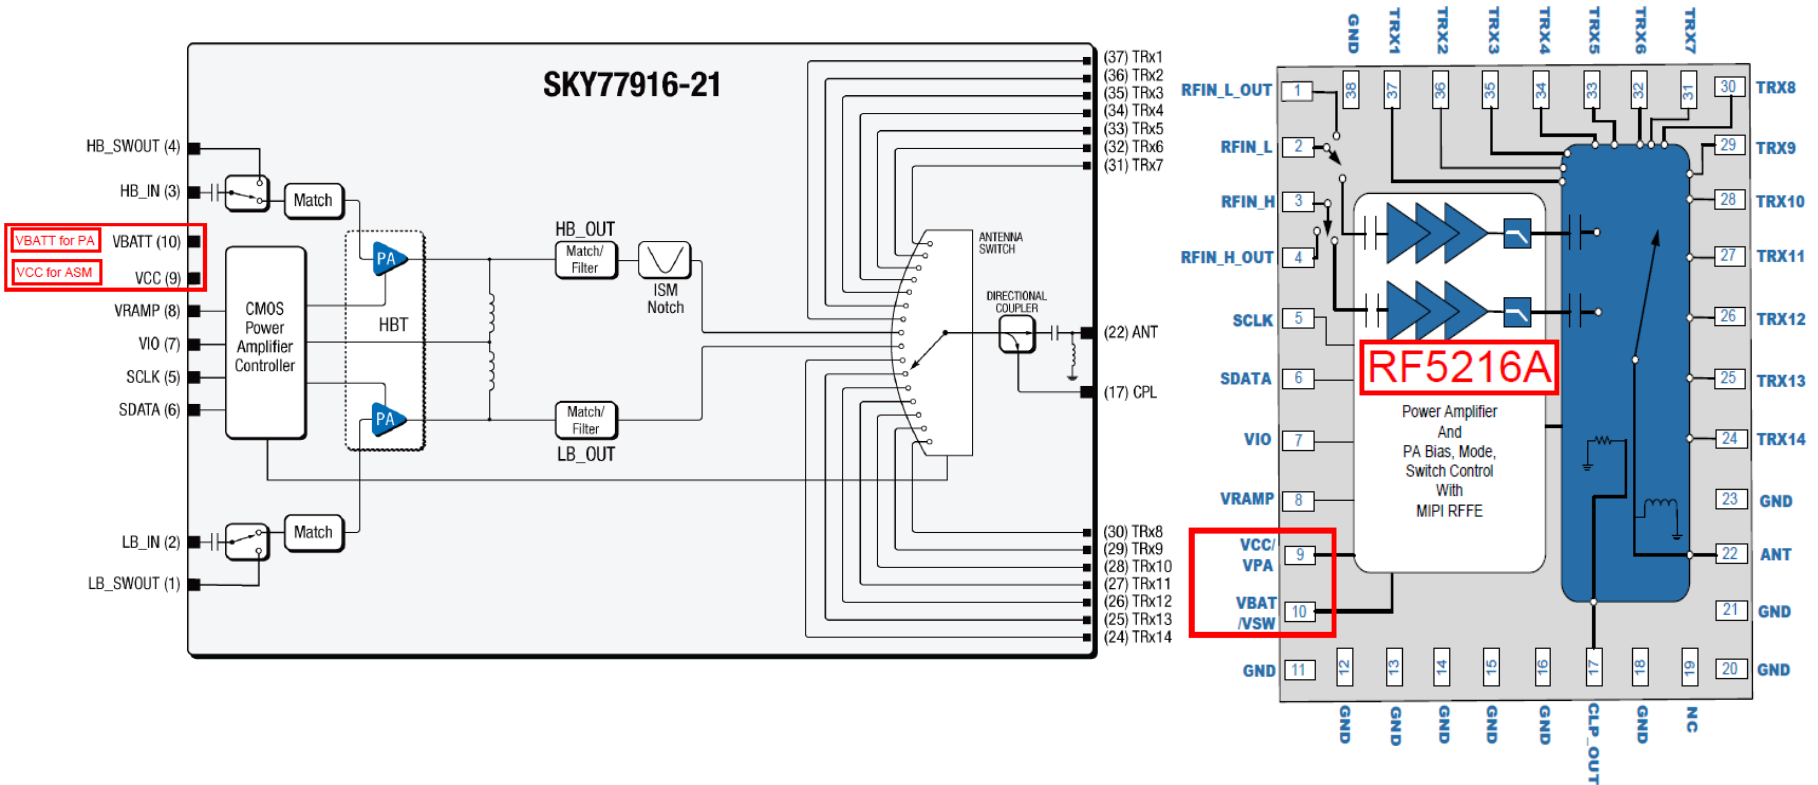
Application note for TxM like SKY77916 and RF5216A

- **适用平台**：所有
- **问题描述**：当使用TxModule SKY77916/RF5216A作为射频前端时，需要特别注意供电方式的选择。
- TxM有三个供电管脚：VIO，VBATT，VCC。其中VIO是MIPI部分的IO电源，需要连接到1.8V. 另外VBATT和VCC是给PA和ASM的电源。

- 如果需要支持GSM APT或者TDD/TDS APT，需要将PA部分供电电压接到QFE2101 VPA_APT 输出。**ASM电源一定不能连接到VPA_APT 上**，否则在APT模式下，ASM会因为电源电压偏低而工作异常，导致插损很大。
- 如果不需要支持GSM/TDD/TDS APT，需要将TxM **VCC/VBATT 全部连接到VPH_PWR**。
- 由于SKY77916/RF5216A同一管脚给内部模块供电功能不一样，在支持APT的项目上没有办法做兼容 (for SKY77916, VPA_APT 需要连到pin10 VBATT, for RF5216A, VPA_APT需要连到pin9 VCC)。

- **Platform:** All
- **Issue:** When use TxModule like SKY77916/RF5216A, need pay attention to the power supply connections
- TxM has three power supply pins: VIO,VBATT and VCC. VIO is the IO power supply for MIPI, should connected to 1.8V. VBATT and VCC are for PA and ASM power supply.

- If need support GSM/TDD/TDS APT mode, need connect TxM PA power supply to QFE2101 VPA_APT output. The power supply for ASM CANN'T be connected to VPA_APT, otherwise in APT mode, ASM will work abnormal due to low power supply, like high insertion loss.
- If don't support GSM/TDD/TDS APT, need connect TxM both VCC/VBATT to VPH_PWR.
- As SKY77916 and RF5216A use different function for same Pin, it can't be compatible when need support APT mode(for SKY77916, VPA_APT need connect to Pin10 VBATT; for RF5216A, VPA_APT need connected to Pin9 VCC).

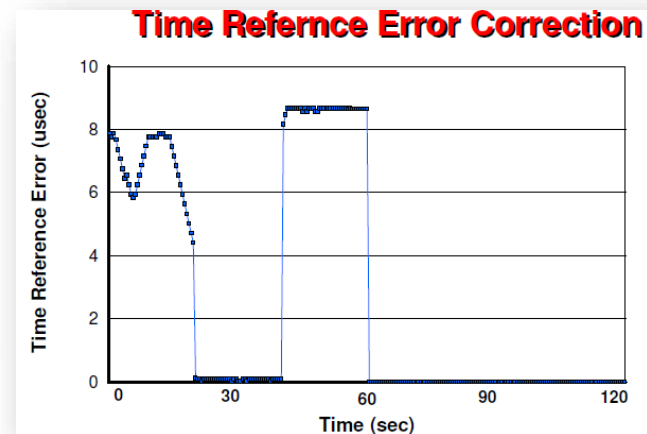
CDMA 4.3.1 Time Reference test failure

- **Platform:** MSM8916+WTR4905
- **适用平台:** MSM8916+WTR4905
- **Description:** Customer project cannot get 4.3.1 Time Reference test data in 3rd party certification lab. In customer own lab with Agilent 8960, Time reference is fine.
- **问题描述：**客户项目在第三方实验室做CDMA测试时，测试项4.3.1测试结果为Undetermined. 实际实验室里使用单仪表测试发现没有问题。

Time Ref Corr Rate:	0.00 ns/msec
DTTime Passed:	Undetermined
Failure Reason:	
LTE Status:	N/A

- **Analysis:** We found that in customer's test report, there is one parameter setting is wrong which may lead to such kind of issue. And with single Agilent 8960, it couldn't do 4.3.1 fully test.
- **问题分析：**我们发现客户的测试报告中，有个参数设置存在问题，这个参数设置可能会影响测试结果。而客户使用单仪表Agilent8960，是不能完整测试4.3.1这个测试项的。

- **Solution:** Set “Dynamic TTime Enabled” to “No” from test system and redo the test, then test result is passing. In below snapshot of customer failure test report, we can see that this parameter is set to “Yes” which is wrong.
- **解决办法：**将测试系统参数”Dynamic TTime Enable”设置成“No”，然后重新测试，客户手机通过了该项测试。下面截图可以看到客户失败测试报告中，该参数被设置为了”Yes”. 这是错误的，应该设成“No”.
