## Applicability

This document applies to the part numbers of STM32F038x6 devices listed in [Table 1](#) and their variants shown in [Table 2](#).

Reference	Part numbers
STM32F038x6	STM32F038C6, STM32F038F6, STM32F038G6, STM32F038K6, STM32F038E6

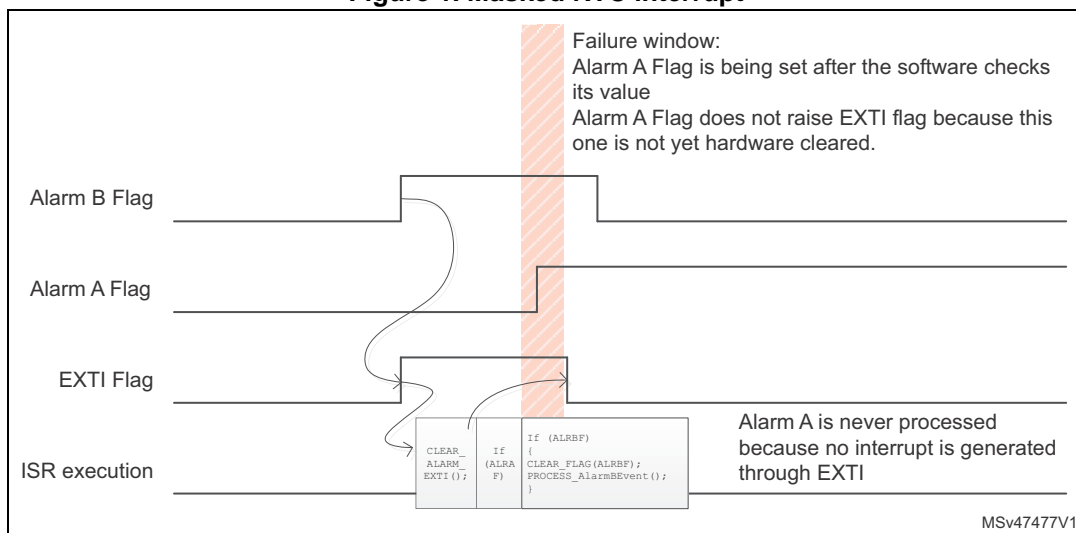
**Figure 1. Masked RTC interrupt**

The following code example and figure illustrate the failure mechanism: The Alarm A event is lost (fails to generate interrupt) as it occurs in the failure window, that is, after checking the Alarm A event flag but before the effective clear of the EXTI interrupt flag by hardware. The effective clear of the EXTI interrupt flag is delayed with respect to the software instruction to clear it.

In the interrupt service routine, apply three consecutive event flag checks - source one, source two, and source one again, as in the following code example:

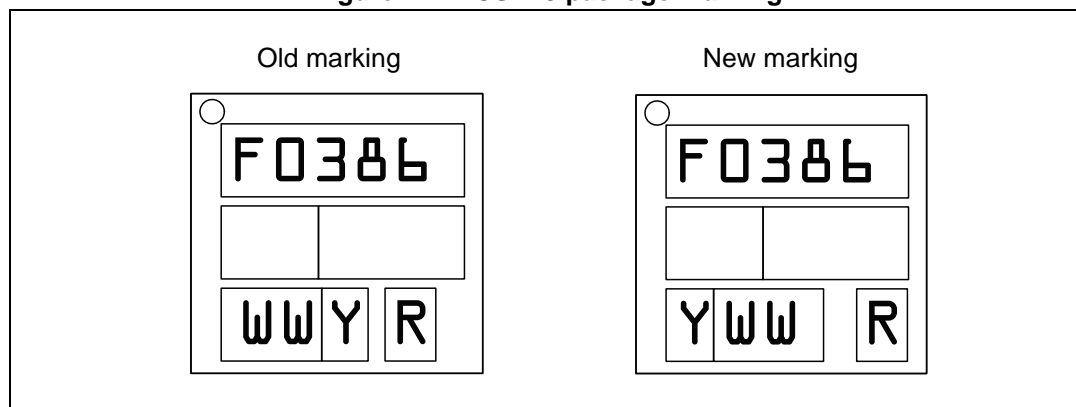
Figure 2. WLCSP25 package marking

From week 9, 2017 on, the marking on the WLCSP25 package is modified to show the date in the format YWW. [Figure 2](#) illustrates the difference between the old and the new product marking. The figure in the product datasheet was also updated to better reflect the dimensions and layout of the marking on the package.
