Qualcomm Charger Detect Issues Debug Guide

80-P8536-1 A

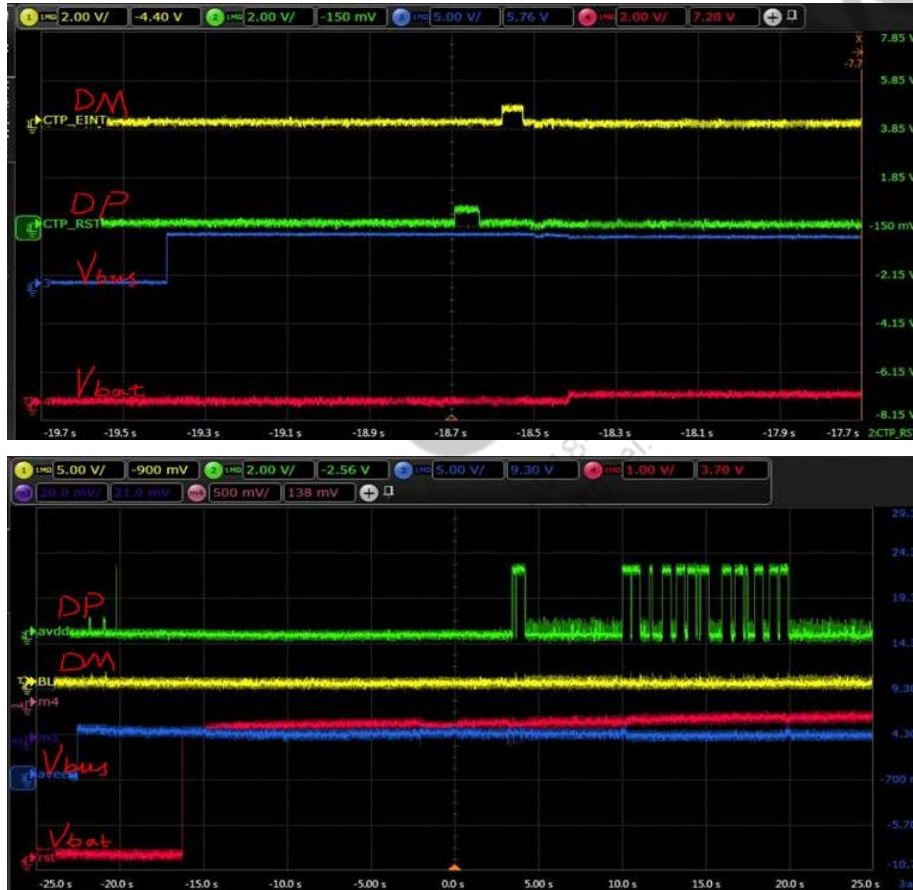
[8952] USBID Connect Issue

- Description
 - Low battery, plug in SDP, detect as CDP sometimes

- Root cause
 - USBID is wrongly connected to both MSM and PMIC side in customers' design.

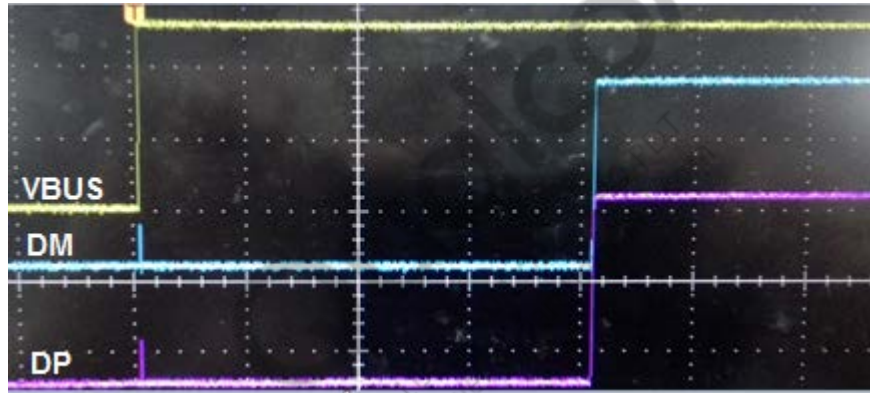
[8953/8996] USB Controller Power Issue

- The device can't detect USB when the system is in suspend mode.
- SDP will be recognized as DCP occasionally. From plot, D+/D- have been pulled up to 3.3V by fault.

- ON 8953, QUSB PHY's DVDD is power supply with LDO3. This LDO3 is not always ON, it can be turned OFF.
- When this LDO3 is turned OFF, QUSB PHY's configuration is not retained (this is happening on USB cable disconnect and putting system into suspend).
- The results into QUSB PHY coming up with unknown state when LDO3 is turned ON which is interfering charger detection (i.e. USB cable connect case)

- Forcing L3 always on could be a WA, but will introduce sleep current.
- CR1046610 (mainlined). Make sure QUSB PHY is into proper state to avoid interfering USB charger detection.
