Multimedia Power Debugging Case Studies Overview

80-NT616-1 C

- Customer is reporting 720p video playback power is high for an APQ8084-based product
- Determine customer use case power consumption
 - Use case mentioned is a QTI standard use case
 - Customer measured power consumption using QTC77
 - Customer device power consumption is high using the QTI standard dashboard use case
 - Root cause of power difference must be determined

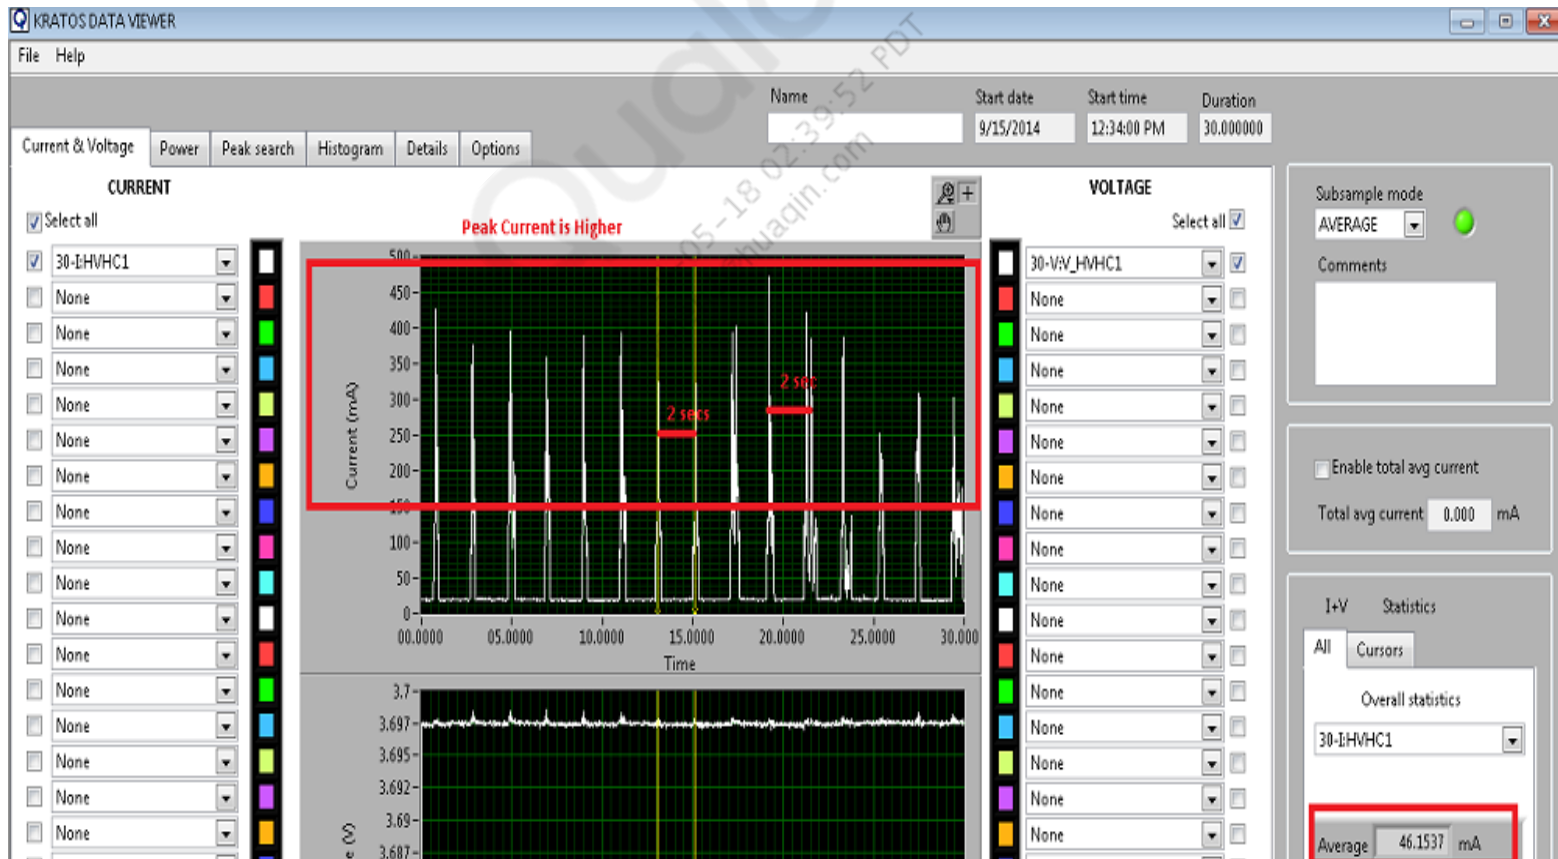
- The current wave form for the use case showed higher peak current with the customer setup (mp3 Offload mode playback using file manager).
- Wake-up is occurring every 2 sec (apps to DSP), confirming the mp3 is being played in Offload mode.

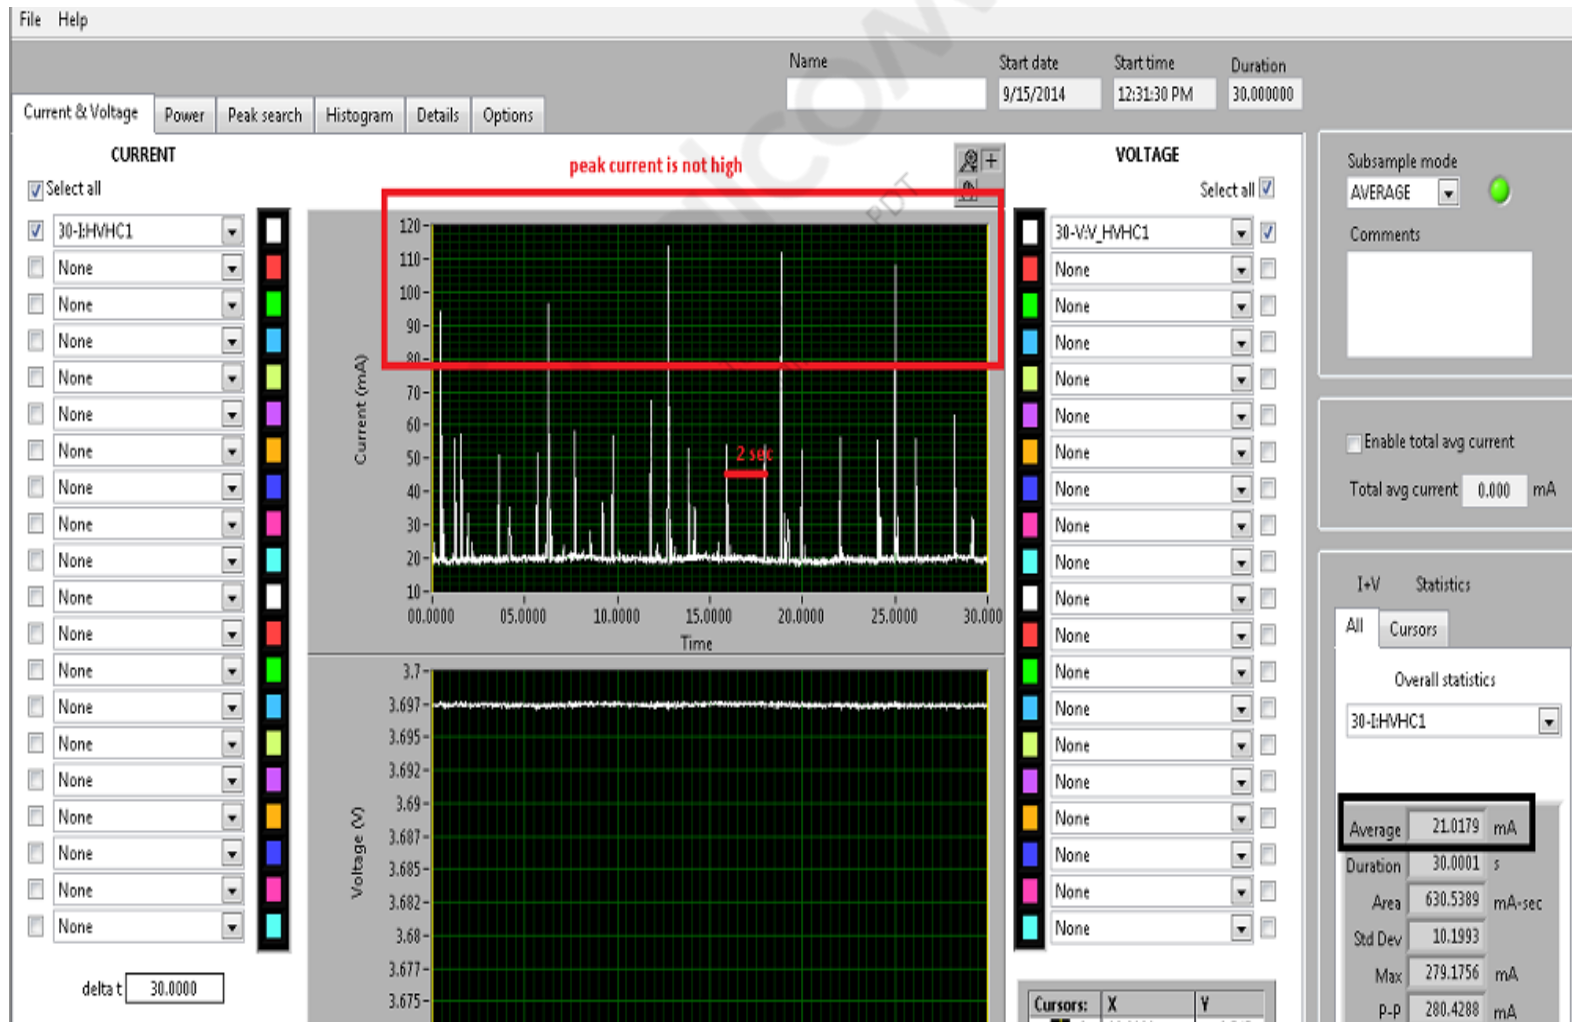
- As shown in the graph below, peak current is not high for mp3 playback in Offload mode using the stock Android music app (Music.apk).

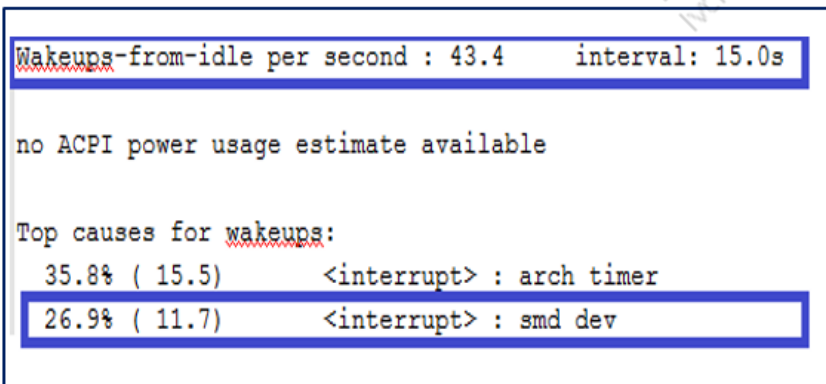
MP3 Offload mode playback using stock android music app

- As shown in the data below, wake-ups from idle and smd_dev interrupts are occurring more frequently in the right side image than the left.
- To find the root cause of why more smd_dev interrupts are occurring, analysis of FTrace logs using a pytime chart is necessary.

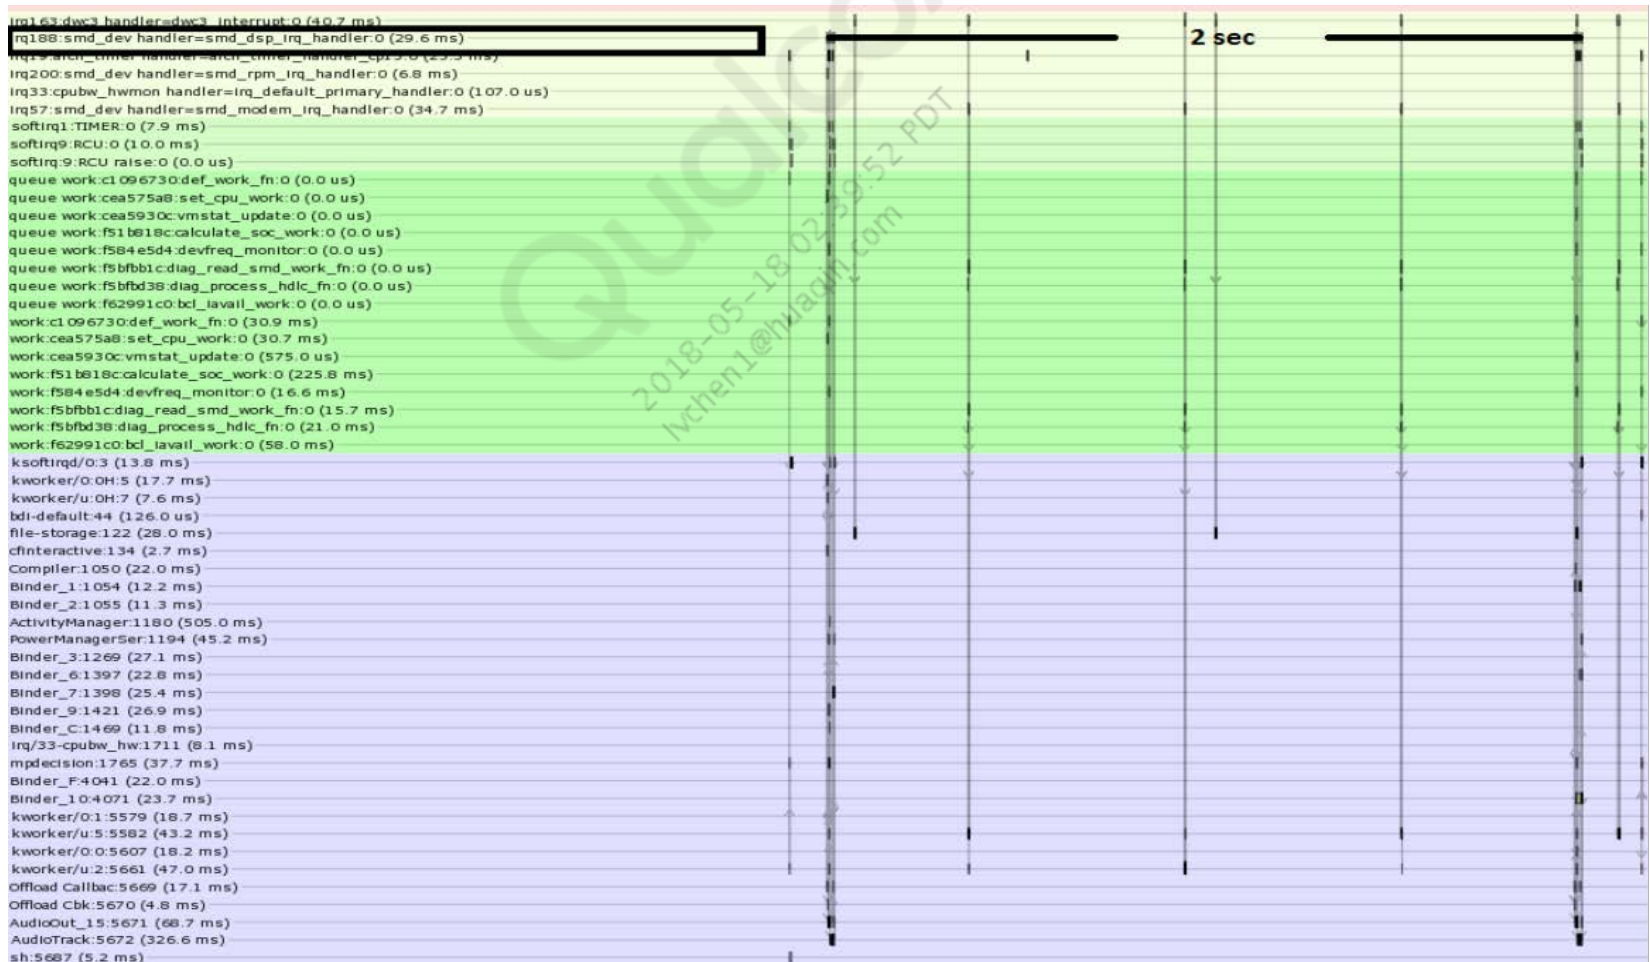
- During Offload mode mp3 playback using the default Android music app, smd_dsp_irq is occurring every 2 sec, which is the expected correct behavior. This occurs when apps is giving data to the DSP.

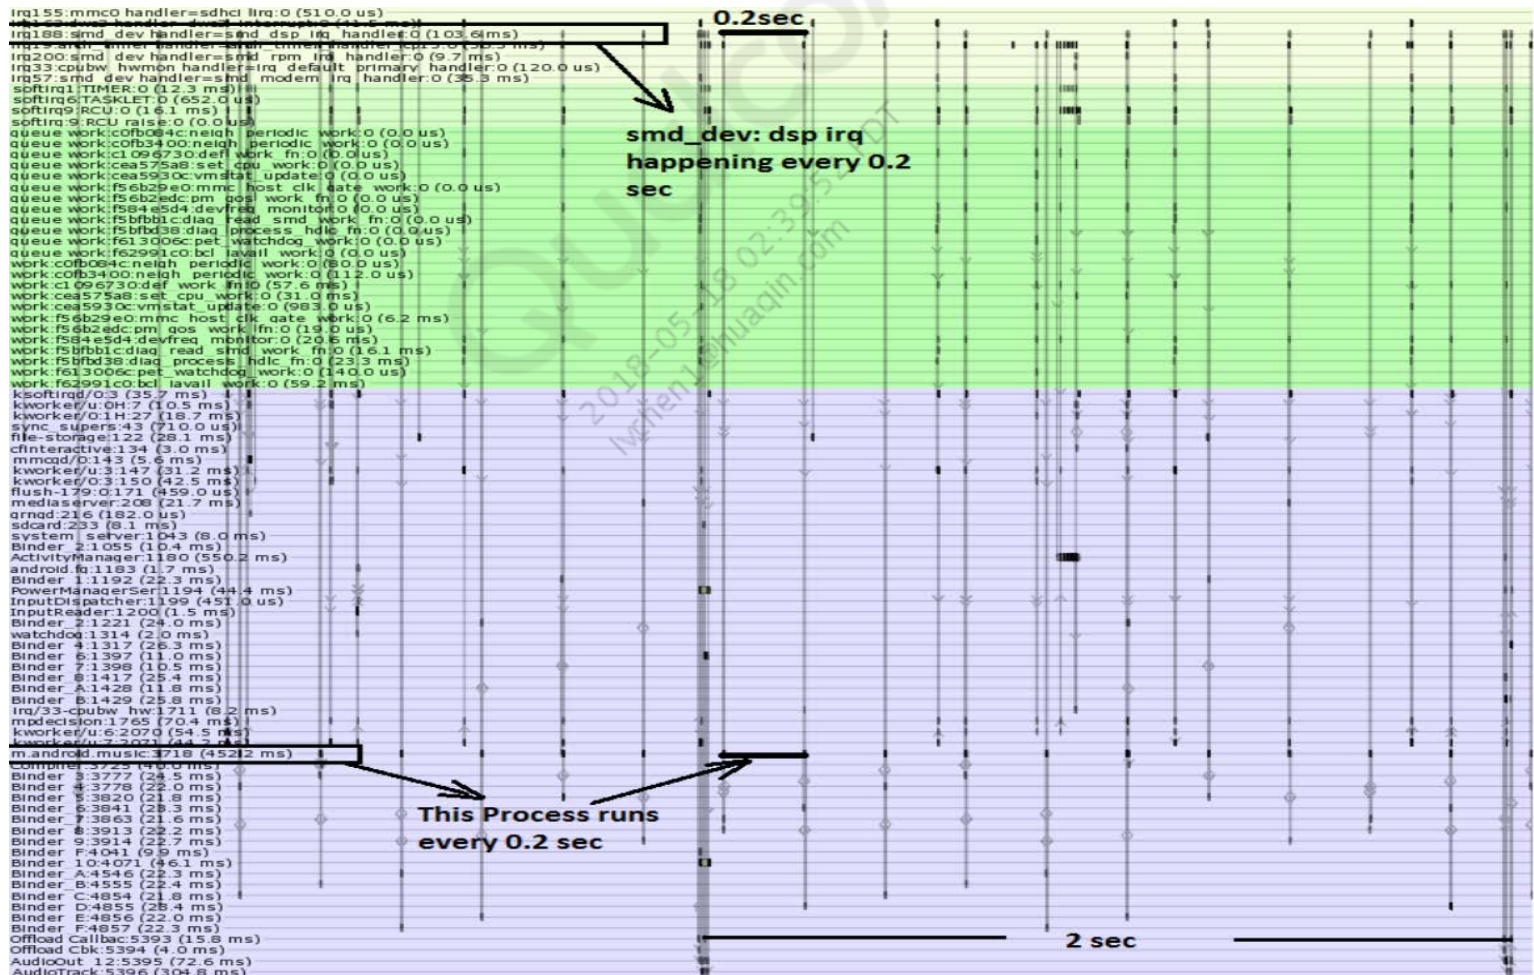
- During Offload mode mp3 playback using File Manager, `smd_dsp_irq` is occurring every 0.2 sec, which is not correct behavior. This IRQ is triggered because of the `m.android.music` process.

- Offload mode mp3 when played using File Manager apk:
 - m.android.music process runs every 0.2 sec
 - This causes 1rq188 smd_dev (dsp irq handler) interrupts to be fired every 0.2 sec.
- The above pattern was not observed while playing an mp3 in Offload mode using the default music player in stock Android.

- Conclusion – The customer must modify their music player app to hold a wakelock when an mp3 is played and the display is off. In this case, the customer app is File Manager.
