Multimedia Power Debugging Case Studies Overview

80-NT616-1 C

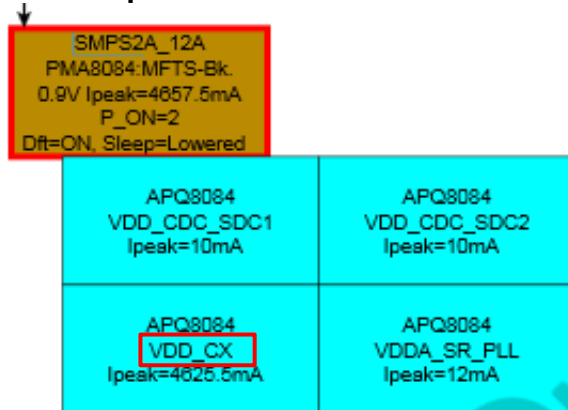
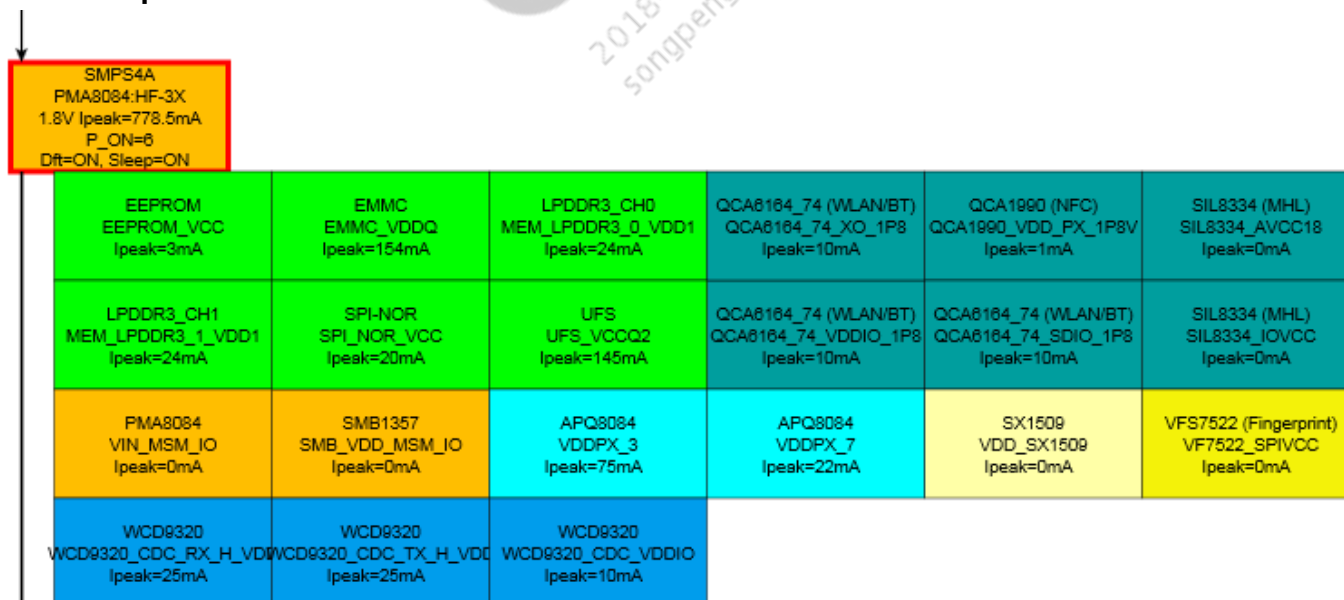
Identifying Power Rails Using a Power Tree

- SMPS2A powers CX rail

- SMPS2 is VDD_CORE (CX) rail source
- SMPS4 powers the LPDDR, EMMC, etc.
 - BIMC manages the clock for DDR, hence look for BIMC power consumption to know DDR consumption

- SMPS4A powers audio codec and DDR

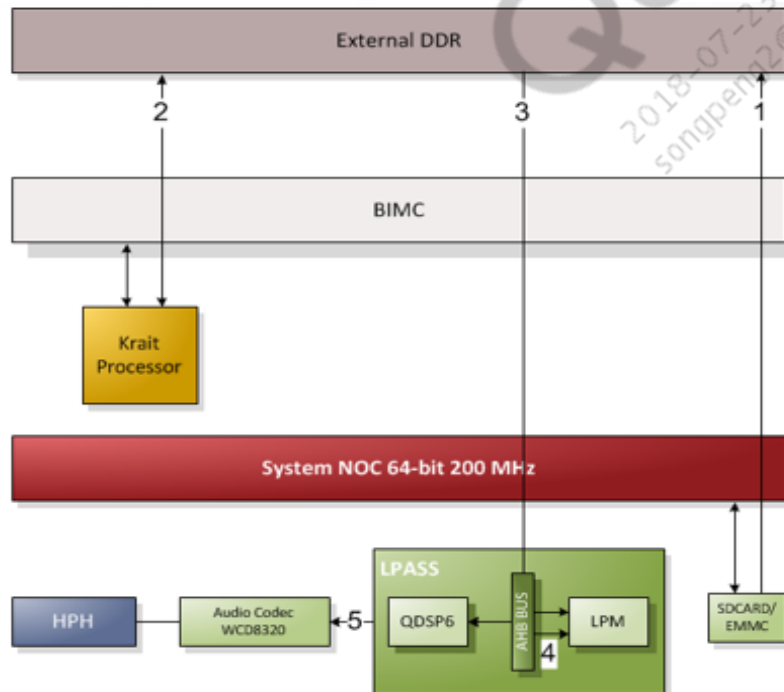
Why LPASS in Video Playback?

- The diagram shows that LPASS is involved in audio processing during video playback.
- LPASS requests DDR bandwidth and can influence BIMC frequency.
- The customer issue was isolated to audio processing and does not exist when video clips without audio are used.
- LPASS/audio bandwidth voting code must be checked to see LPASS bandwidth voting.

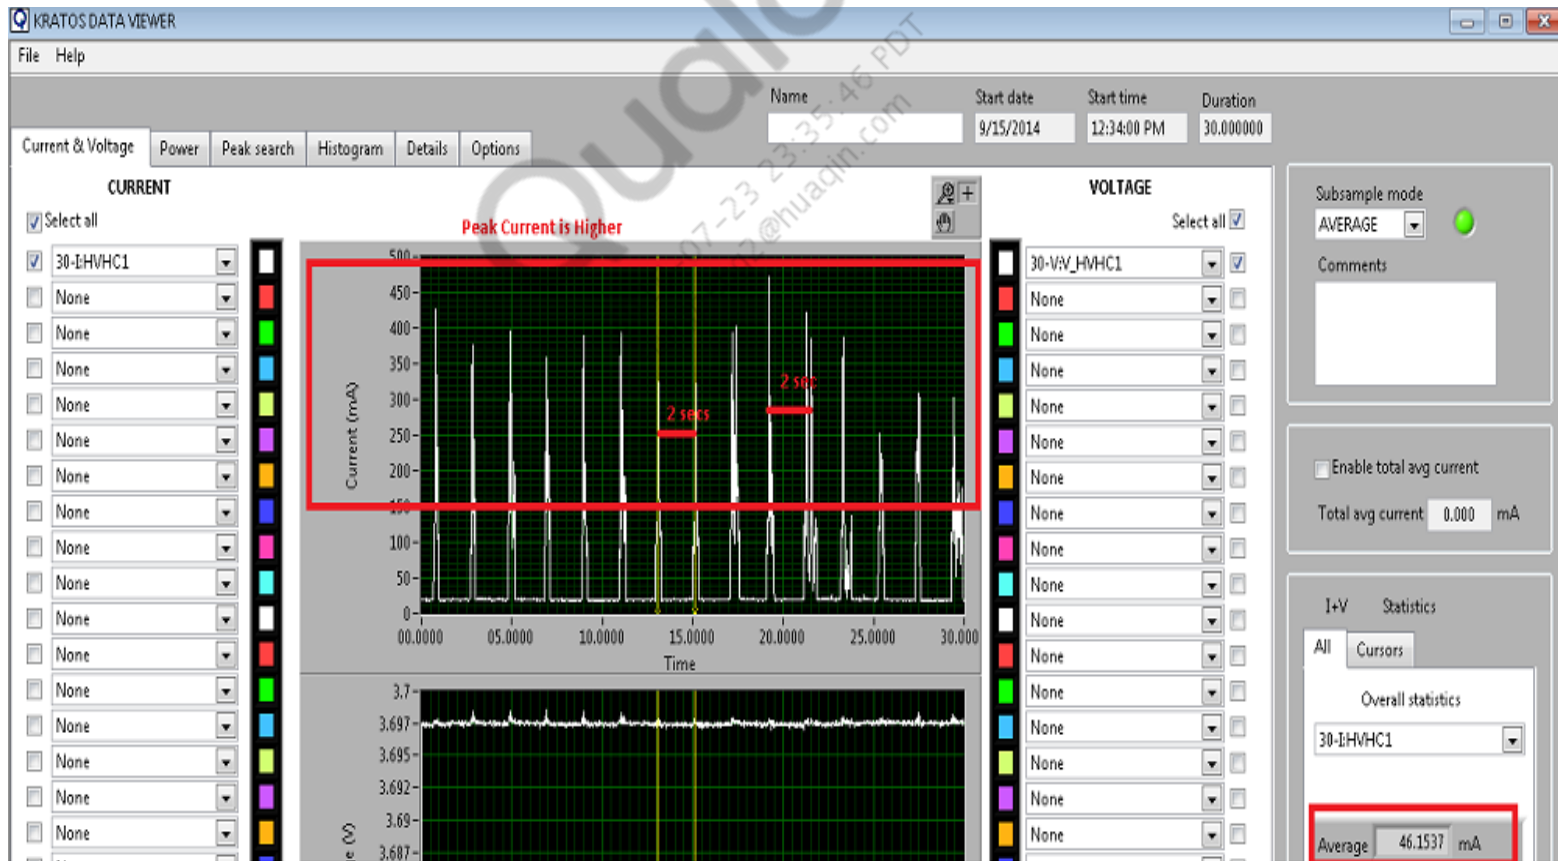
Wave Form Comparison

- The current wave form for the use case showed higher peak current with the customer setup (mp3 Offload mode playback using file manager).
- Wake-up is occurring every 2 sec (apps to DSP), confirming the mp3 is being played in Offload mode.

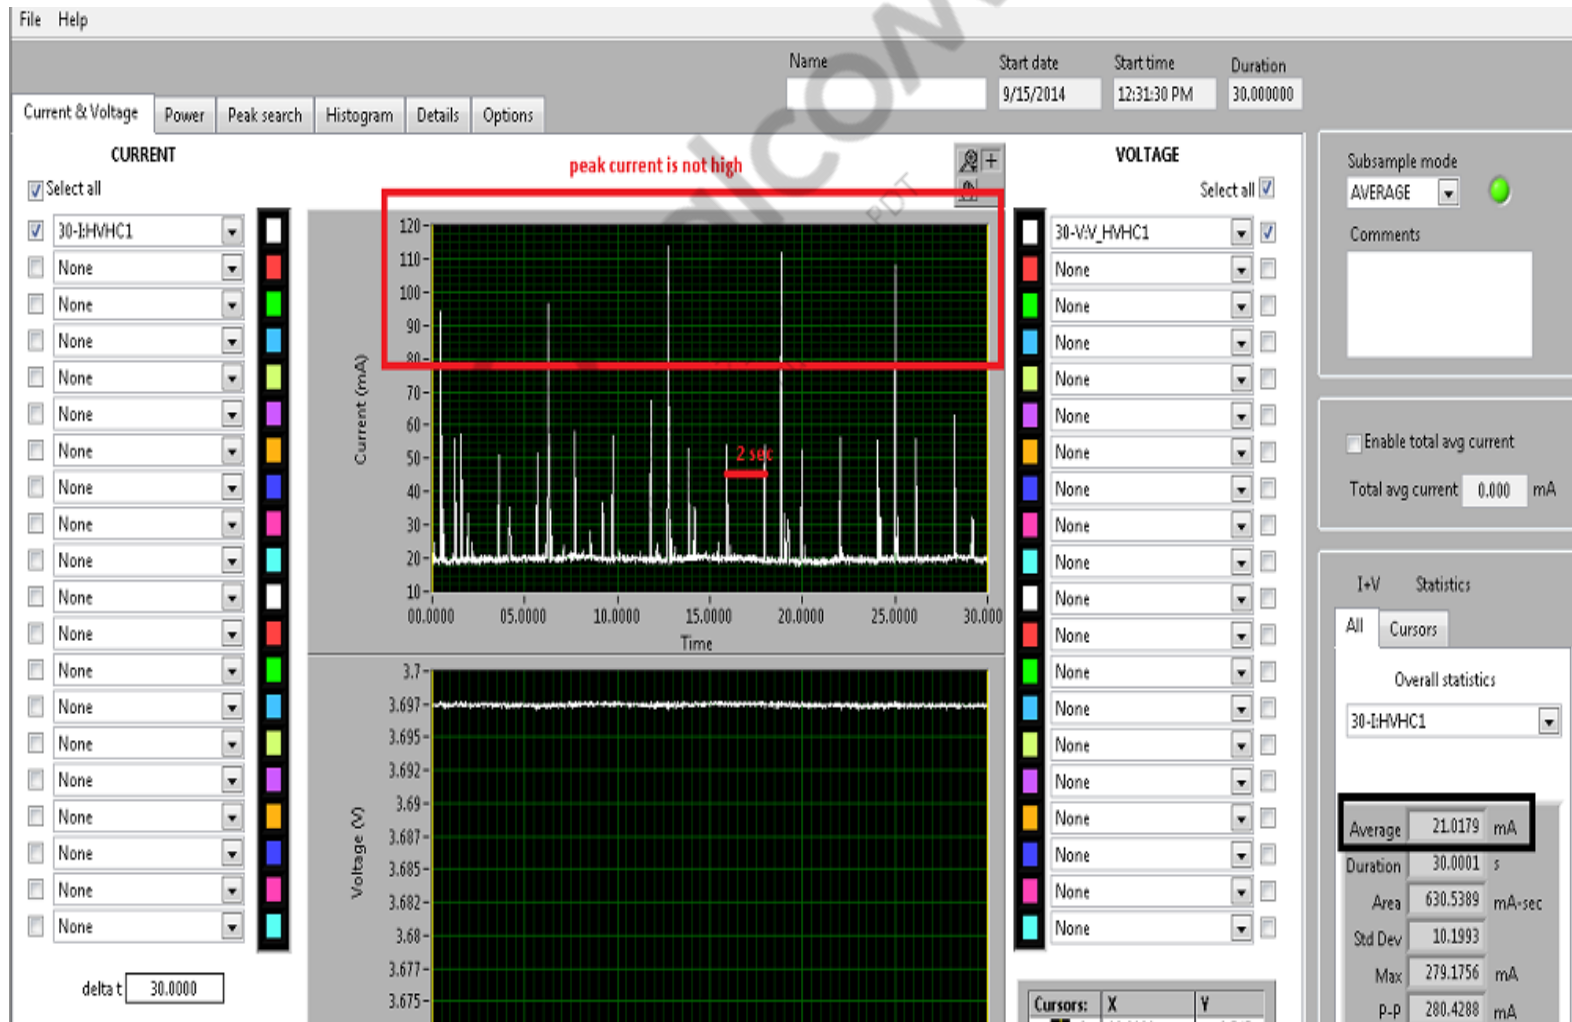
- As shown in the graph below, peak current is not high for mp3 playback in Offload mode using the stock Android music app (Music.apk).

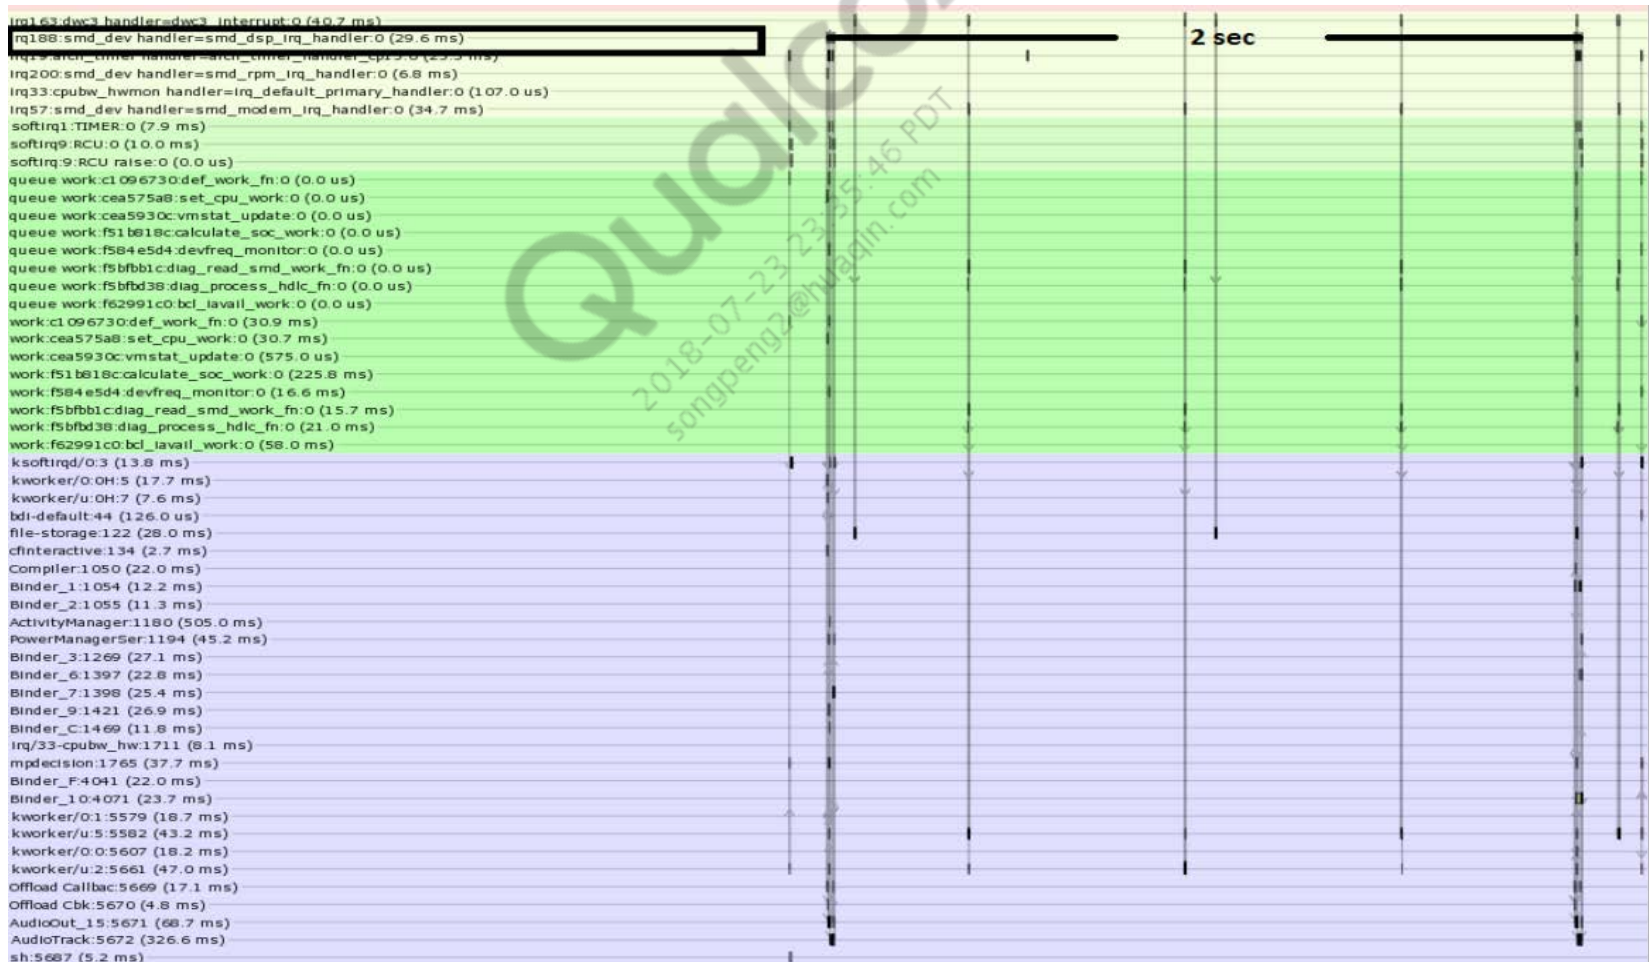
FTrace Analysis

- During Offload mode mp3 playback using the default Android music app, smd_dsp_irq is occurring every 2 sec, which is the expected correct behavior. This occurs when apps is giving data to the DSP.

- During Offload mode mp3 playback using File Manager, `smd_dsp_irq` is occurring every 0.2 sec, which is not correct behavior. This IRQ is triggered because of the `m.android.music` process.

- Conclusion – The customer must modify their music player app to hold a wakelock when an mp3 is played and the display is off. In this case, the customer app is File Manager.
