## How to debug charger detect issue

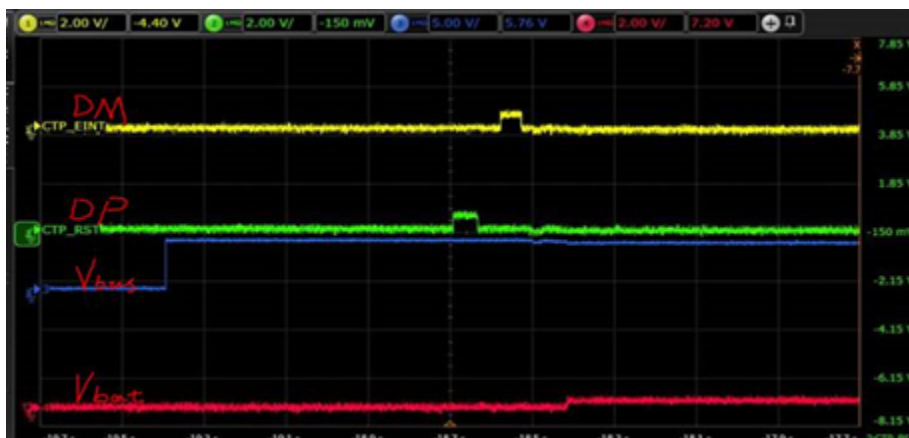
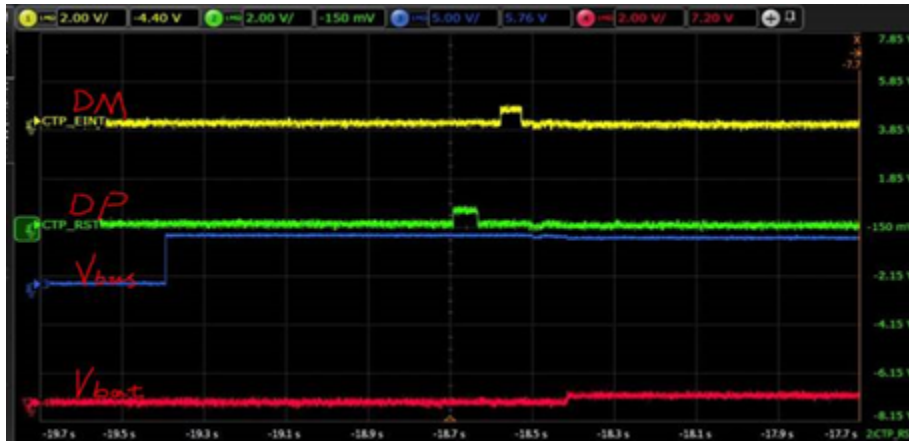
Description:

Low battery, plug in SDP, detect as CDP sometimes.

Root Cause:

USBID is wrongly connected to both MSM and PMIC side in customers' design.

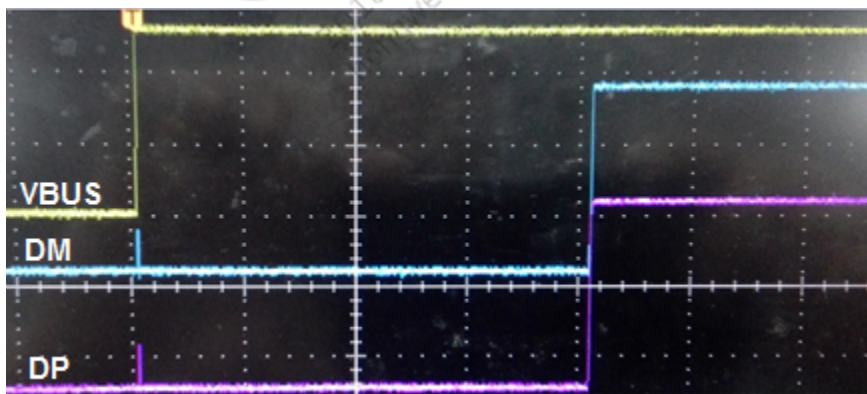
Description:

the device can't detect USB when the system is in suspend mode.

SDP will be recognized as DCP or DCP detect as other type occasionally. From plot, D+/D- have been pulled up to 3.3V by fault.

Analysis:

ON 8953, QUSB PHY's DVDD is power supply with LDO3. This LDO3 is not always ON i.e. it can be turned OFF.

When this LDO3 is turned OFF, QUSB PHY's configuration is not retained (this is happening on USB cable disconnect and putting system into suspend).

This results into QUSB PHY coming up with unknown state when LDO3 is turned ON which is interfering charger detection (i.e. USB cable connect case)

Solution:

Force L3 always on could be a WA, but will introduce sleep current.

CR1046610. Make sure QUSB PHY is into proper state to avoid interfering USB charger detection
