Plane forced to divert after mechanical failure

May 15, 2018

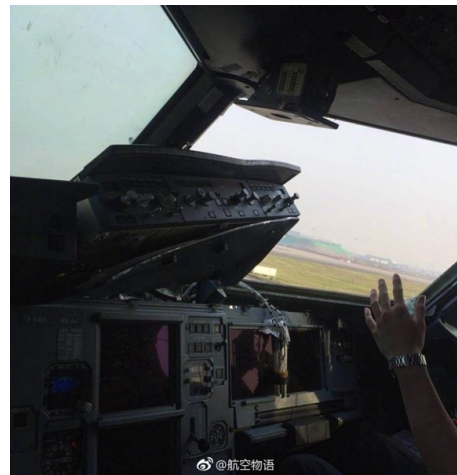
According to the Civil Aviation Administration of China (CAAC), part of the cockpit window broke (Fig. 2) as the Airbus A319 flew over Chengdu. The aircrew enacted emergency code 7700¹ and landed in Chengdu.

Figure 2: The broken window of flight 3U8633

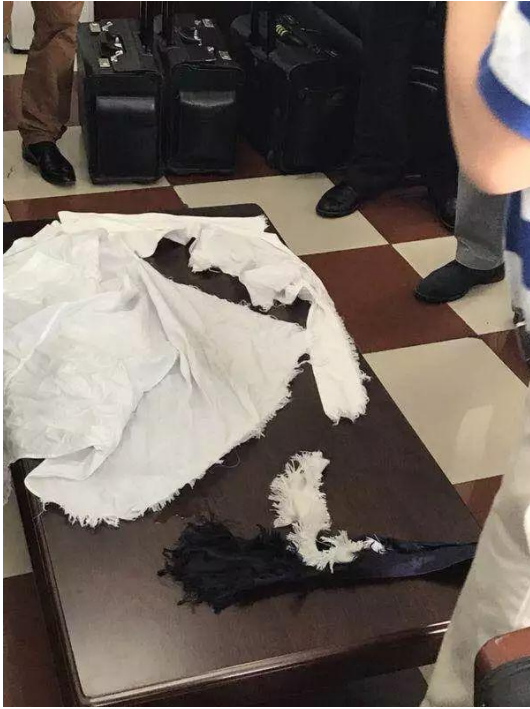
It was their faith of protecting the safety of passengers that made pilots bearing the wild wind and extremely cold. Imagine that the speed of several hundred kilometers per hour and lack of oxygen. We average persons can't sustain any of these. And when the airplane diverting, the hands and arms of co-pilot was frostbite. What's more his clothes was blown to be worn out (as shown in Fig. 3). That's entirely a copy of the film *Sully*.

Figure 3: Co-pilot's worn-out clothes
