TRANSCANADA KEYSTONE PIPELINE GP LTD
HABITAT MAP

Site 56 - Skull Creek

APPROVED BY:
DRAWING NO. **010**

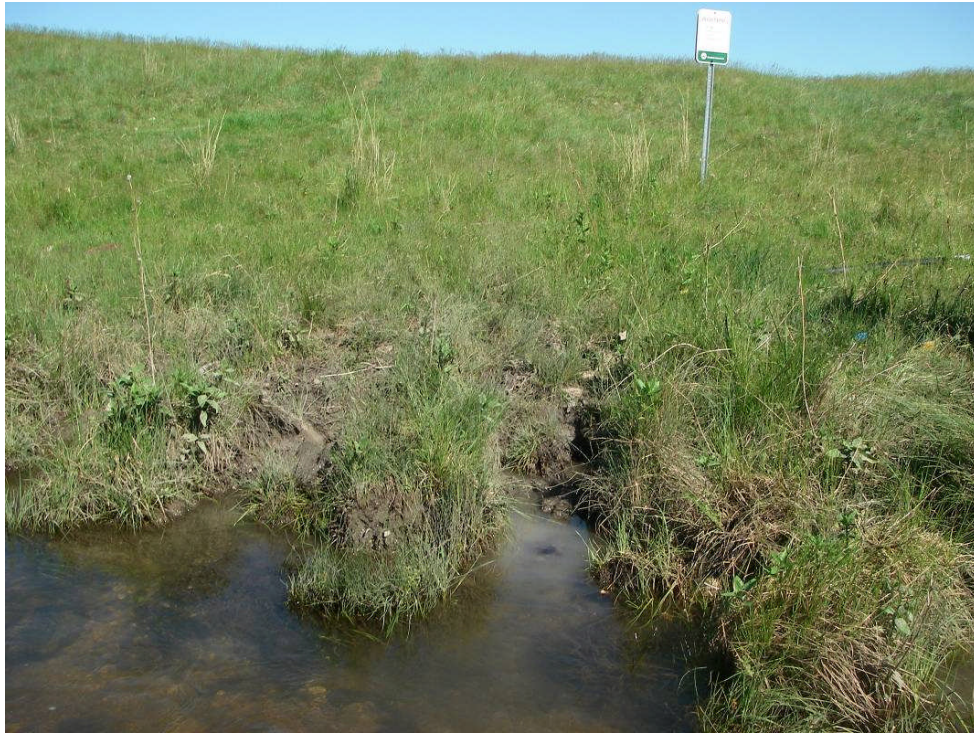
Photo 3

Site 56 Skull Creek: View of Left Downstream Bank at Proposed Crossing Location. June 18, 2008.

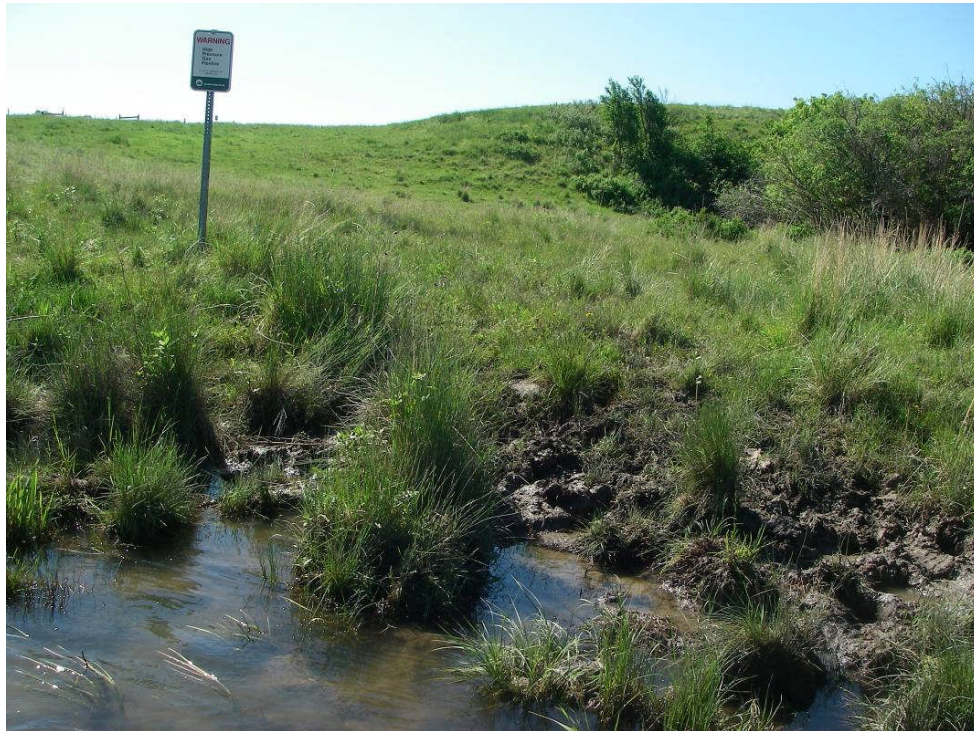
Photo 4

Site 56 Skull Creek: View of Right Downstream Bank at Proposed Crossing Location. June 18, 2008.
