# Drag and drop troubleshooting for MPLAB MPLABx IDE V5.40 and SAM-IOT

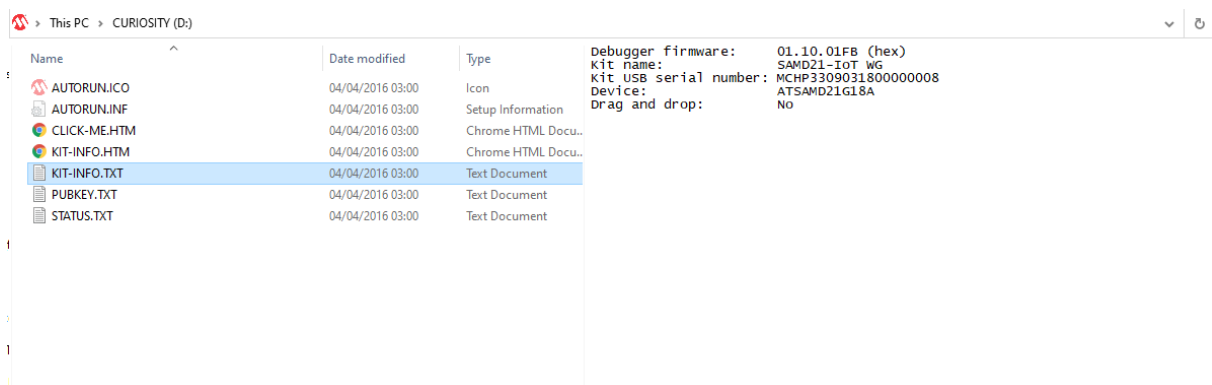
MPLABX silently upgrade “Downgrade in reality” nEDBG debugger to default embedded firmware version 1.1.0.

This version does not support the drag and drop feature.

nEDBG firmware Version can be checked using either KIT-INFO.TXT file or atfw.exe tool (Studio package):

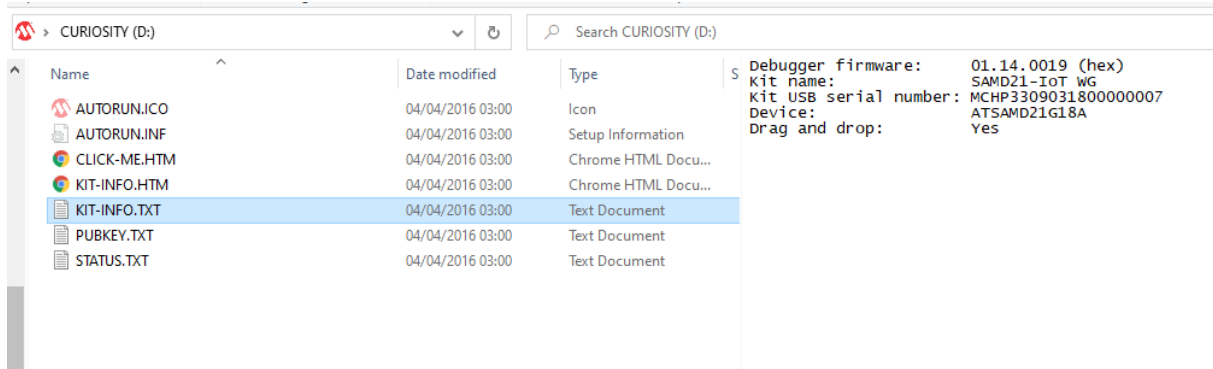
The drag and drop feature will be available again. The new version can be checked using KIT-INFO.TXT file or afw.exe tool
