Fault Code F133: Loss of Communication from System Control Unit (SCU) to Energy Storage System (ESS).

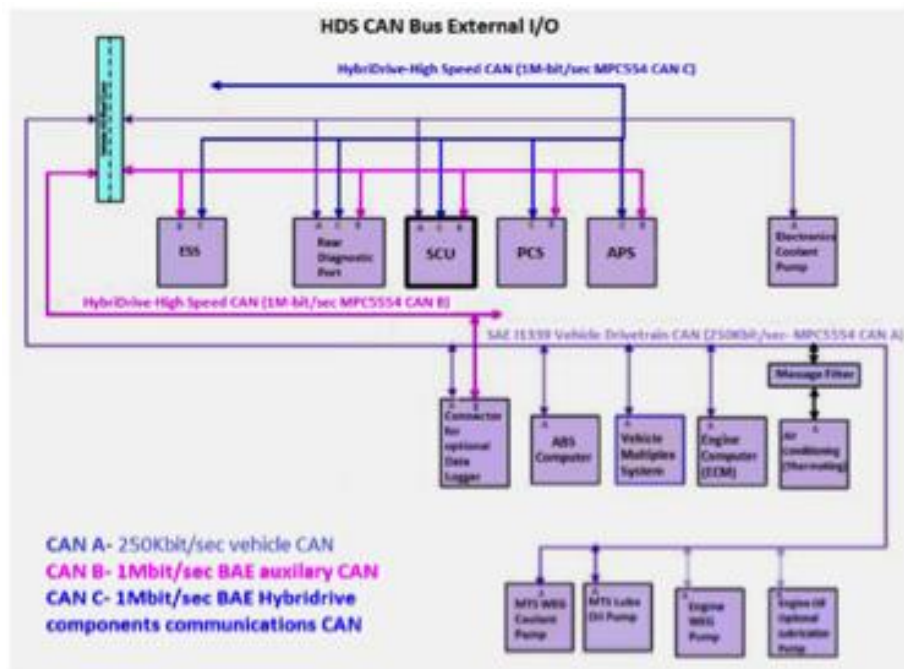
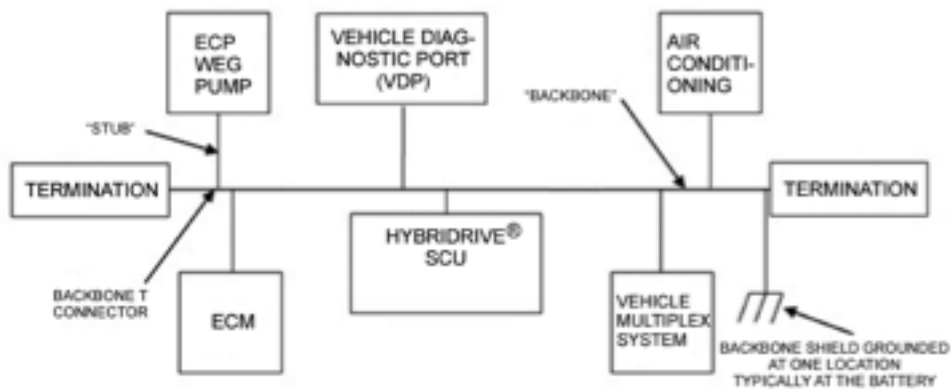
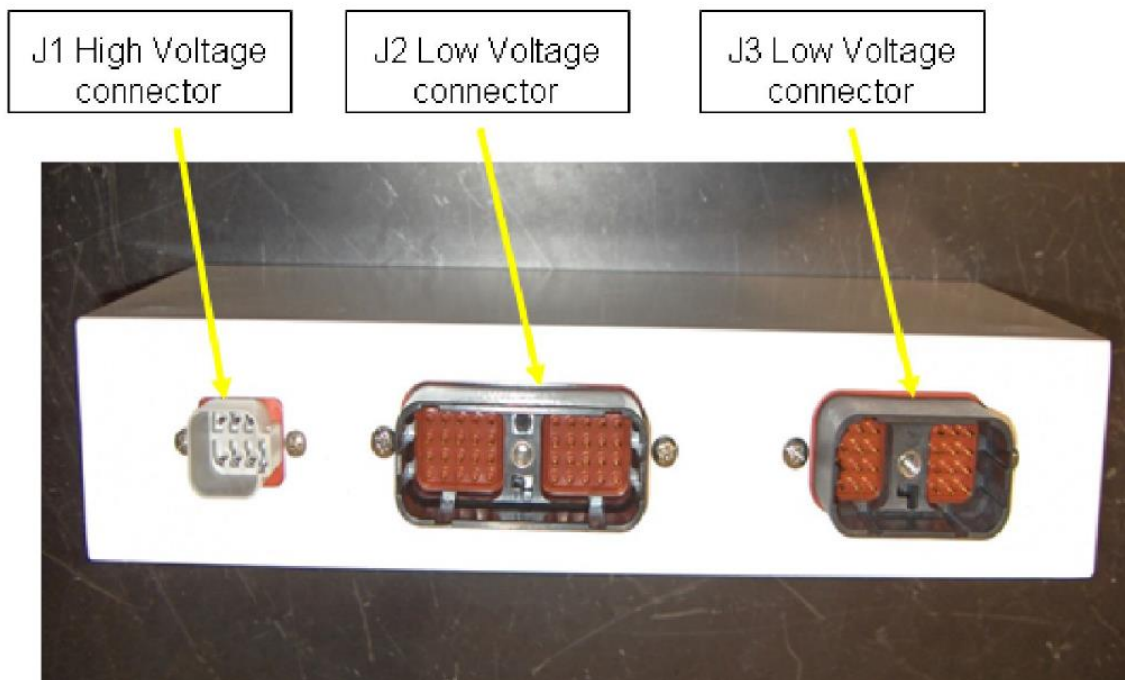
ESS J80-U to ESS J80-c should not be less than 20V..

and SCN P50-30 to ESS J80-V should be < 5 Ohm

J80-V: signal CAN Hi

J80-W: signal CAN Lo

J80-f: shield, should be connected to chassis.

SCU P50-29 is shield and is connected to chassis

1. Verify Energy Storage System (ESS) has power. Refer to SCU to ESS CAN Wiring verification procedure, steps 1 and 2.
2. Refer to CAN wiring verification procedure substituting ESS J80 pins V and W for steps 1 through 3 respectively and J80 pin f for step 4.
3. Refer to SCU to ESS CAN wiring verification procedure, steps 2 through 5.
4. Replace Battery Management System (BMS).
