GD32 and STM32 Compatibility

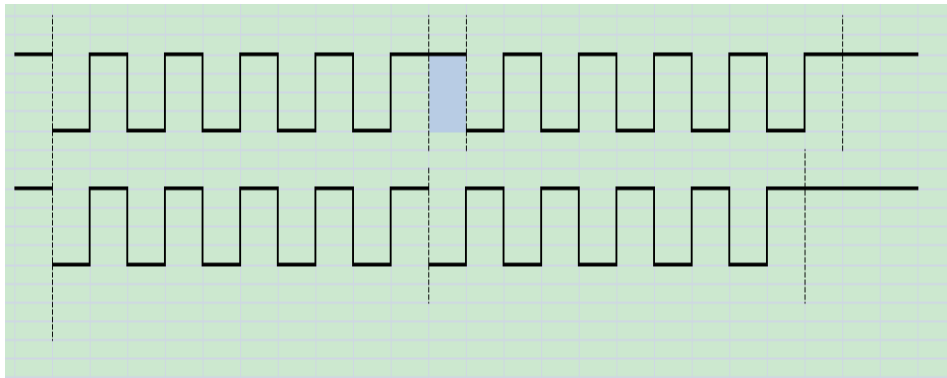
Fig. 1.2

reason	There is idle bit between byte and byte. (Fig 1.2)
solution	There is no effect on common communication. If communication need special demand, please simulate USART in software.
type	GD32F10x series
tips	Other series without this question

There is a bit of idle between byte and byte, when USART send data continuously. As is shown below.
