QUICKBASE CHANGE PROPOSAL: *X296 RR FLOOR*

Revision 1.1

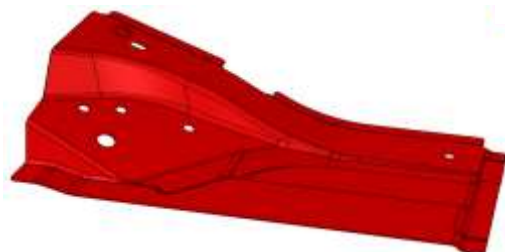
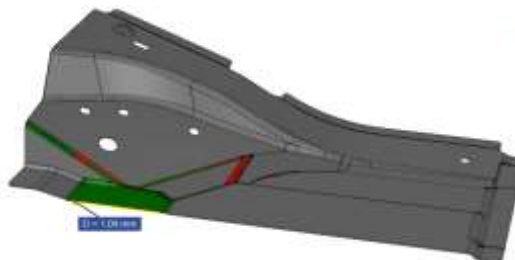
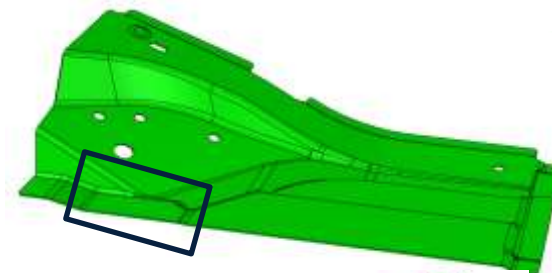
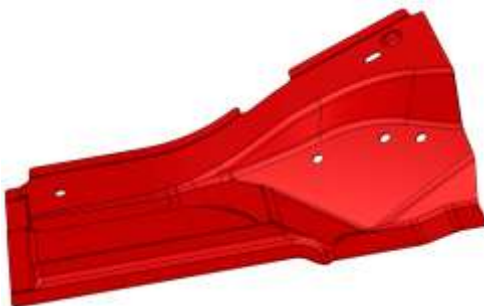
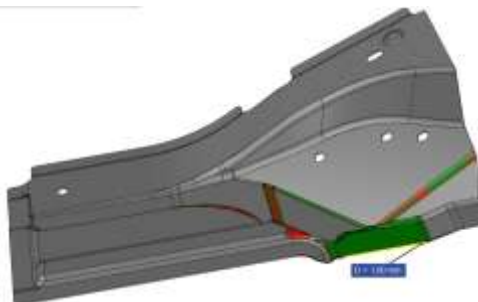
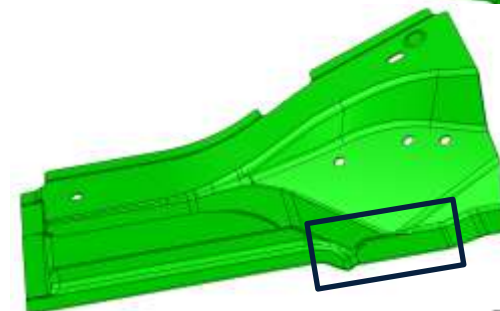
Current Status, Problem Description	A2966115500 0012.03 ZGS: 0004 A2966115600 0012.03 ZGS: 0004 Correction in CAD to improve reducing the gaps in seat attachment area	New Status, Solution Description	STUDY FILES A2966115500 0013.04 A2966115600 0013.04 Collision with SPR, surface of press parts moved by 1mm in +Z direction
---	---	--	---

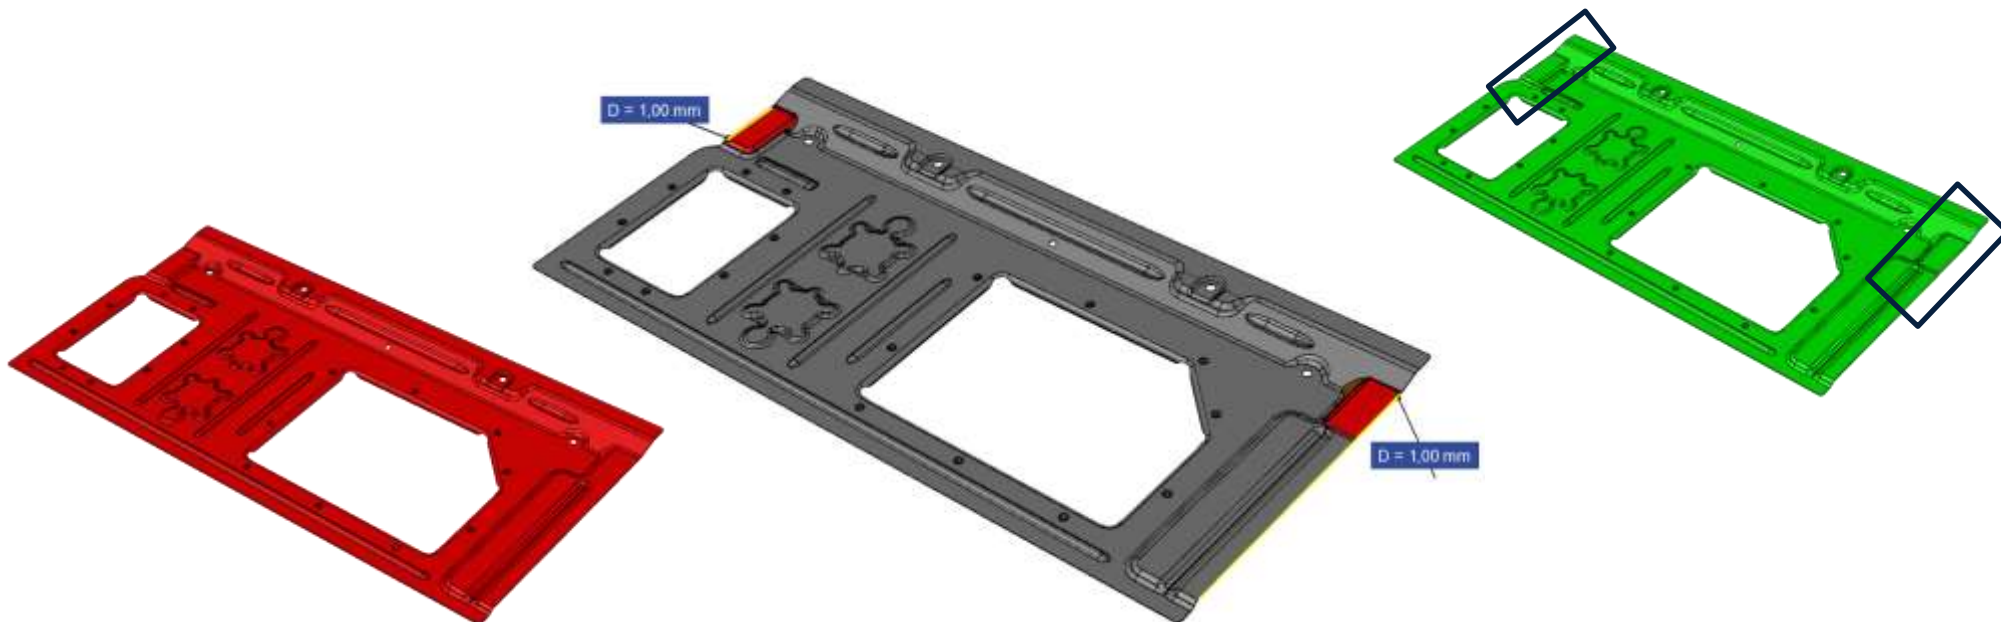
A2966182300 0012.03 ZGS: 0005
Correction in CAD to improve reducing the
gaps in seat attachment area

STUDY FILES
A2966182300 0013.03
Collision with SPR, surface of press parts
moved by 1mm in +Z direction
