## TT190506 – Troubleshoot - SRU Communication Problems

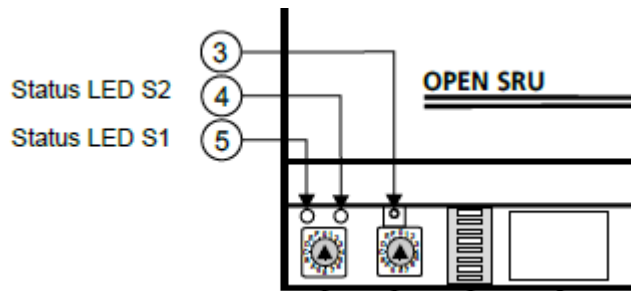
1. You can check the communication of the SRU with the S1 and S2 LEDs
