# ME220

## ASSIGNMENT 3: FAILURE ANALYSIS

### GORILLA TRIPOD

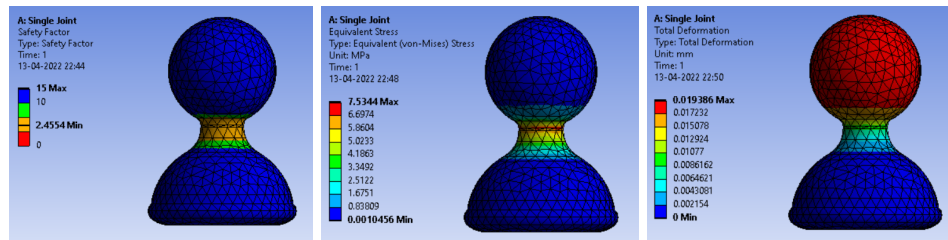
#### a) Purely tensile load

With the concave surface fixed and a downward force of 150N on upper surface, a minimum factor of safety of 2.46 is obtained.

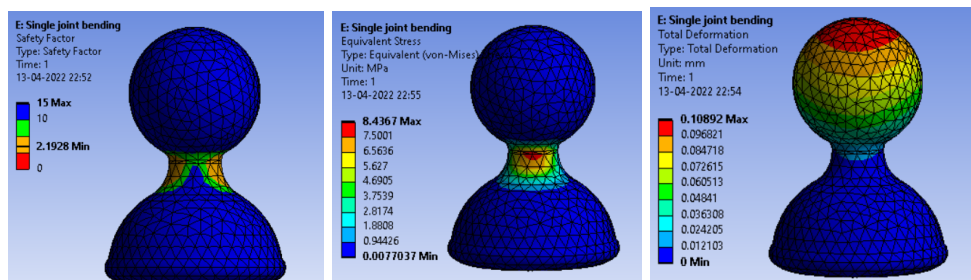
#### b) Purely bending load

With the concave surface fixed and a sideways force of 20N on the upper surface, a minimum factor of safety of 2.19 is obtained.

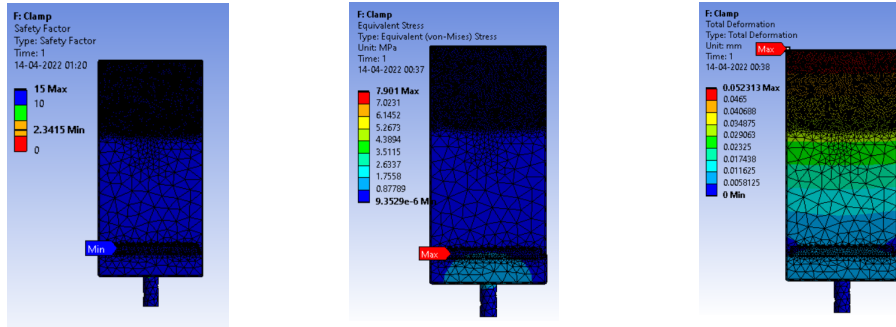
## 2) Clamp Base

For a force of 900N on the lower phone clamp and fixed support on the underside, a minimum factor of safety of 2.34 is obtained.

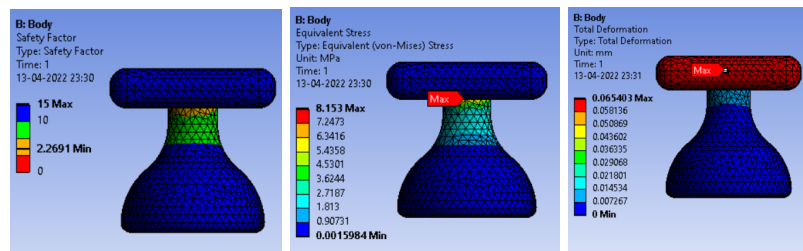
## 3) Body

For a downward force of 150N on the upper surface and fixed support concave one, a factor of safety 2.27 is obtained
