Report ID:71

Name Of Building: Amalienborg

Report Overview

Date: 2016-04-15

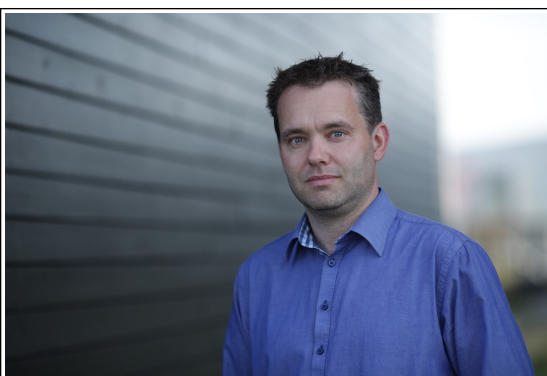
Picture:

Wall	Go away
Roof	Not looking good at all

A photograph of a man with short dark hair, wearing a blue button-down shirt, standing in front of a building with horizontal siding. He is looking directly at the camera with a neutral expression.
Decription:	Ugly Pic
