Name Of Building: Amalienborg

## Report Overview

Date: 2016-04-15

Address: Amalienborgs Slotsplads 1

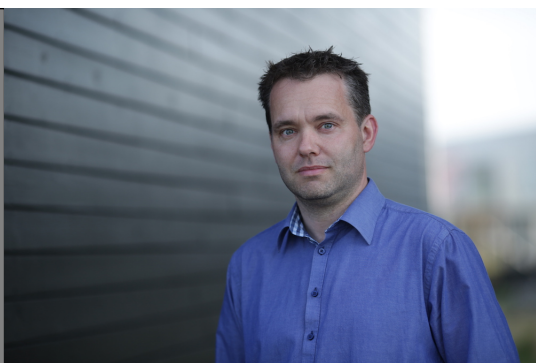
Wall	Go away
Roof	Not looking good at all

Decription:	Ugly Pic
