# Authorized Field Change

AFC G-06912

**Subject:** Inspect For Possible Missing Bolt at Rear Mount Pad

Model: 9200i, 9400i, 9900i

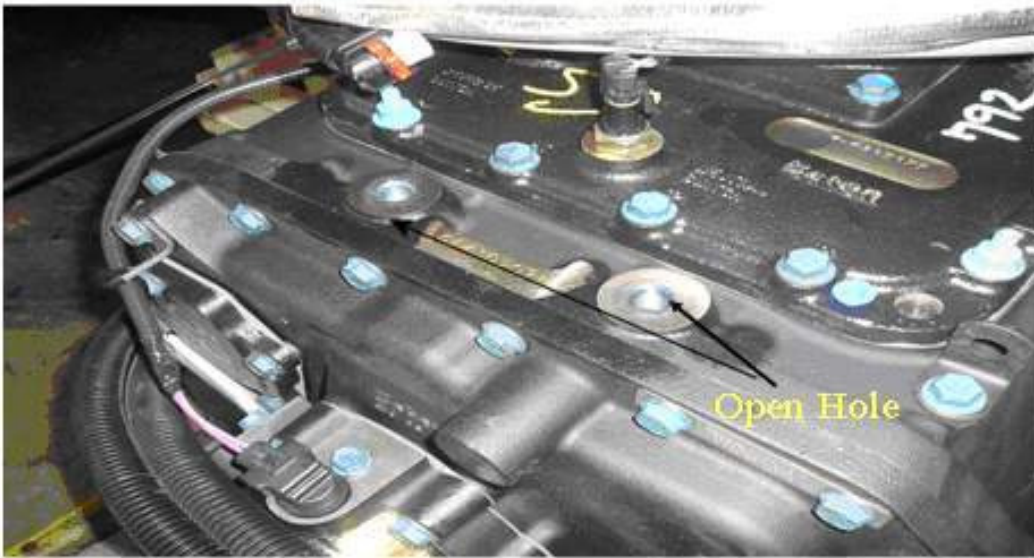
**Figure 1**

Possible oil leakage from the top right rear of the transmission due to missing rear mounting pad bolts.

1. Visually check transmission mounting pad for bolts.
2. If bolts are present and no signs of leak, release unit.
3. If bolts are missing, check transmission fluid level. If fluid is within 1 inch of fill plug, top off with correct fluid. Install M16x1.5 25.4 mm or shorter bolt in each hole. (Make sure to use sealant on bolt threads.) Torque bolt to 50 lbf-ft and release unit.
4. If bolts are missing and fluid level is lower than 1 inch below the fill plug or the fluid is contaminated with water, drain the fluid. Pull PTO cover and inspect gears for wear. If gears are not damaged, install PTO cover and fill with new fluid. Install M16x1.5 25.4 mm or shorter bolts in each hole. (Make sure to use sealant on bolt threads.) Torque to 50 lbf-ft and release unit.
5. If gear damage is found, repair as needed.
