"2007" SEMINAR INFORMATION

AUTOMATIC TRANSMISSION SERVICE GROUP

Seminar Information

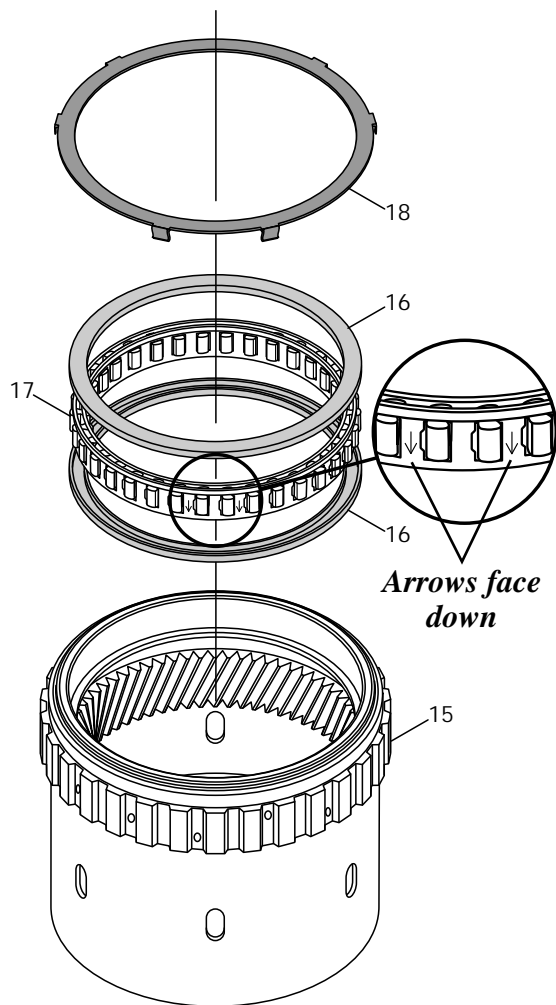
LOW SPRAG LOCATION AND INSTALLATION

CAUSE: The cause may be a bad Low Sprag. Figure 1 shows the computer strategy of the Low Reverse Clutch application thru the Low Reverse Solenoid. The chart shows the Low Reverse Clutch is turned OFF at 6 mph. It is the responsibility of the Low Sprag to hold from 6 mph up until the 1-2 upshift occurs. The Low Sprag also has to come back on during the 2-1 downshift. If the sprag does not hold it will cause the neutralizing effect. Notice that when the selector is in Manual Low, the Low Reverse Clutch stays ON while in 1st gear.

CORRECTION: Replace the Low Sprag as shown in Figure 2 and ensure the inner and outer races are good. Refer to Figure 2 to ensure the sprag is assembled correctly in the Output Internal Ring Gear, and verify that the carrier freewheels in the correct direction as shown in Figure 3.

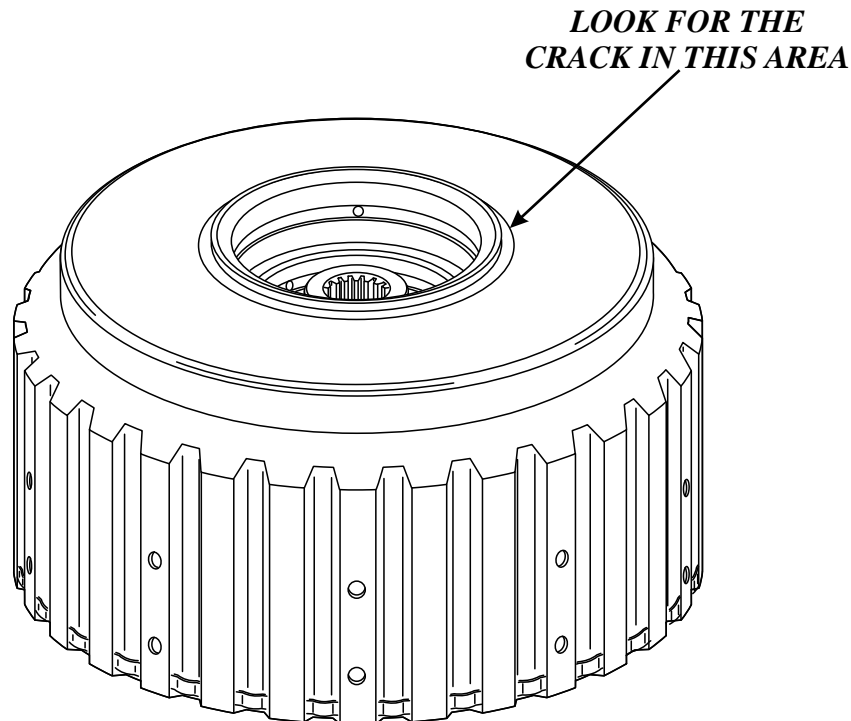
Figure 1

CAUSE: The cause may be, that the Overdrive / Reverse Clutch Drum is cracked around the weld on the back of the drum as shown in Figure 1. **CAUTION:** This crack is easy to miss!

CORRECTION: Replace the Overdrive / Reverse Clutch Drum and renew the piston seals as shown in Figure 2.

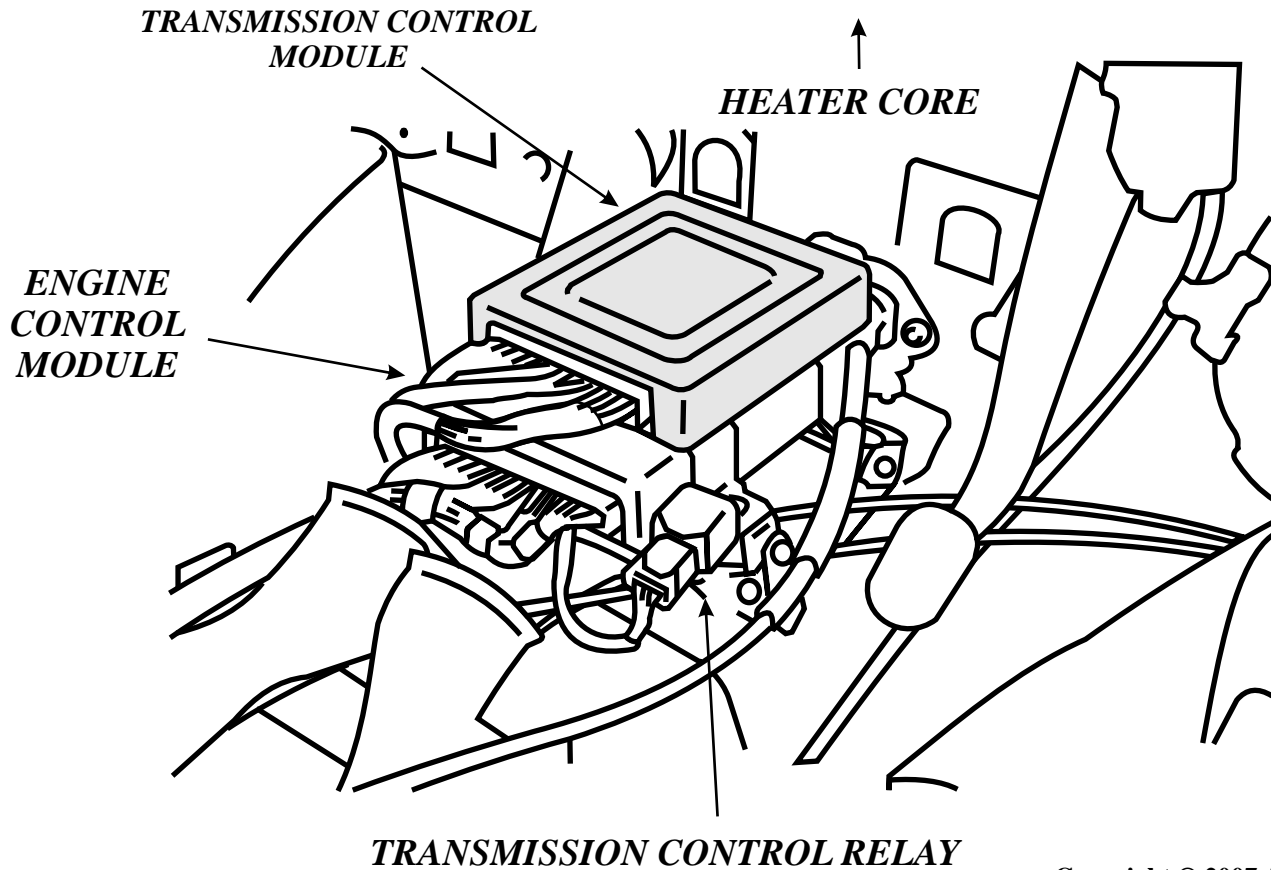
Figure 1

CAUSE: The cause may be that the Trans Control Relay *may* be damaged from water dripping down onto it from a leaking heater core located just above the relay on the center fire wall. See Figure 1. The Trans Control Module, Engine Control Module and Trans Control Relay are located on the floor behind the center console. When the relay develops condensation inside of it, it can not close and connect the 12 volts needed to power up the solenoids in the transmission .

CORRECTION: Replace the heater core and replace the Trans Control Relay.

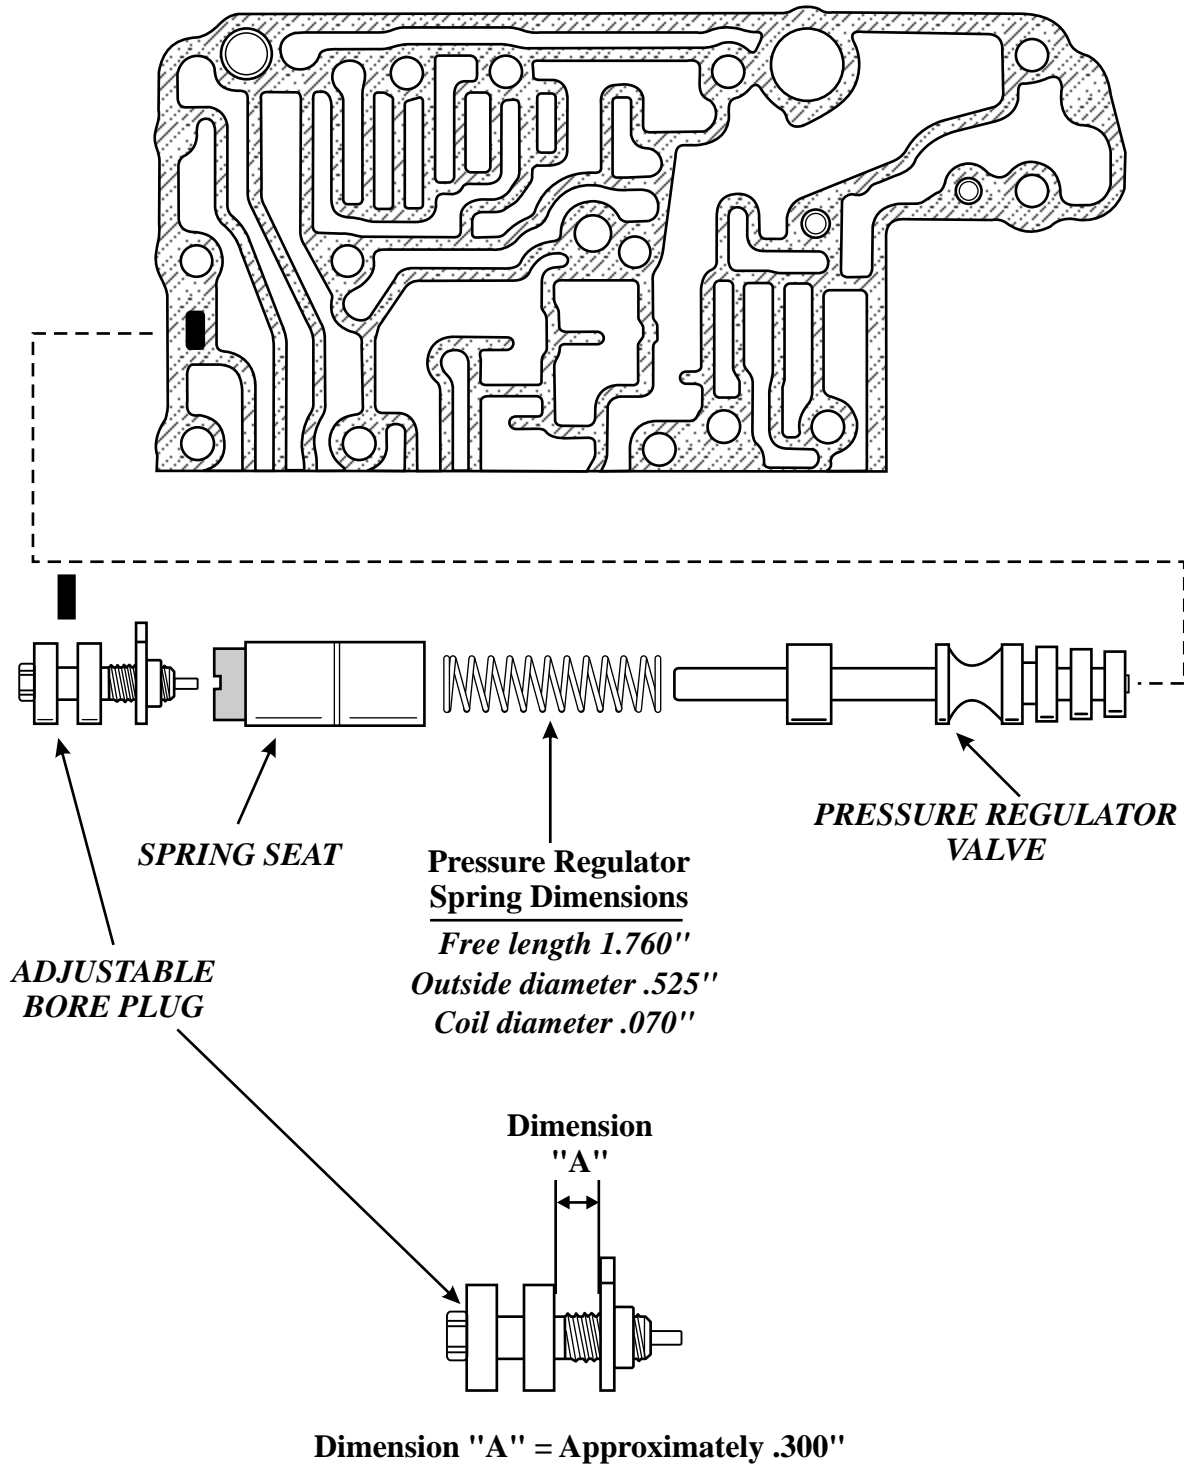
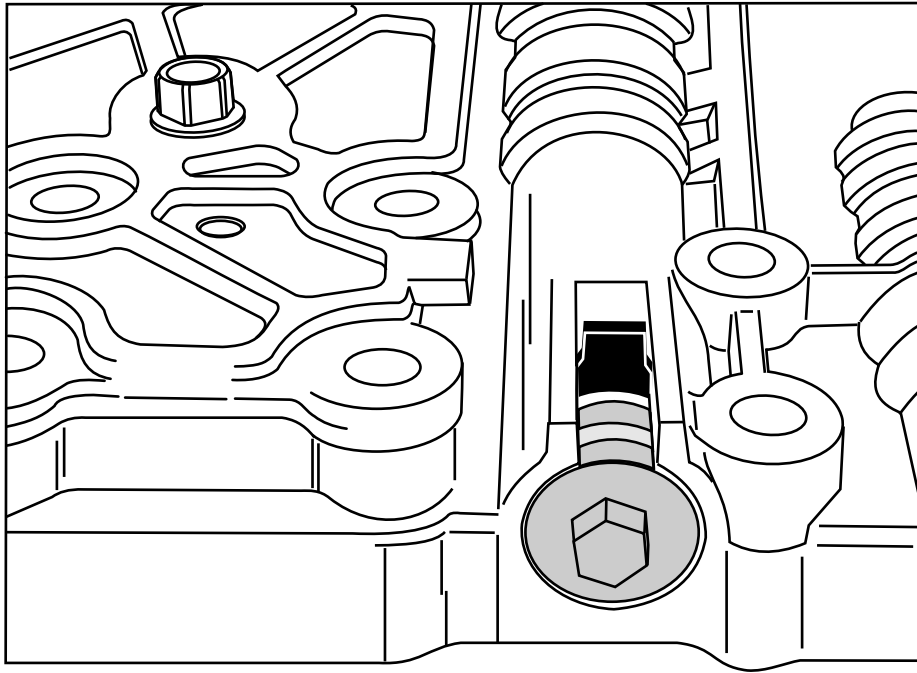
PRESSURE REGULATOR VALVE COMPONENTS

CAUSE: The cause may be that the Pressure Regulator Spring may be losing it's tension or is shrinking from the extreme heat of the planetary failure. *Note: The planetary failure is usually due to Torque Converter Clutch failure clogging the cooler causing a loss of lubrication.*

CORRECTION: To correct this condition, first verify what the base pressures are on the Underdrive clutch and the Low Reverse Brake in the Drive Position, as shown in Figure 1. If the Pressure is below 147-152 in both ports, remove the valve body and inspect the pressure regulator valve for sticking in it's bore. If it is free, refer to the specs in Figure 2 to verify the specs of the spring. If the spring is below 1.760, " the adjustment, as shown in Figure 3 will have to be turned counterclockwise to increase the Base Line Pressure and replace the pressure regulator valve spring if necessary.

TURNING THIS PLUG COUNTER CLOCKWISE WILL INCREASE PRESSURE

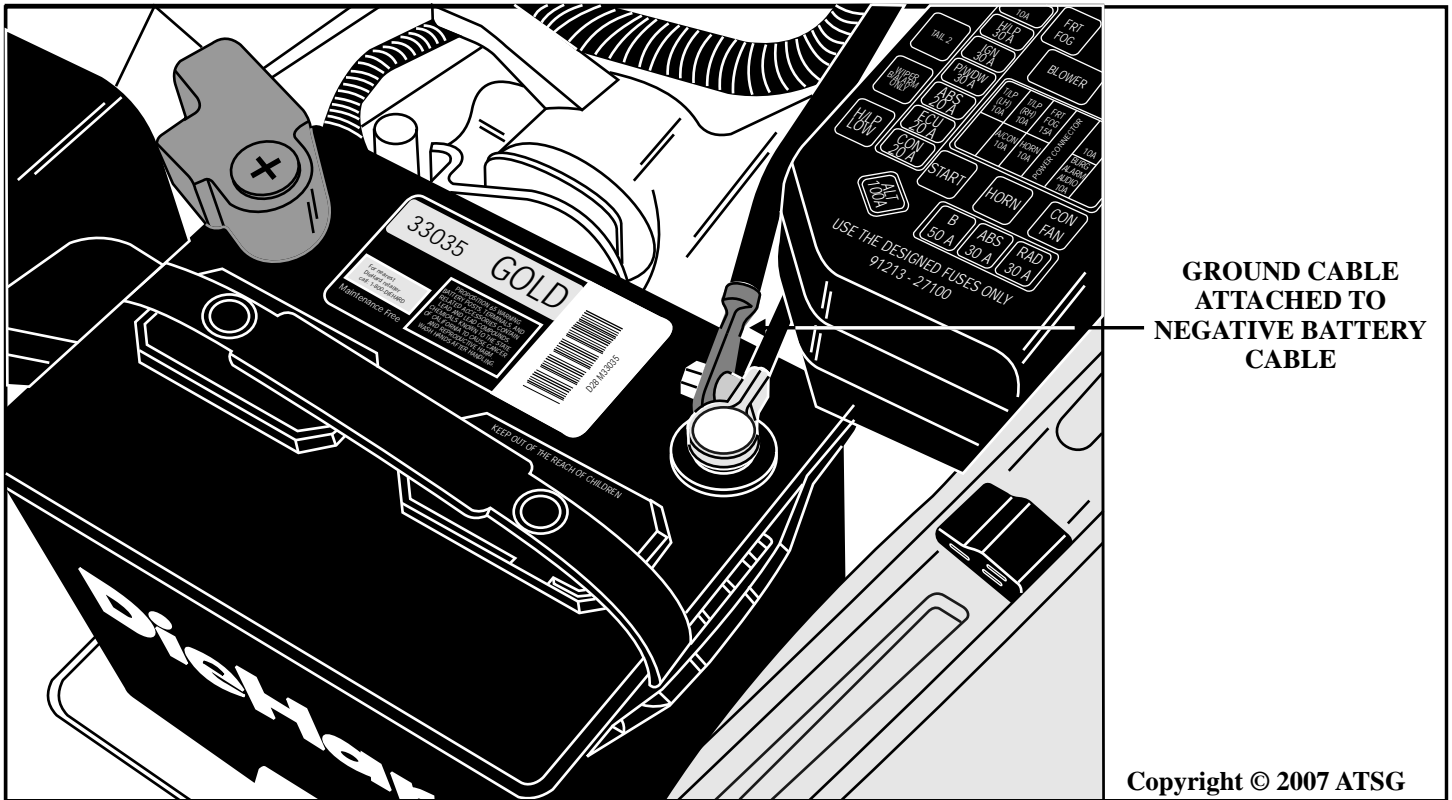
Figure 1

COMPLAINT: The vehicle has the "MIL" on with no apparent driveability complaints and the A4BF1 transmission is NOT in limp mode. However, when the TCM is scanned for codes, P0743, TCC Solenoid circuit fault and P0747, Pressure Control Solenoid "A" circuit fault are stored. Solenoid circuit checks revealed no problems, and system voltage and TCM power and ground checks also indicated no faults. The TCM was not considered for replacement as the transmission was not in limp.

CAUSE: A spare "known good" set of solenoids were connected to the vehicle harness and ground was provided for the solenoids directly to the negative battery cable. The codes were cleared and did not return. As a test these "known good" solenoids were installed into the transmission and the codes immediately returned.

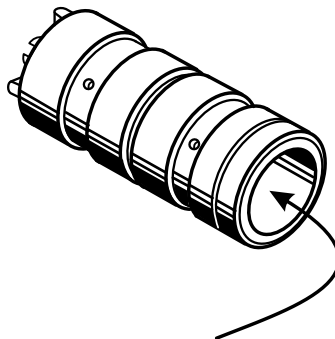
540-E BOOST SLEEVE

CAUSE: The cause may be, the inner o-ring in the Overdrive Direct Clutch Piston is blown out causing a leak in the O.D. Direct Clutch circuit. The reason for the piston seal blow out may be excessive wear in the Pressure Regulator Boost sleeve, causing high pressure in the Reverse circuit, bowing the piston in the center and blowing the piston seal out. **NOTE:** *ATSG has also had complaints with some after market filters having defective cork gaskets causing numerous holes in the spacer plate to be plugged causing very high pressure and the same failure.*

**INSPECT FOR WEAR
INSIDE OF SLEEVE**

CORRECTION: To correct this condition, replace the boost sleeve with a replacement from Toyota or Sonnax, See Figures 1 and 3. Renew the piston seals in the O.D. Direct drum as shown in Figure 2. Verify that the piston is not warped by checking with a straight edge, also shown in Figure 2.

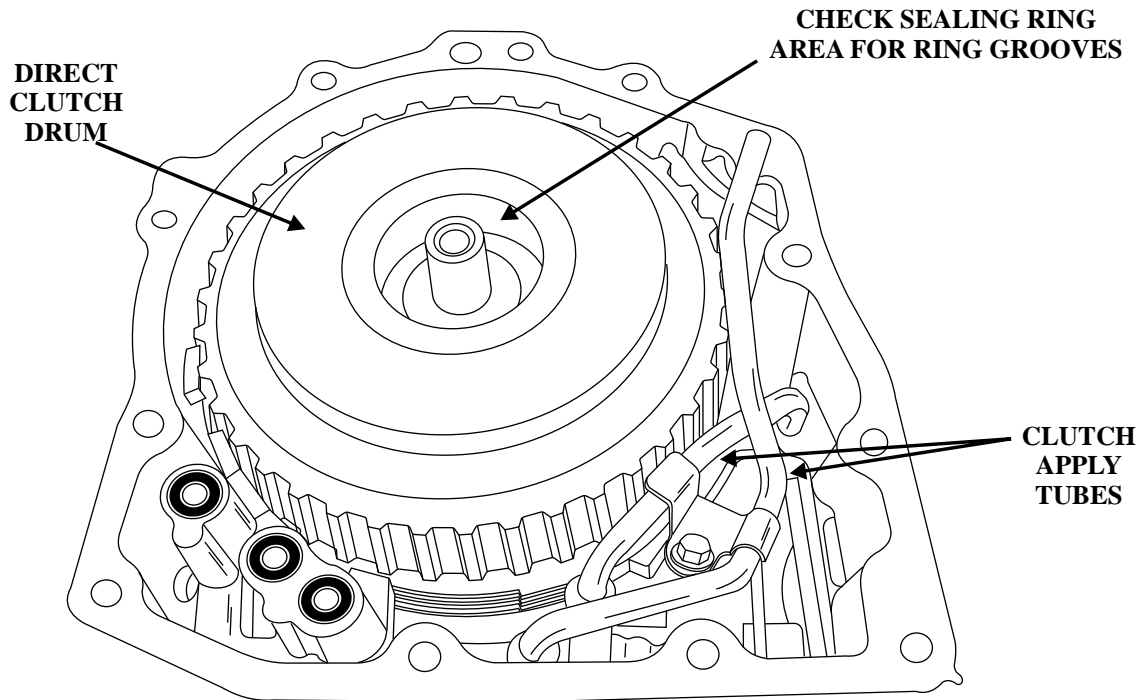
Figure 1

COMPLAINT: The vehicle comes in slipping badly in third gear, upon dis-assembly the direct clutch, (See Figure 1), is found to be severely damaged. During the after overhaul road test, the technician notices a shift shuttle on the 2-3 shift followed by a bind-up which results in an extremely harsh shift.

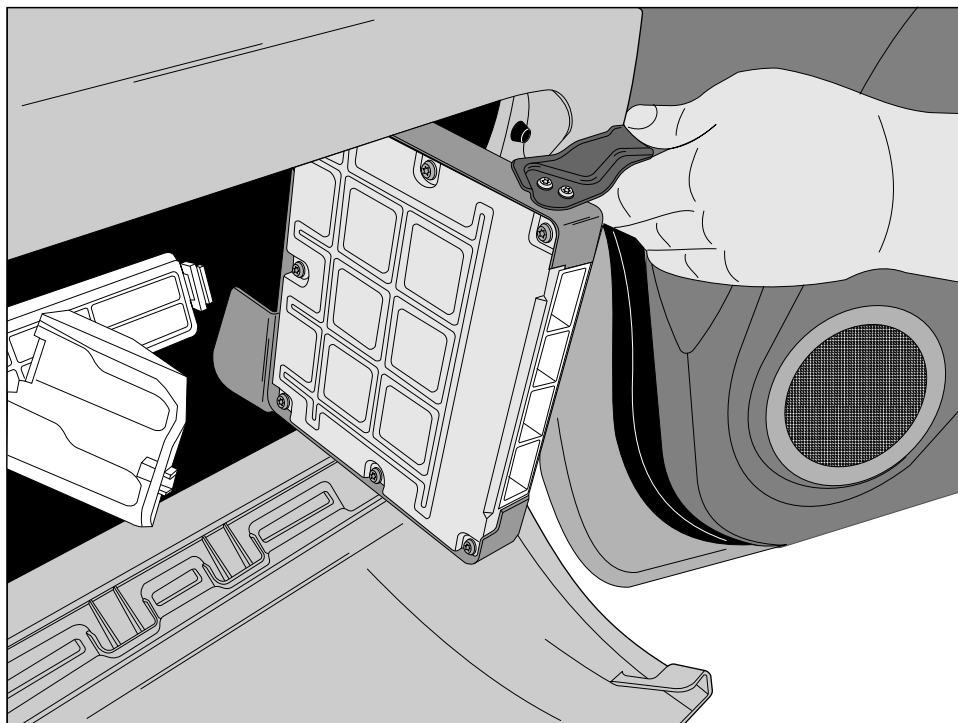
Figure 2

CAUSE: The cause of all these complaints is a faulty PCM.

CORRECTION: The PCM will require programming and replacement., Refer to Figure 2).

**THE NEW PCM
MUST BE
PROGRAMMED
TO FUNCTION**

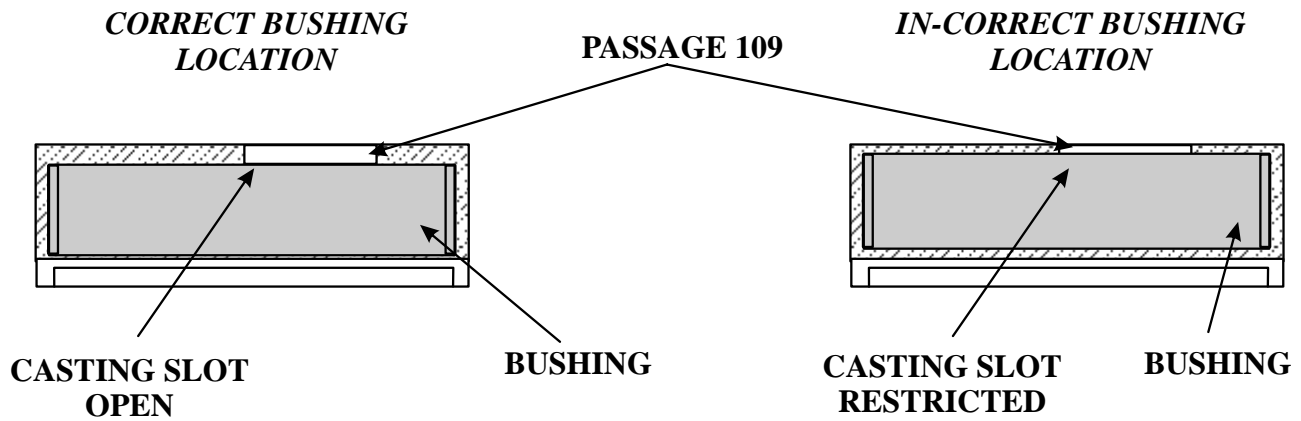
Figure 1

CAUSE: The Cause may be, that during bushing installation, a THM 350 bushing was used and was placed too deep into the bellhousing, as shown in Figure 1. When this happens, and the Torque Converter Clutch is commanded "Off," the bushing will partially block the passage that is connected "To Cooler", which will act as a cooler restriction, creating the partial engine stall. See Figure 3 For a partial hydraulic circuit diagram of TCC OFF. When the Torque Converter Clutch is commanded "On," the "Converter Apply circuit" is restricted creating low apply pressure and premature Torque Converter Failure as well as discoloring of the Torque Converter. Refer to Figure 4 for a partial hydraulic circuit of TCC ON. Refer to Figures 1 and 2 to see the dimensional difference between the Sonnax bushing and the THM 350 bushing and to identify the previously mentioned passage in the bellhousing. One other cause may be a partially stuck Converter Clutch Control Valve, as shown in Figure 5.

NOTE: The Sonnax 54253-01 Bellhousing bushing width is .560"
The THM 350 Bellhousing bushing width is .610"
Passage 109 slot is .095" from the top of the bushing to the mating surface
of the pump when the bushing is installed correctly.

CORRECTION: Replace the bushing with the Sonnax Bellhousing bushing or when using a THM 350 bushing use a die grinder to remove the excess material to ensure no restrictions in the passage shown in Figures 1 and 2.

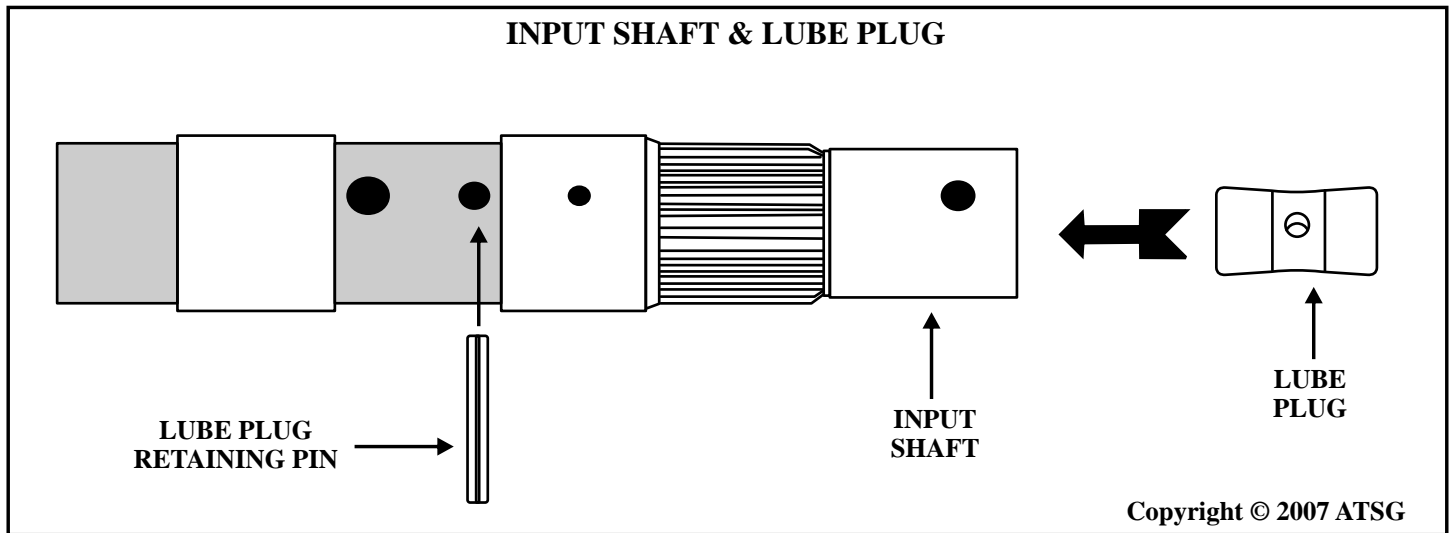
Figure 3

An area that can cause converter drainback is the input shaft shown in Figure 3. There is a plastic plug inside the shaft that separates converter fill and lube circuits. It is held in place by a retaining pin, if this plug were missing you would have drainback, if it were melted you could have lube problems or converter fill issues. Converter clutch problems could generate enough heat to melt this plug.

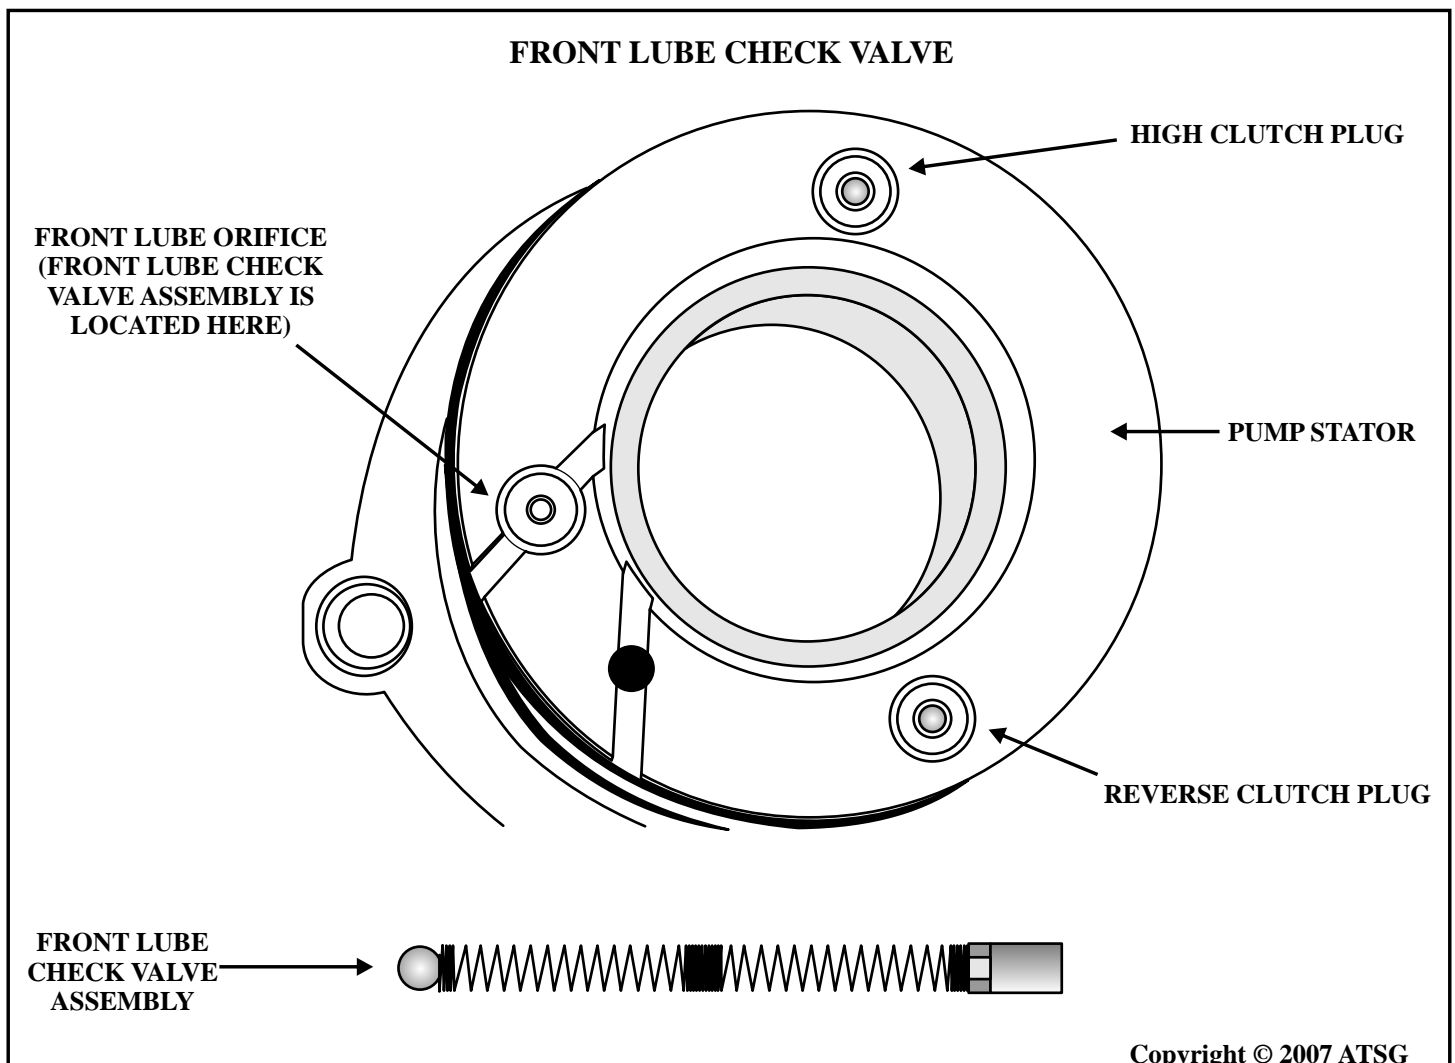
Figure 4

Another lube passage that should be inspected as shown in Figure 4, is in the pump cover. Under the lube orifice is a spring loaded ball that could get jammed with debris which will block the lube passage causing front gear train failure. There is also a spring loaded ball under the front cooler line, which if left out would also cause drainback problems, or even worse if it were stuck closed, catastrophic transmission failure.

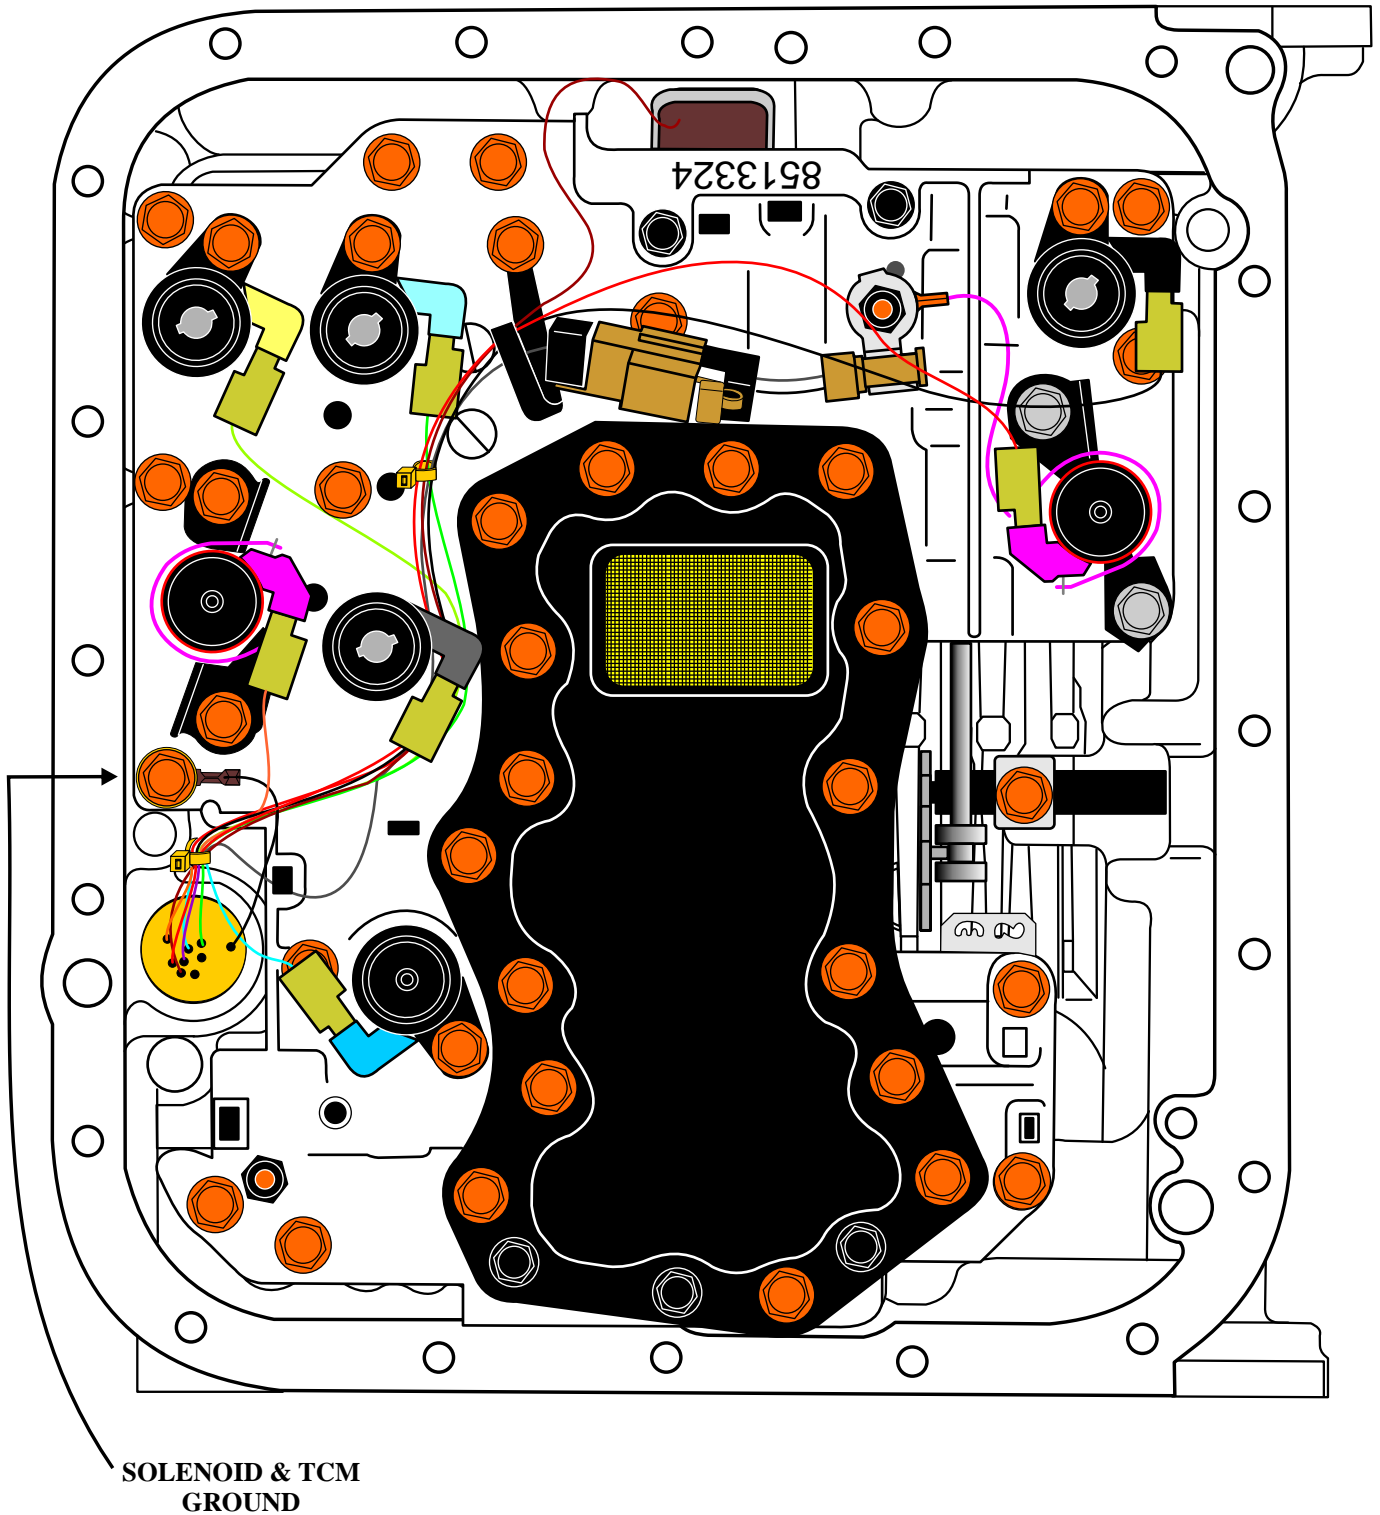
Figure 2

CAUSE: Referring to the wire diagram in Figure 1, the ground circuit for the TCM can be seen as it is located inside the transmission which is also ground for the internal solenoids. The physical ground point can be seen in Figure 2. It is a typical wire/eyelet which a valve body bolt goes through. the ground wire then travels through the case connector at terminal 16 as shown in Figure 3, and then continues to terminals 9 and 19 at the TCM where it serves as ground for the TCM as well.

CORRECTION: Make certain this ground is in good condition as well as tight to insure it is a good ground. Since it serves as ground for both the transmission solenoids as well as the TCM, a variety of complaints could arise as a result of this ground being faulty.

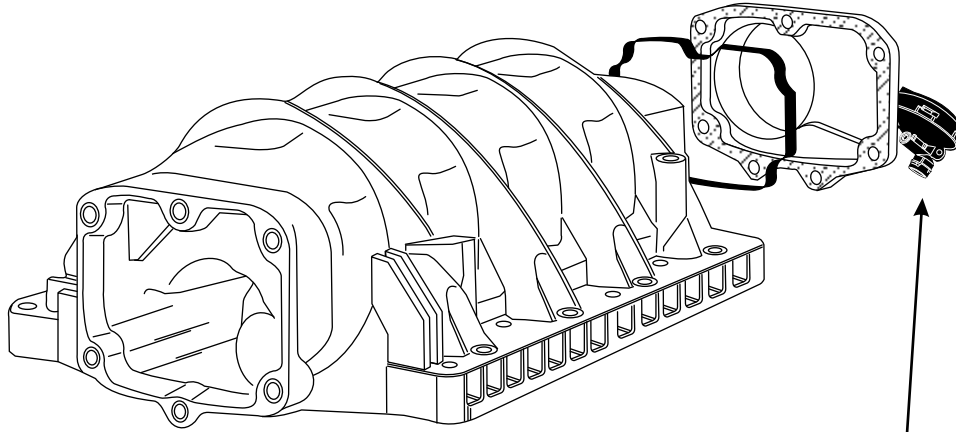
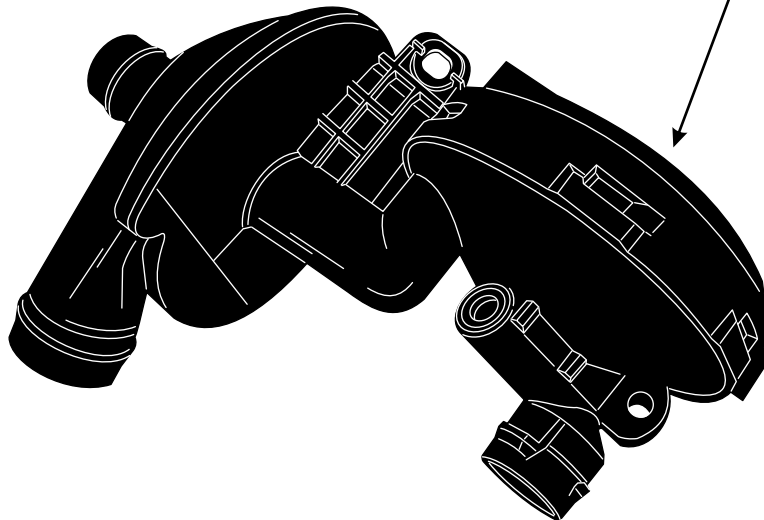
OIL SEPARATOR

CAUSE: The cause of this problem is typically a valve resonance coming from the oil separator which happens to be located at the back of the intake plenum, right above the bell housing. It can be compared to the noise we have had on the 4EAT in the Ford Escort with the dirty PCV valve.
TESTING: To verify if this is the problem with this vehicle, start the engine and wait for the noise to start, remove the oil filler cap and see if the resonance goes away. If it does the oil separator will need to be replaced.

CORRECTION: To correct this condition refer to Figure 1 to locate the oil separator and replace it. Due to the part number differences for the different models, you will need to contact your local dealer for the replacement part number.
