## **"2008" SEMINAR INFORMATION**

## ***AUTOMATIC TRANSMISSION SERVICE GROUP***

## ***"Shiftin' Great in 2008" Seminar Information***

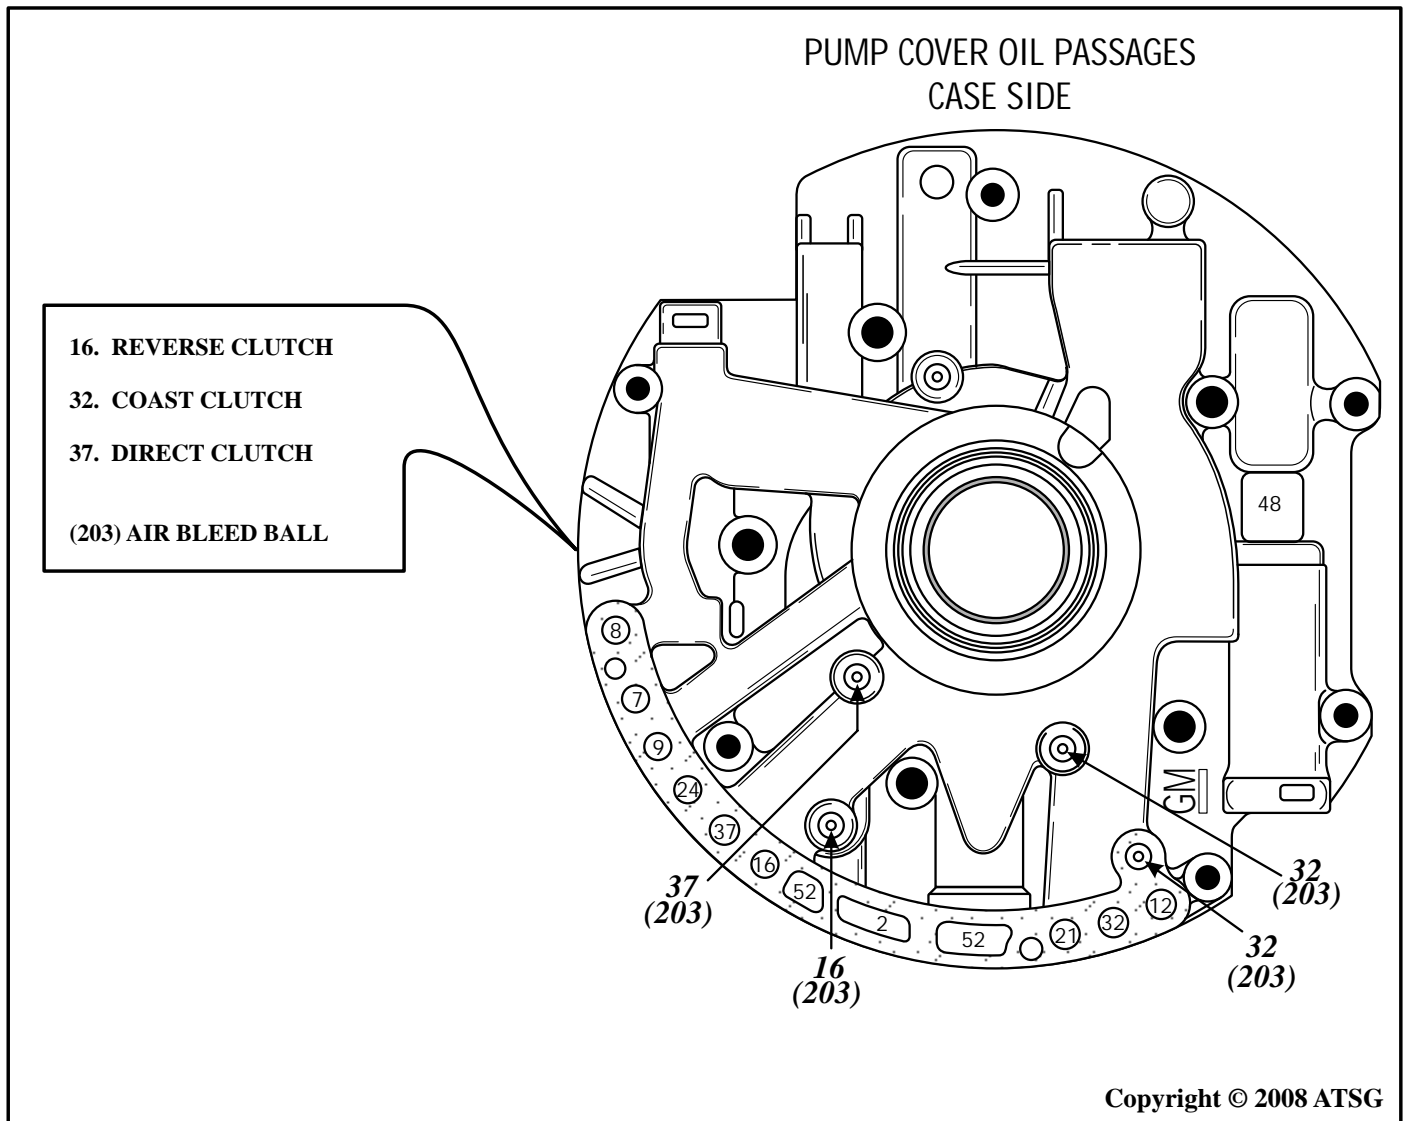
Figure 1

## 5L40E PREMATURE FAILURE OF THE REVERSE, DIRECT AND OR COAST CLUTCH

**COMPLAINT:** Before and after a rebuild, the transmission may exhibit premature failure of the reverse, direct or coast clutch.

**CAUSE:** Inside the pump cover there are air bleed ball capsules for each of these three clutches that may not be seating properly. If the unit originally came in with bad pump rings or converter clutch failure, debris may be lodged in the capsule preventing the air bleed ball from seating causing a leak in the circuit (See Figure 1).

**CORRECTION:** The air bleed capsule can be flushed out with air and mineral spirits. When done, place drums on to an assembled pump and air check to ensure that the balls seat with pressure.

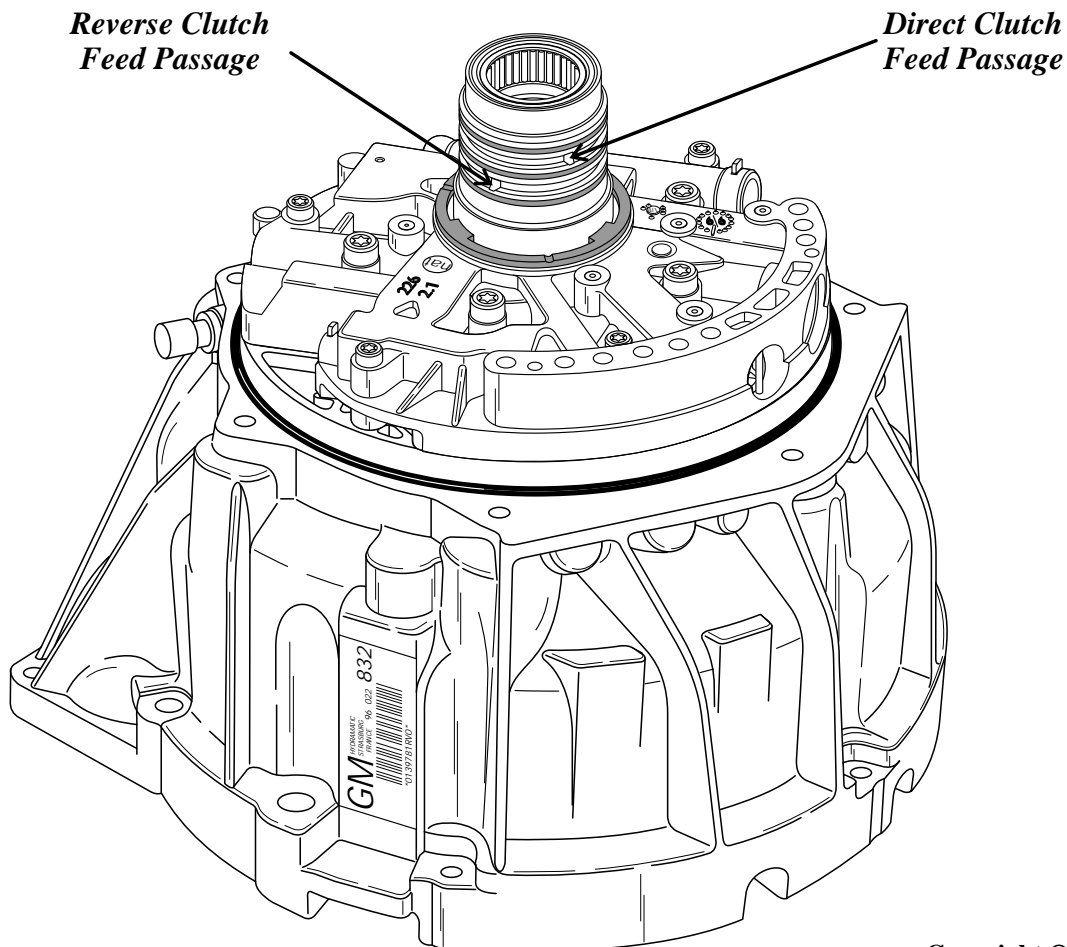
Figure 2

**COMPLAINT:** The vehicle owner may complain of a delayed reverse and/or a flare 3-4 shift. In some cases a bind up in reverse or on the 3- 4 shift may be noticed. The unit may failsafe with an incorrect 4th gear ratio code.

**CAUSE:** Pump rings used to seal reverse clutch and direct clutch oil pressure are known to develop excessive wear causing their respective clutch to slip or to allow fluid pressure to cross leak into the incorrect passage (Figure 2). The middle ring seems to be most prone to wear. This problem is usually attributed to pump misalignment. Pump alignment is critical. The pump is not a full circle which can allow misalignment if care is not taken.

**CORRECTION:** Replace seal rings and parts as necessary and align the pump. Inspect for high line pressure problems and correct. Inspect for direct clutch drum bushing wear and excessive end play which can accelerate ring wear and repair or adjust as necessary. In some cases the edges of the ring grooves in the aluminum drum support of the cover are rough and cut into the ring. Carefully dress the sharp edges of the ring groove with a fine file.

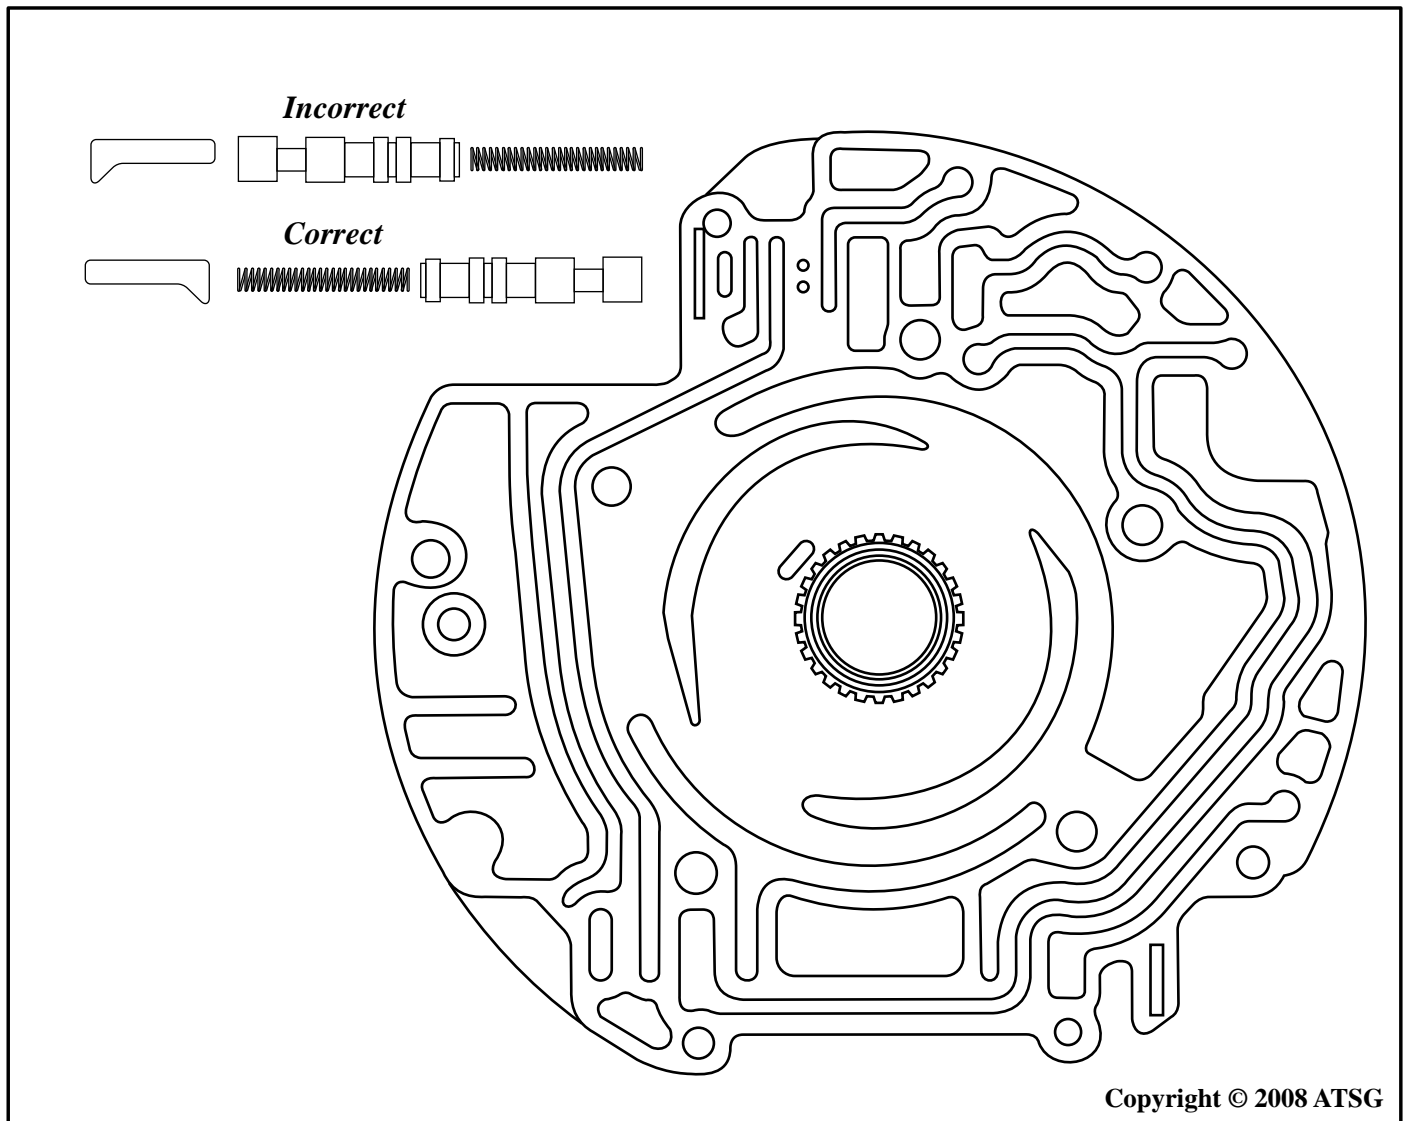
Figure 4

**CAUSE:** Some early pumps utilize a single TCC Valve that can be placed into the pump incorrectly. The valve must go into the pump first followed by the spring and retainer. If the spring is placed into the pump first followed by the valve and retainer, a no converter clutch apply problem will occur.

**CORRECTION:** Install the TCC valve lineup correctly as shown in figure 4.

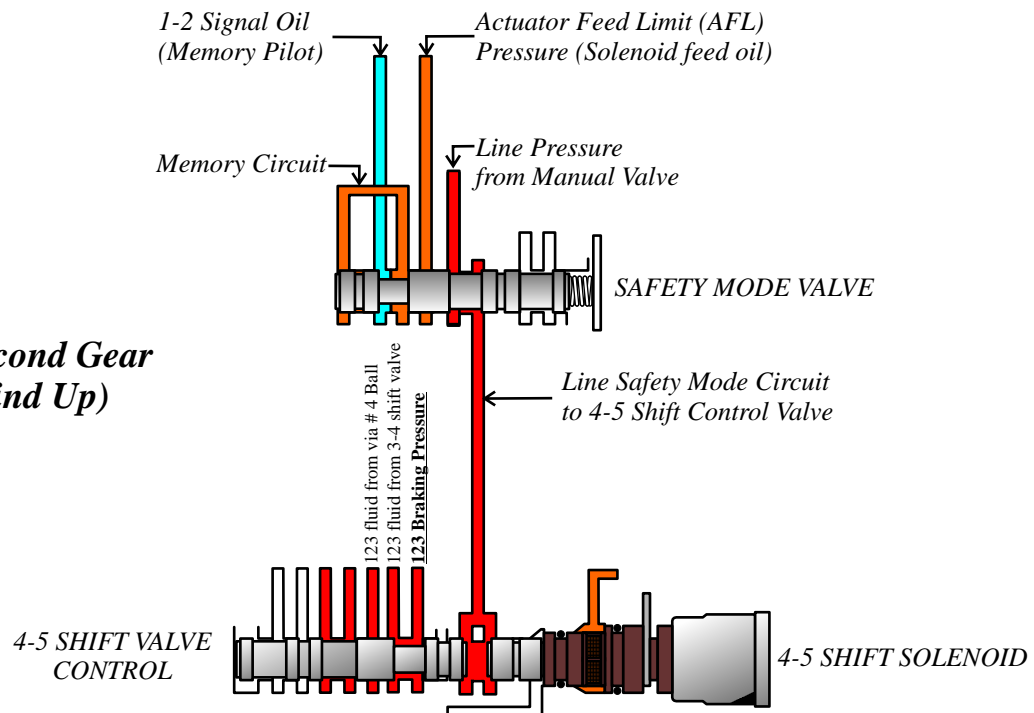
**NOTE:** This bulletin explains that if the Safety Mode Valve should stick in an un-stroked position a bind up in 2nd will occur. But if this valve should get stuck in a stroked position, a loss of engine braking in first gear may be noticed. If the vehicle failsafes, it will have 5th gear even after an ignition cycle.

## Second Gear (Bind Up)

If the Safety Mode Valve cannot stroke on a 1-2 up shift, the L/R clutch stays applied causing the bind up into 2nd.

**CORRECTION:** Clean and free up the Safety Mode Valve. Determine what other problems may have occurred to cause enough debris to stick the valve and repair as necessary.

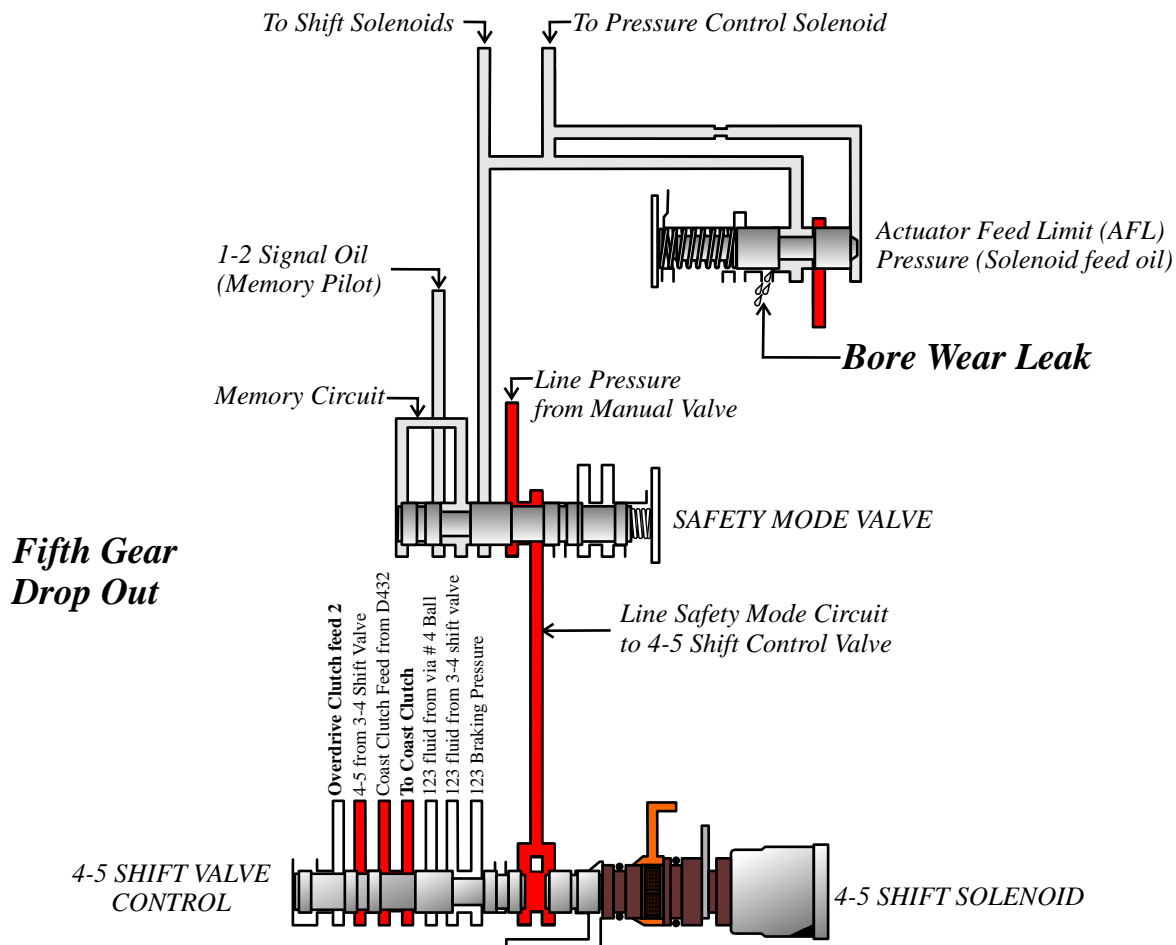
**COMPLAINT:** Before and/or after a rebuild, the transmission may exhibit a sudden falling out of 5th gear or no 5th at all. This condition may be more evident when operating temperature increases and a 5th gear ratio error fault code may be stored.

**CAUSE:** The Actuator Feed Limit (AFL) valve has developed sufficient bore and valve wear that it causes a pressure drop in the memory pilot circuit. This causes the Safety Mode valve to be closed by spring tension. When the valve closes, line pressure passes through the valve and into the 4-5 shift valve circuit forcing the valve into a 4th gear position. (See Figures 14 and 15) The AFL bore and valve can wear to a point where it prevents 5th gear completely.

## GM 5L40E / BMW A5S 360/390R FALLING OUT OF 5th OR NO 5th AT ALL

When the Actuator Feed Limit (AFL) Valve develops marginal bore wear, a pressure drop occurs in the Memory Circuit causing the Safety Mode Valve to close by spring tension. This allows line pressure to pass through the Safety Mode Valve to the 4-5 Shift Control Valve closing the valve and causing a "5th gear fall out" complaint. The AFL valve/bore can develop enough wear to even prevent 5th from occurring at all.

**CORRECTION:** Repair the AFL valve/bore wear with a reamer and sleeve kit or replace the valve body.

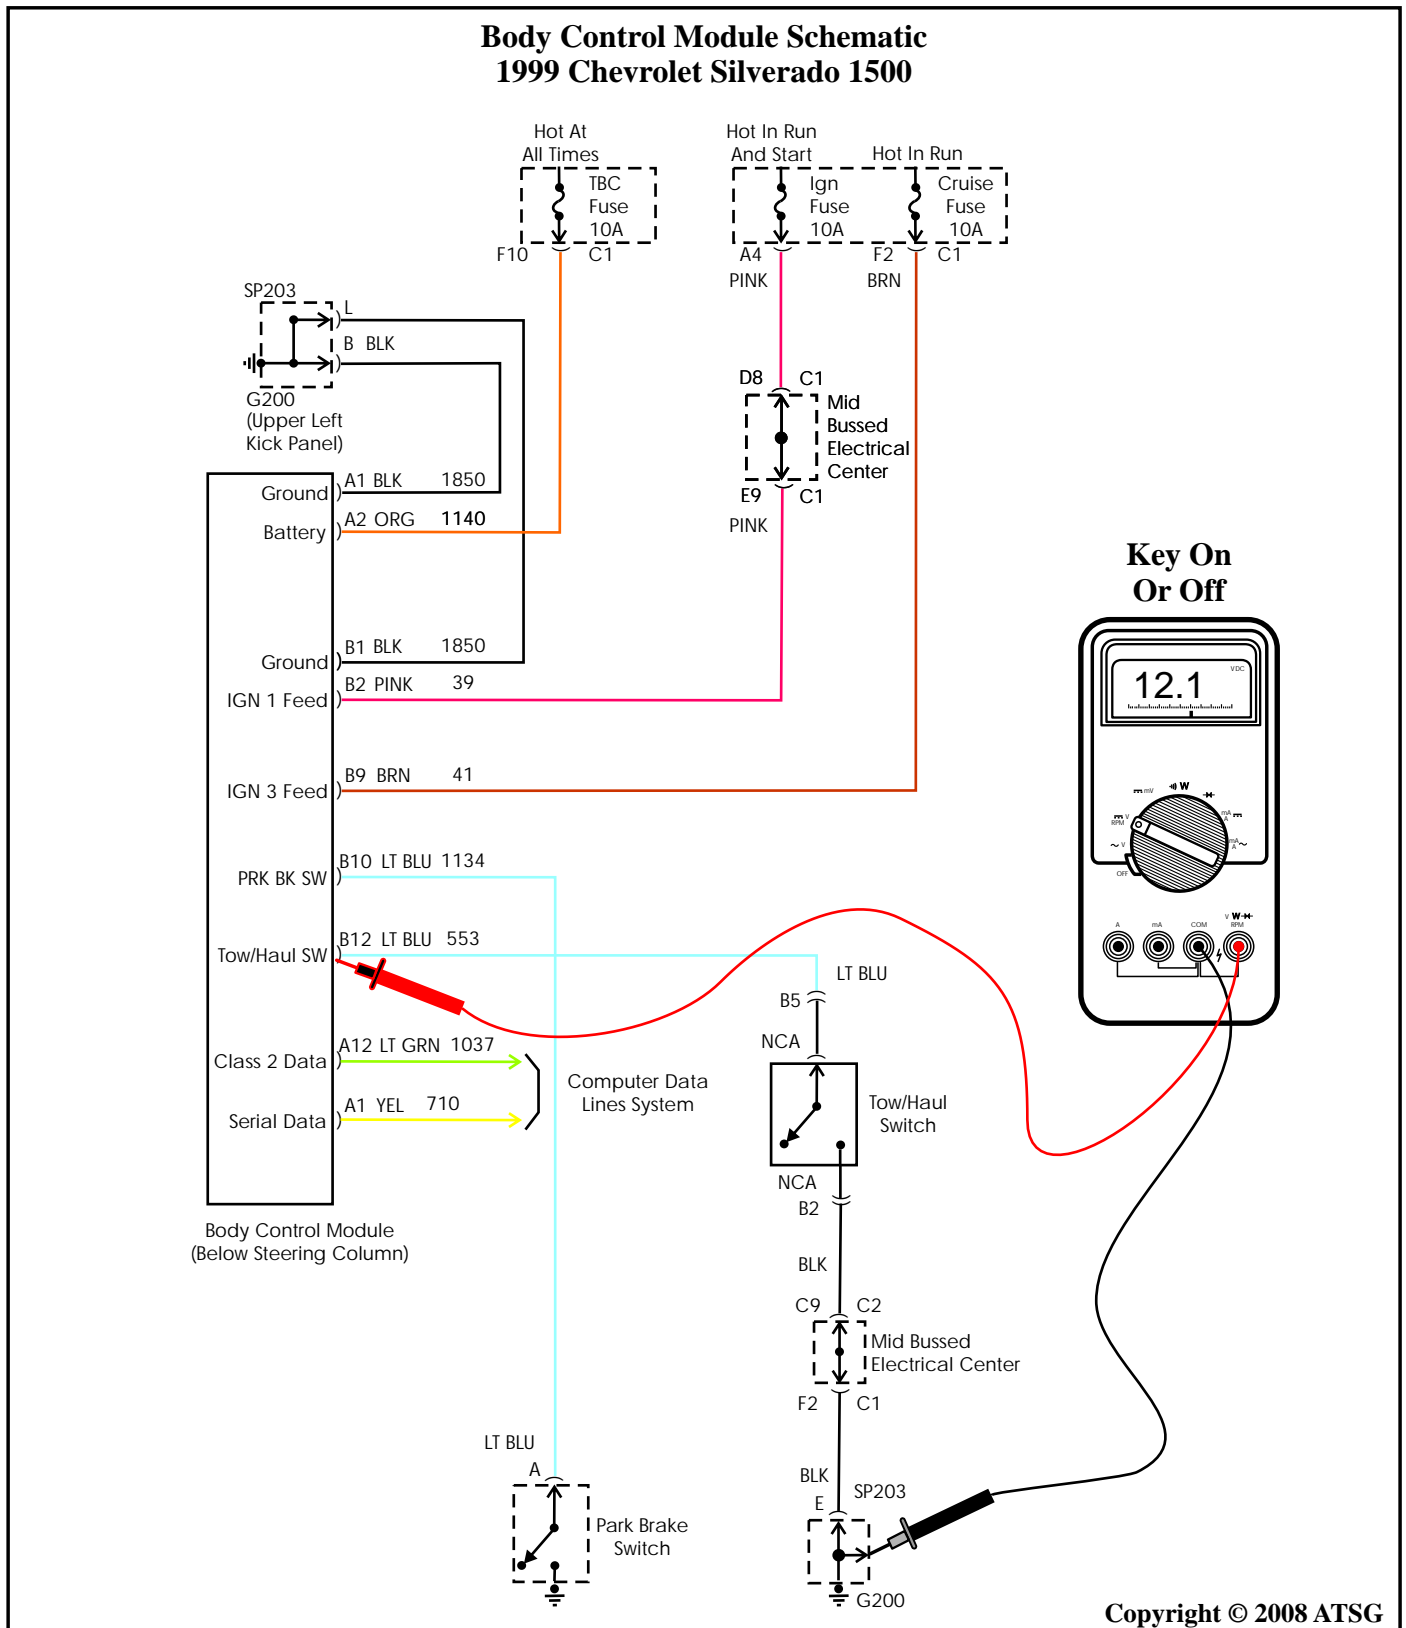
Figure 1

**COMPLAINT:** Tow/Haul Mode inactive, light on dash will not illuminate when switch is activated on shifter handle. This condition could cause code B2722 to set. In some diagnostic information, the Tow/Haul Mode Switch is referred to as a "Preference Switch".

**CAUSE:** A break or short in wiring in the area where the shifter arm pivots on steering column. Possible Tow/Haul Mode switch failure.

## GM TOW/HAUL MODE TOW/HAUL SWITCH MALFUNCTION

**CORRECTION:** Repair the wiring or replace the switch. The switch and wiring are an integral part of the shift lever, it comes as an entire assembly.

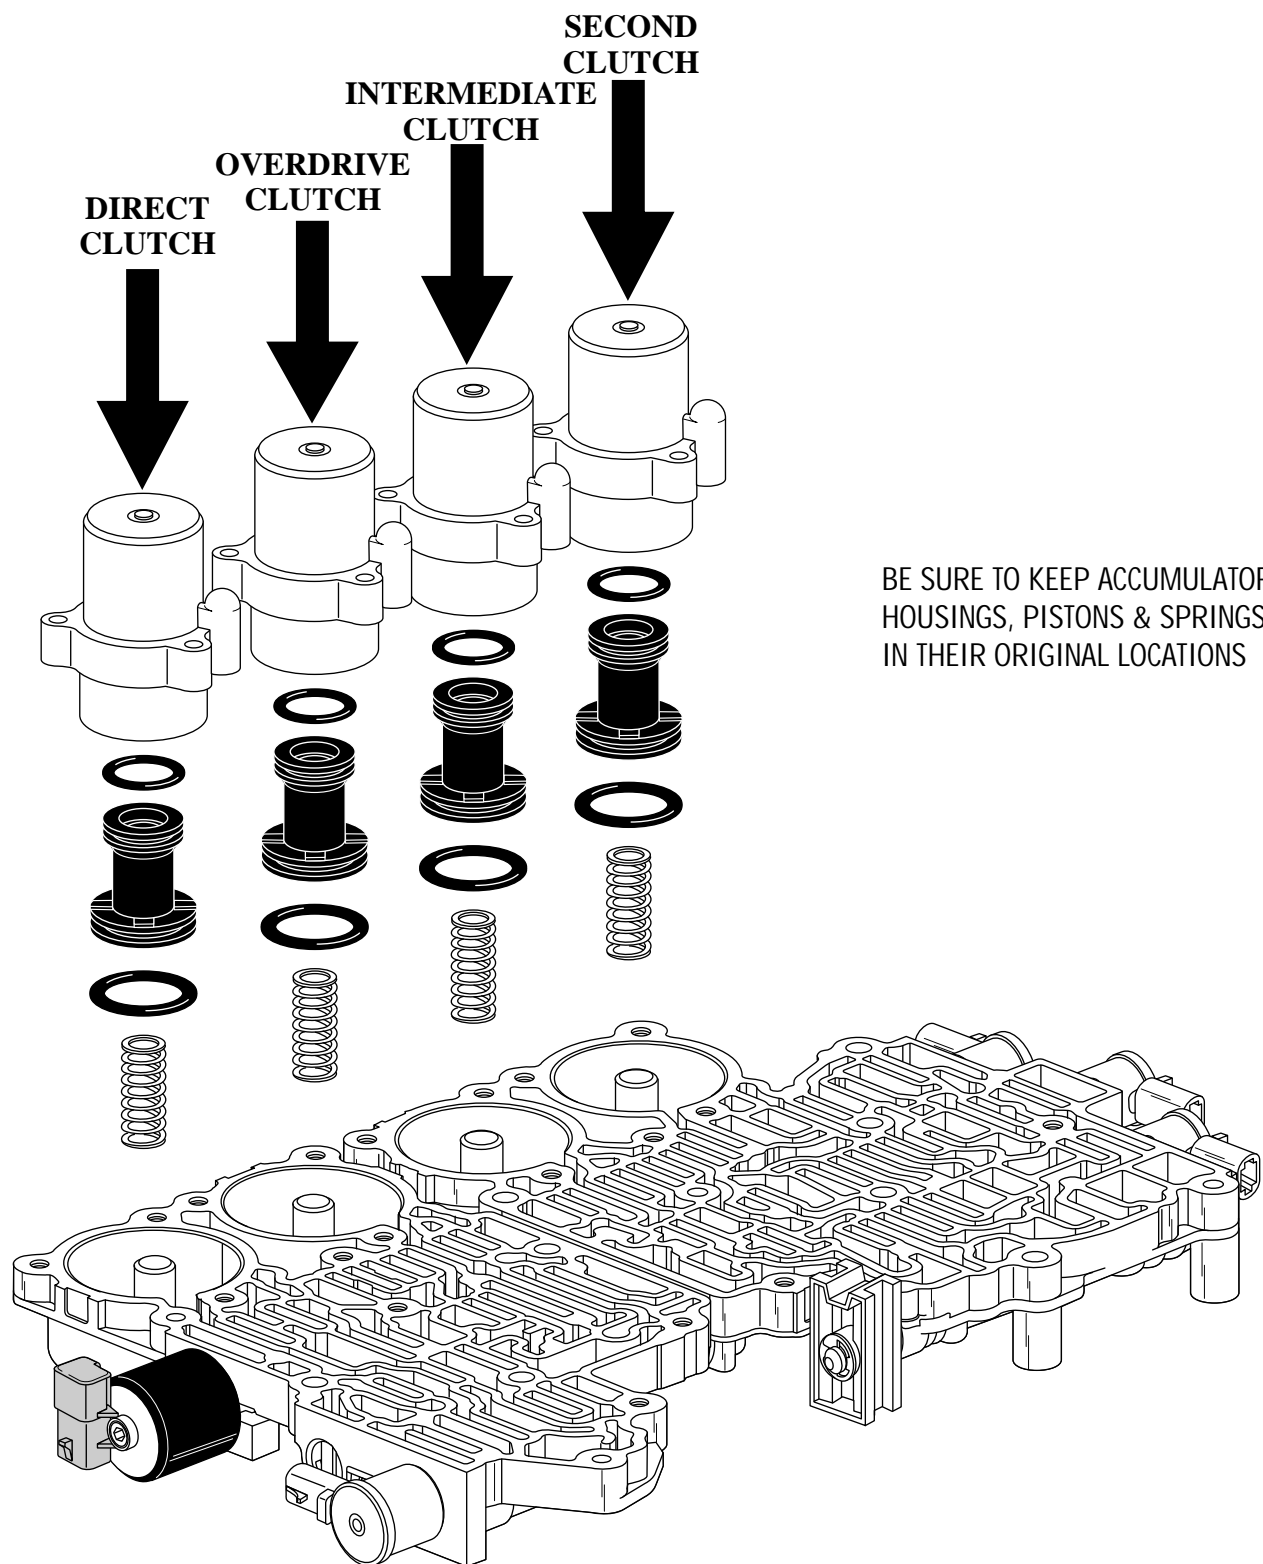
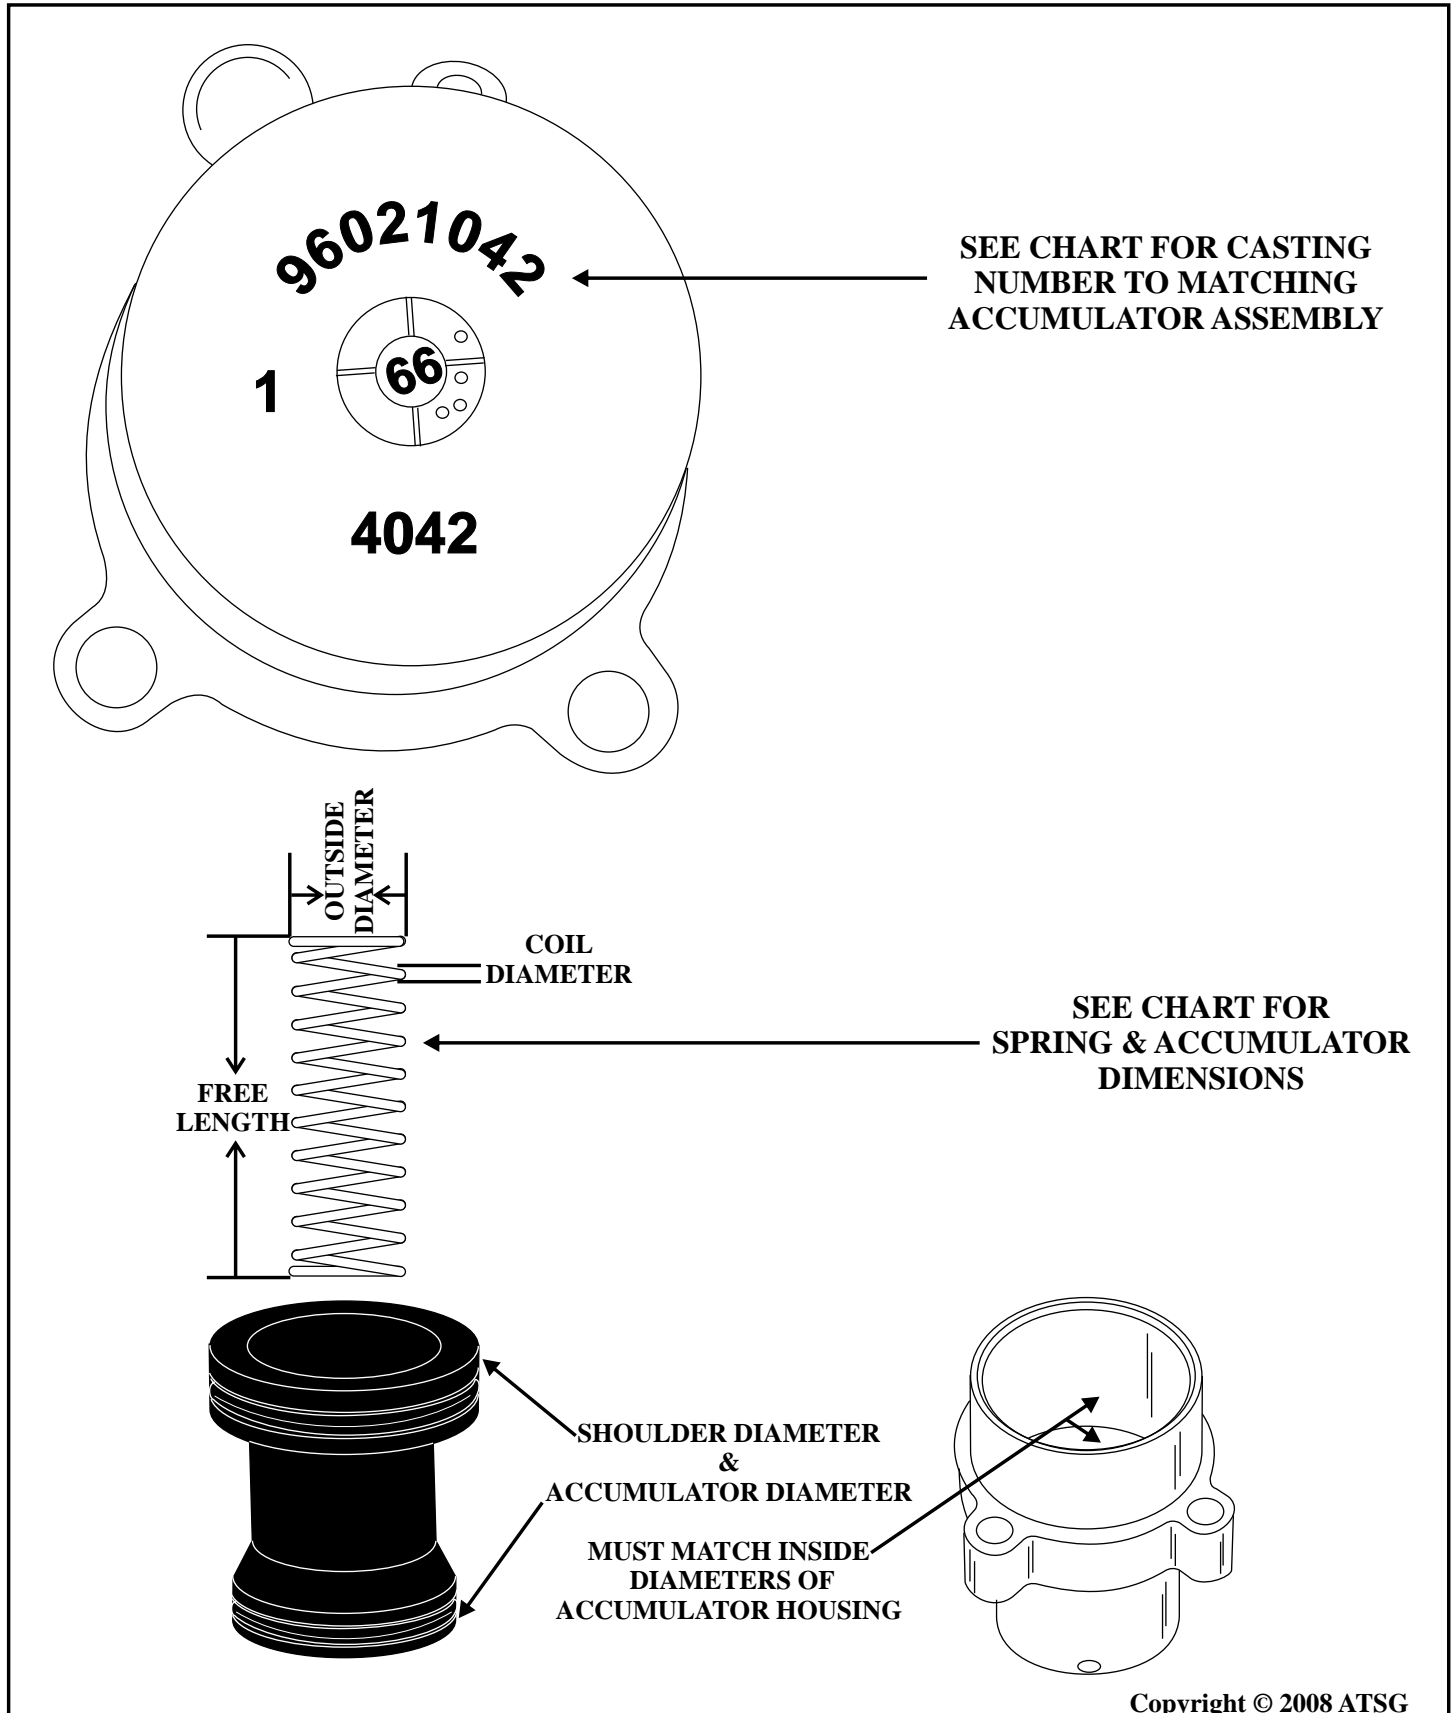
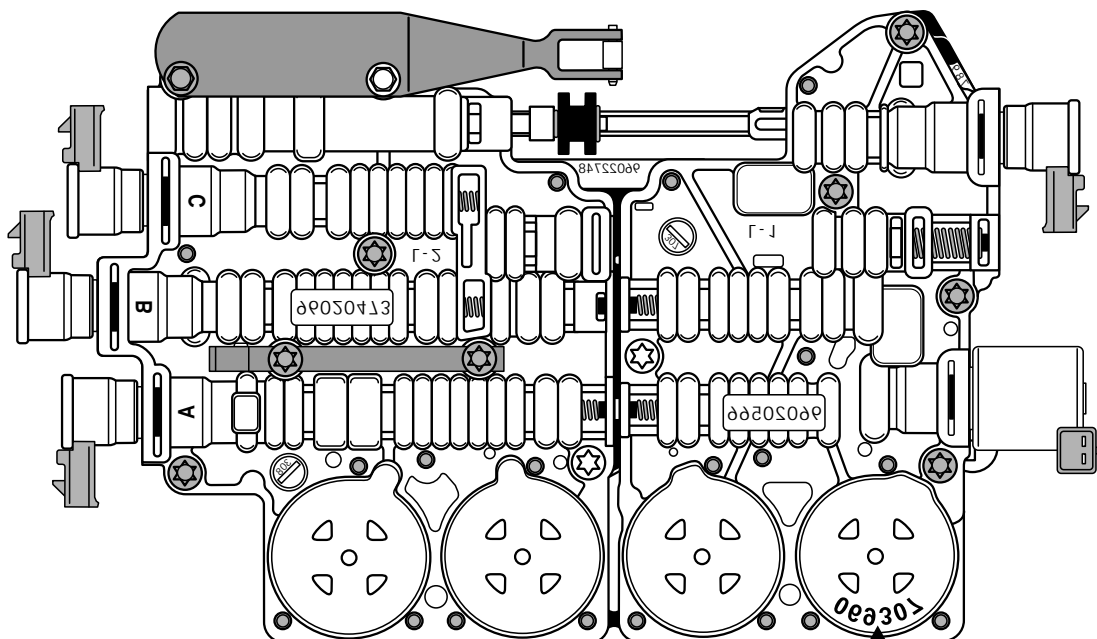
### 5L40E ACCUMULATOR IDENTIFICATION

**COMPLAINT:** After overhaul, the transmission has either harsh or soft shifts. A line pressure check reveals normal operation and there is no valve wear in the valve body.

**CAUSE:** The accumulator assemblies have been mis-assembled.

SEE THE CHART FOR ENGRAVED NUMBER ASSOCIATION TO ACCUMULATOR ASSEMBLY MATCH

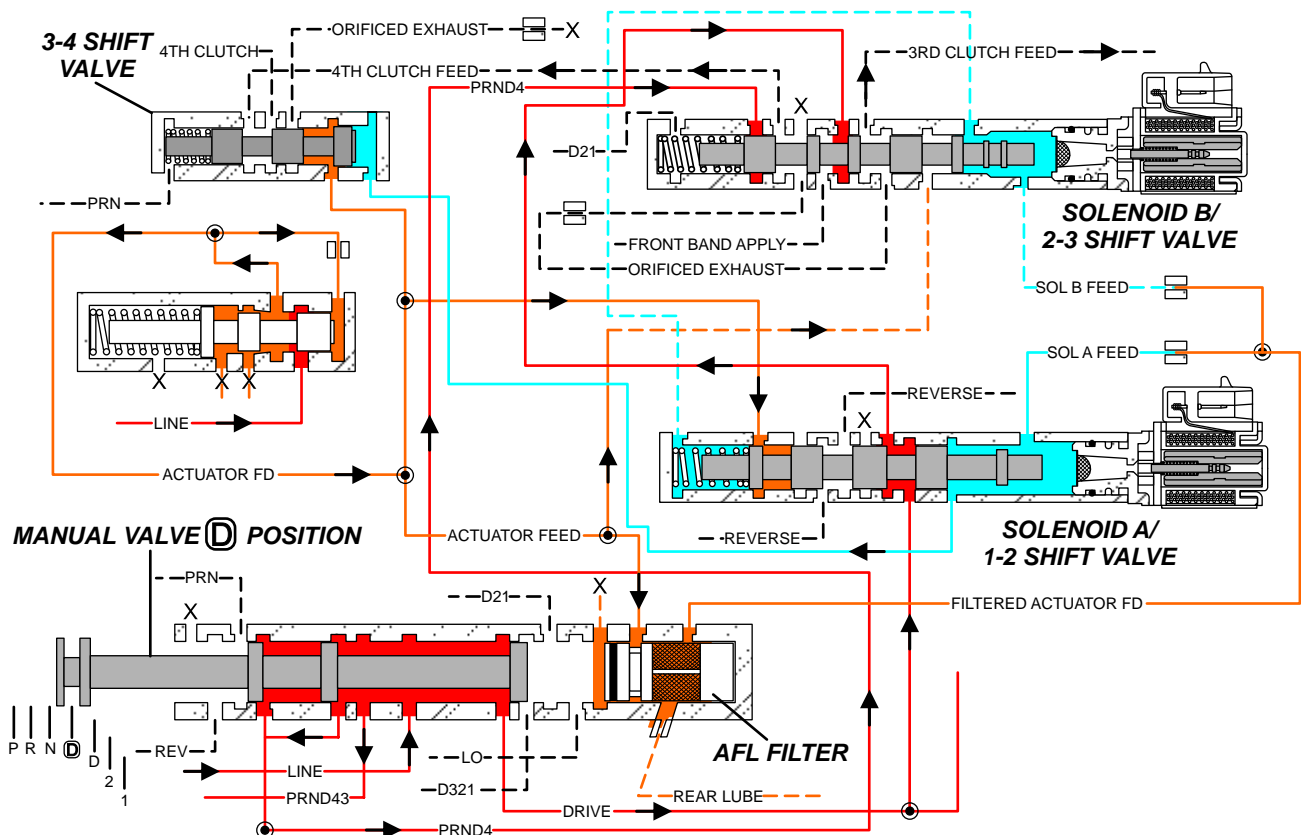
**COMPLAINT:** Before or after overhaul, a GM vehicle equipped with the 4L80E transmission exhibits a complaint of a neutral condition either during the shift to 4th gear, or immediately after the shift.

**CAUSE:** One cause may be a loss of Actuator Feed Limit (AFL) Valve oil pressure in the valve body, or a leak in the Shift Solenoid B circuit.

### PARTIAL 4TH GEAR HYDRAULIC AFL PRESSURE LOSS

This 4th Gear partial hydraulic diagram depicts AFL pressure loss due to a flattened AFL Filter O-ring and a worn AFL Valve bore. Note the loss of Actuator Feed pressure to the 2-3 Shift Valve and also Sol. B Feed. The 2-3 Shift Valve is affected before the 1-2 Shift Valve because the 2-3 Shift Valve Spring is heavier. This loss of AFL pressure moves the 2-3 Shift Valve into the 1st gear position, and 1st gear is obtained regardless of the position of the 3-4 Shift Valve.

**CORRECTION:** Check the AFL bore in the valve body and inspect the O-ring on the AFL filter. Replace the O-ring if it is damaged. If the AFL bore is worn, there is a boring tool and a sleeve and valve kit available from Sonnax as well as a Shift Valve Spring Replacement Kit for both the 1-2 and 2-3 Shift Valves. Refer to Figure 3 for a valve body breakdown showing listed components.

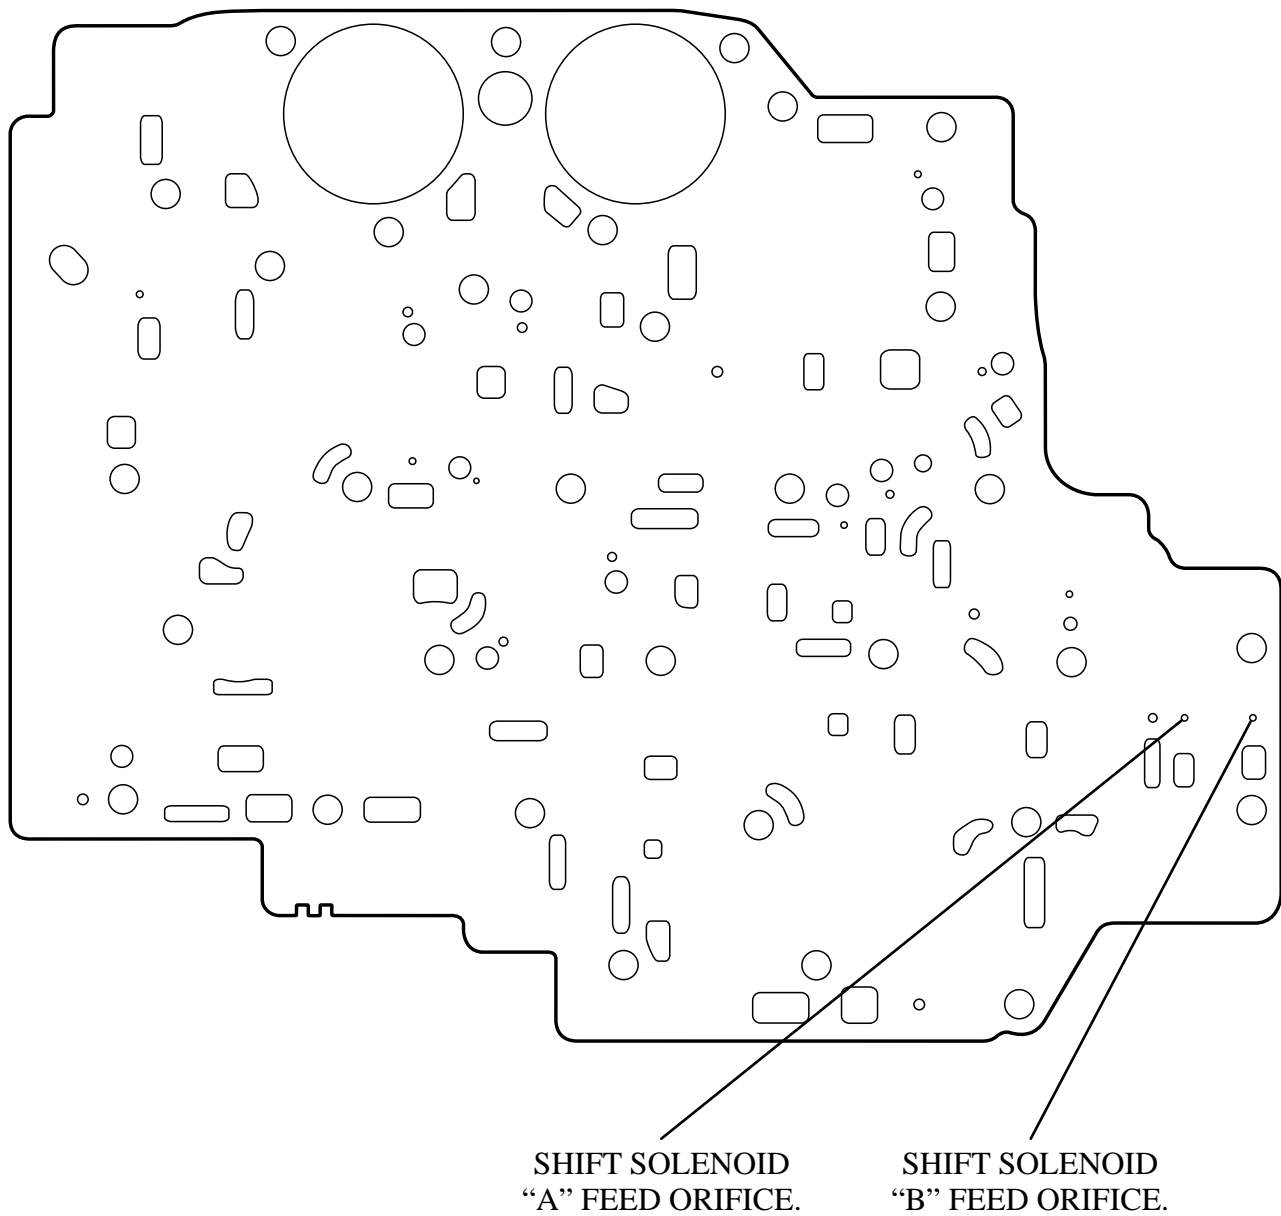
**4L80E SPACER PLATE  
SOLENOID FEED ORIFICE LOCATIONS**

***DO NOT ENLARGE EITHER FEED ORIFICE  
DIAMETER GREATER THAN .035"***

If the AFL valve and the Filter are in good condition, then it may be necessary to replace Shift Solenoid B. In addition, the solenoid feed hole in the separator plate may be enlarged slightly to overcome this condition. Using a .035" drill bit, carefully enlarge solenoid feed hole. **DO NOT ENLARGE SOLENOID FEED HOLE MORE THAN .035"**. Refer to Figure 4 for Shift Solenoid B feed hole location in the separator plate.
