"2006" SEMINAR INFORMATION

AUTOMATIC TRANSMISSION SERVICE GROUP

"Top Tech Tricks for 2006"

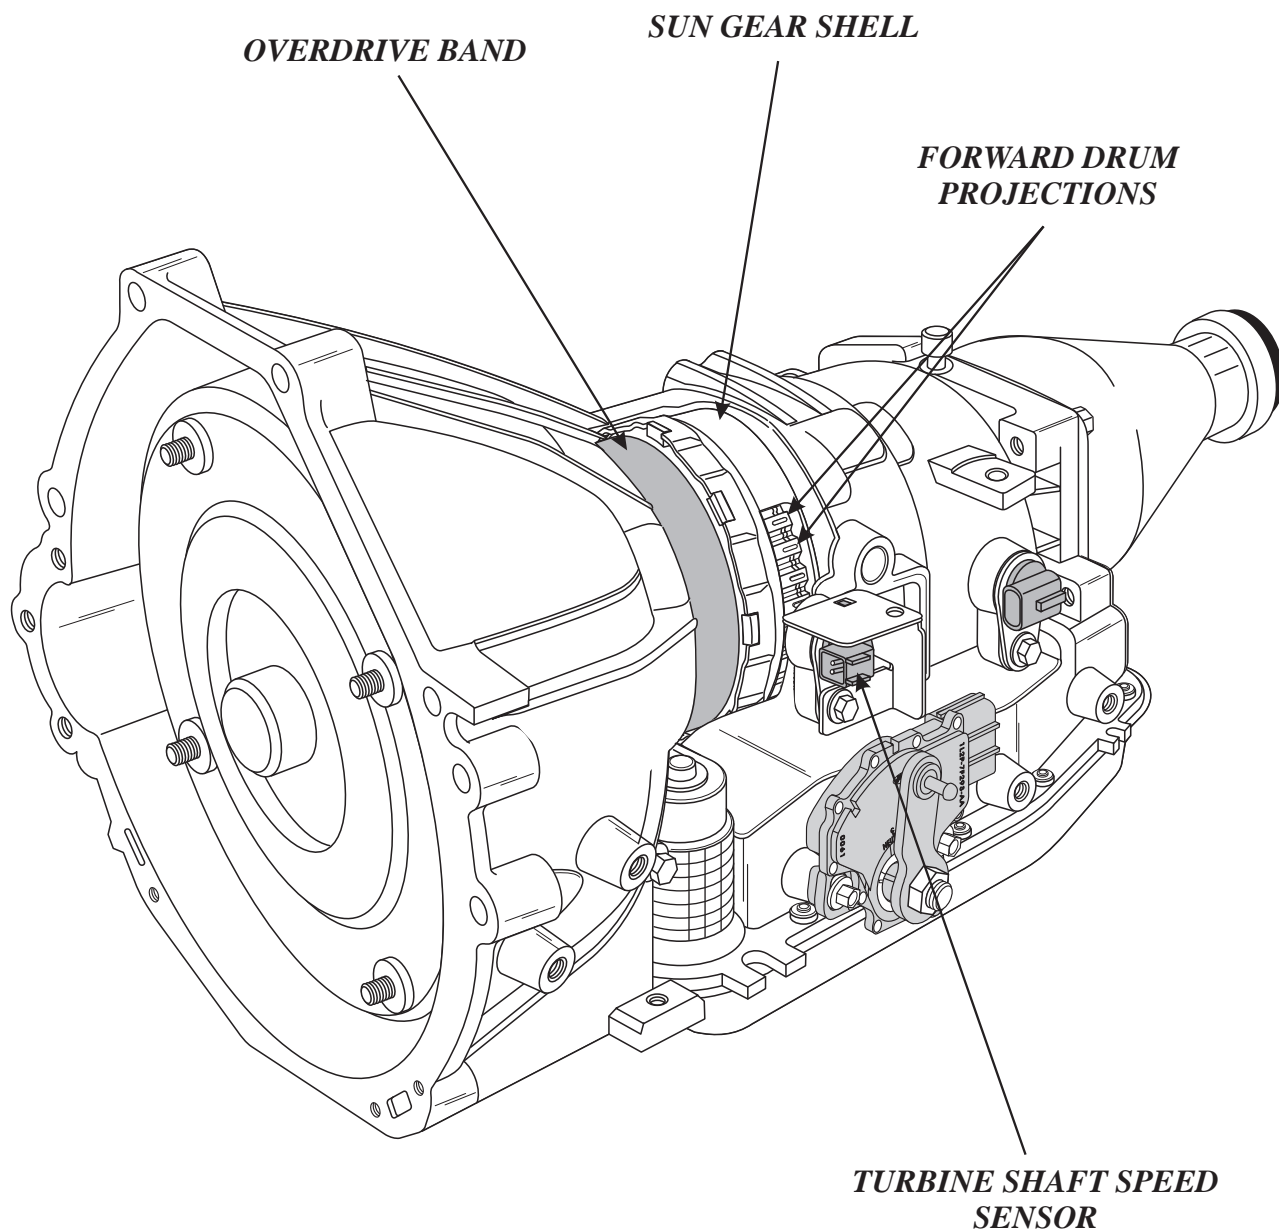
Figure 1
Automatic Transmission Service Group

CAUSE: The cause may be, that the Forward Clutch Drum, as shown in Figure 2, or Sun gear Shell, as shown in Figure 3, were replaced with the previous design parts causing the Turbine Speed Sensor to return a false reading to the Powertrain Control Module. In the start of production for 2004 the Sun gear shell was made of a non-ferrous material to allow the new Turbine Shaft Speed Sensor to read the Forward Clutch Drum, calculating Turbine shaft speed for the PCM. At the same time the Forward Clutch Drum received a new stamping process, to provide 34 projections for the sensor to read from. See Figure 1 for a cross-sectional view.

CORRECTION: Install the correct Forward Clutch Drum or Sun gear shell into the transmission and or replace the Turbine Shaft Speed Sensor as shown in Figure 4.

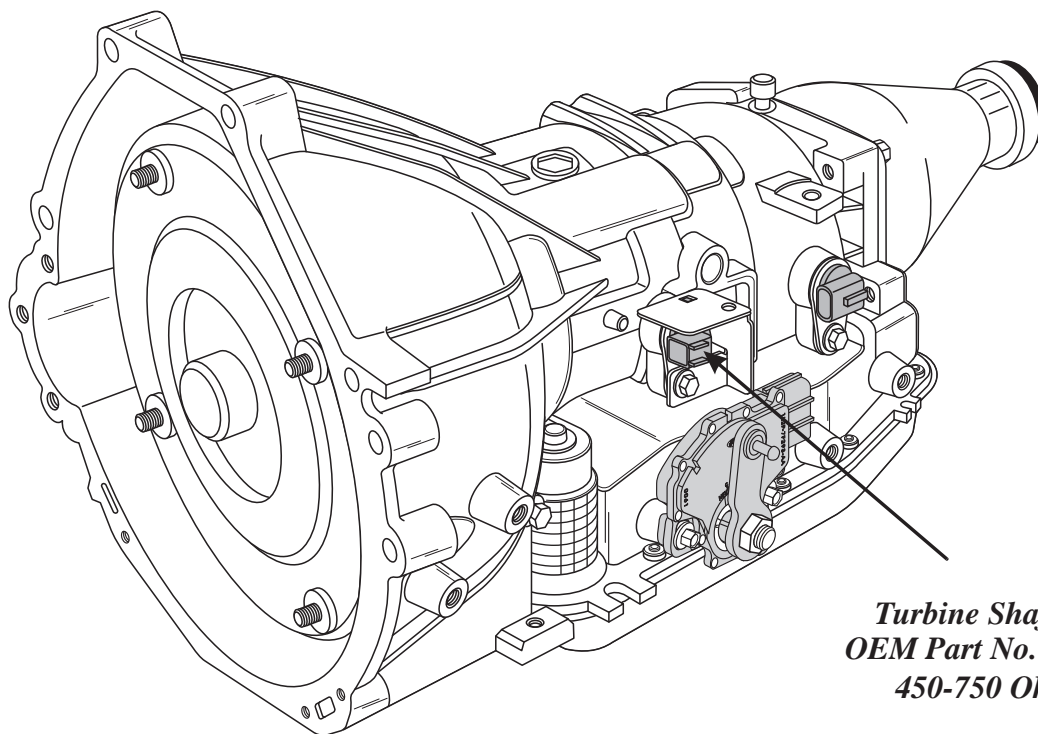
Figure 4

Turbine Shaft Speed Sensor
OEM Part No. 3L3Z-7M101-AA
450-750 Ohms Resistance

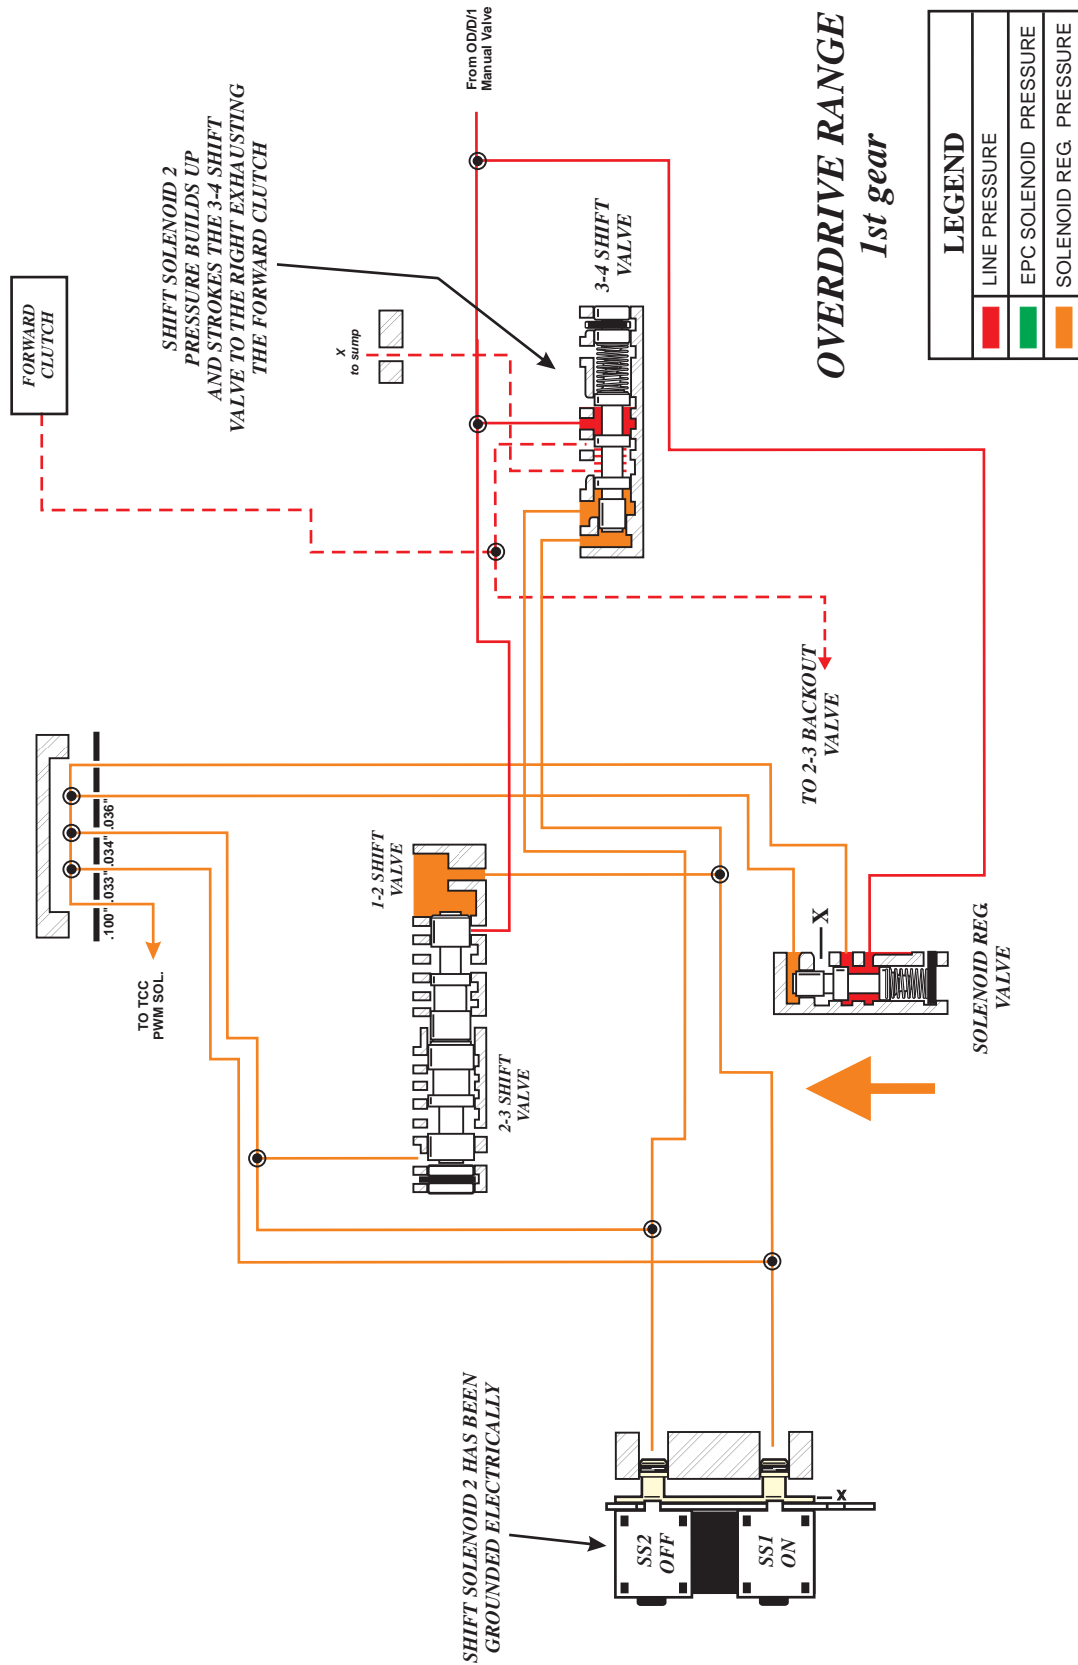
Figure 1
Automatic Transmission Service Group

- CAUSE:**
- (1) One cause for this condition may be that the PPL/ORG or VIO/ORG wire, which is model dependant that controls Shift Solenoid 2 may have rubbed on the rear of the engine, causing the circuit to become grounded. When this occurs with the transmission in first gear, Shift Solenoid 2 closes and fluid pressure acts to stroke the 3-4 Shift Valve to the right, causing the Forward Clutch oil to exhaust through the 3-4 Shift Valve, creating the neutral condition. (See Figure 1). Diagnostic Trouble Code P0755 may also be set.

- (1) Repair or replace the damaged Shift Solenoid 2 wire. Refer to Figures 7 and 8 to locate the proper year and model vehicle that you are working on. Wire Diagrams have been provided in Figures 9, 10, 11 and 12.
- (2) Locate the Solenoid Regulator Valve in the Valve Body. See Figures 3 and 4 To repair a sticking Solenoid Regulator Valve, it may become necessary to replace the valve assembly. There are replacement Solenoid Regulator Valve Kits available in the Aftermarket.
- (3) Replace the Shift Solenoid 1 and 2 assembly.

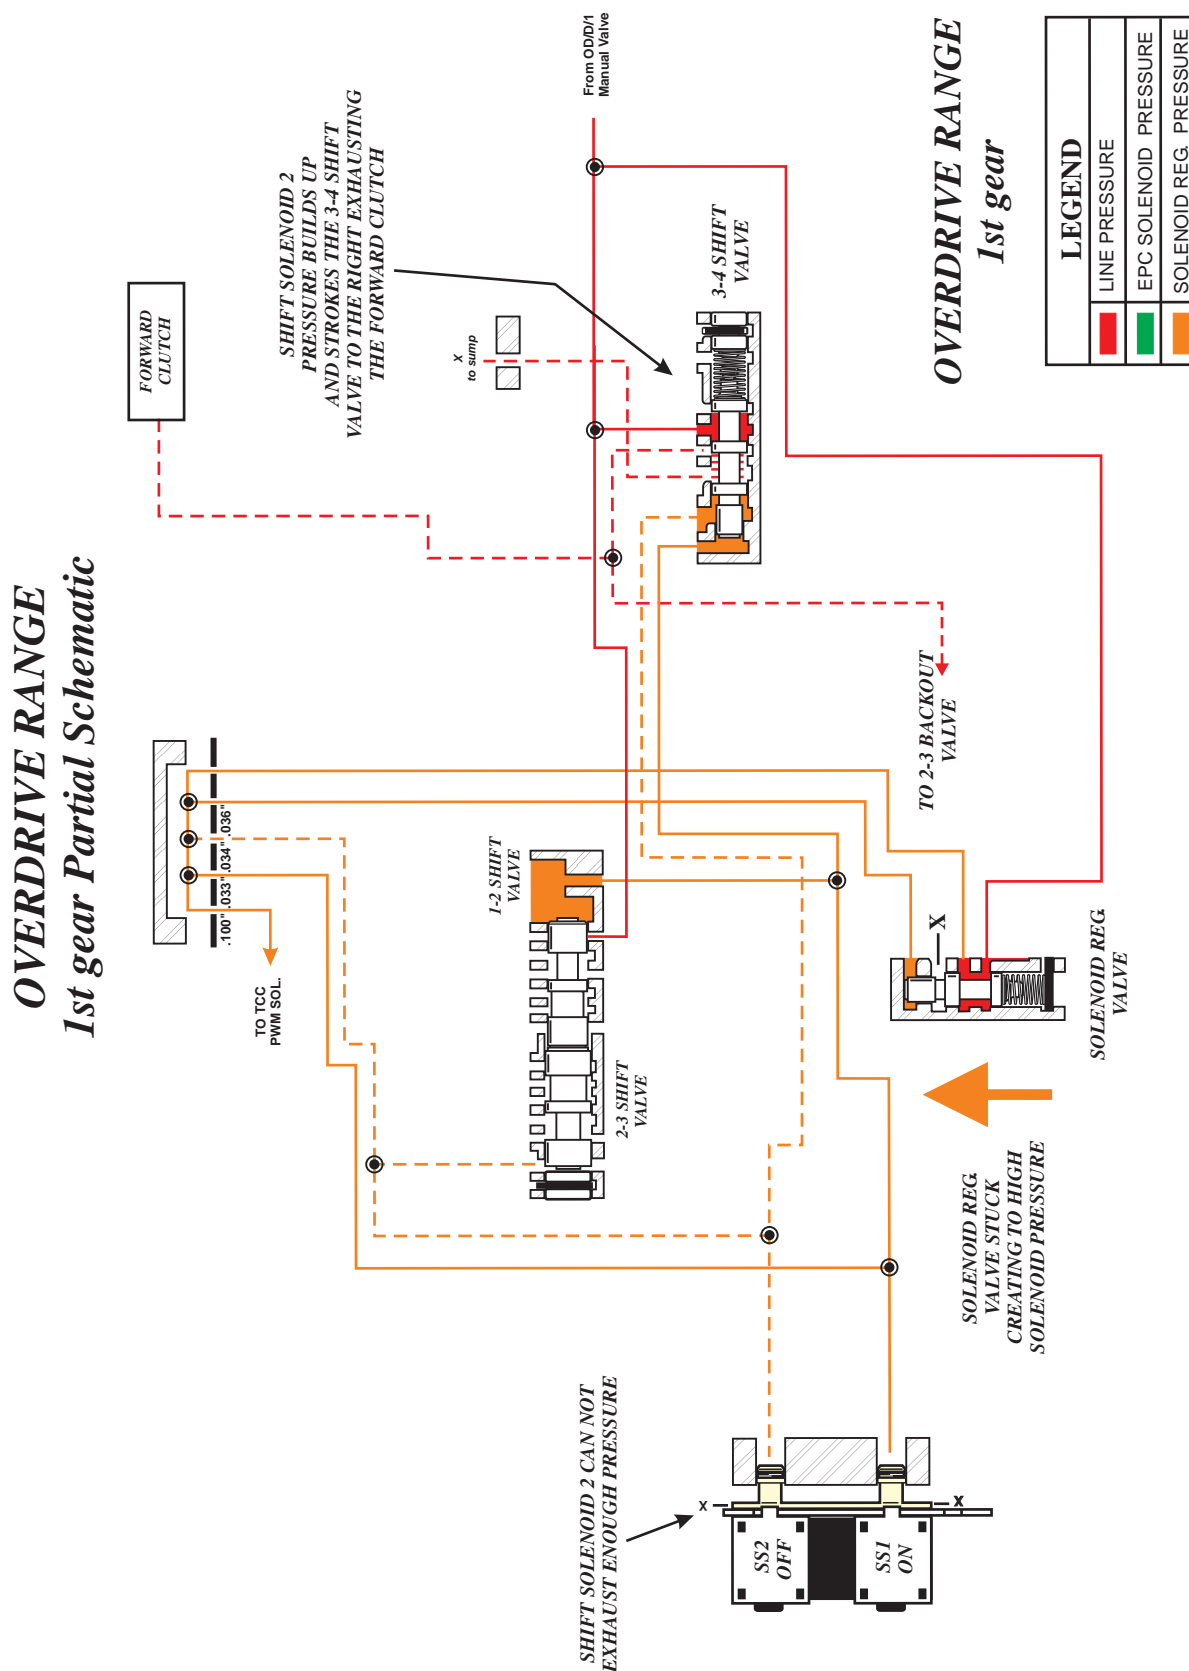
Figure 2
Automatic Transmission Service Group

- (3) Cause 3 is almost identical to Cause 2 with the exception being that Shift Solenoid is sticking closed or has debris built up at the Solenoid exhaust hole, which will allow Shift Solenoid 2 pressure to build up and strokes the 3-4 Shift Valve to move to the right exhausting the Forward Clutch, once again creating the neutral condition. (See Figure 2). No Diagnostic Trouble Codes will be set.

Summary: SSI is ON and SS2 can not exhaust the High Solenoid Reg. pressure, which in-turn strokes the 3-4 Shift Valve turning the Forward Clutch OFF.

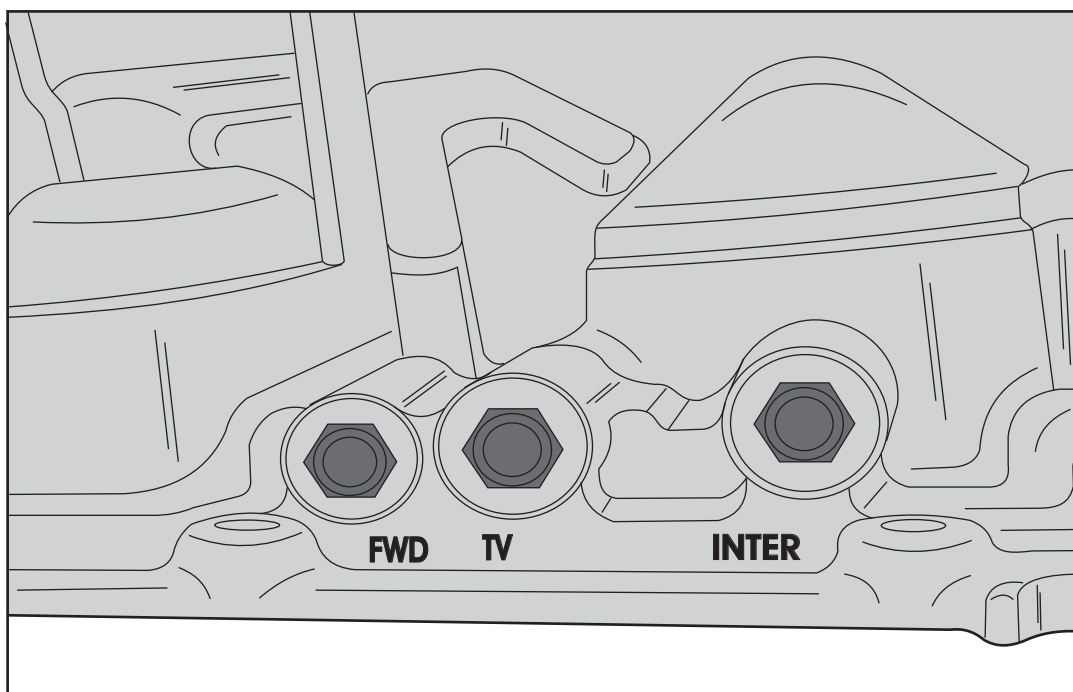
Figure 5

NOTE: When following proper diagnostic procedure for this problem, attach a pressure gauge to the Forward Clutch Pressure Port which is located on the right hand side of the transmission.(See Figure 5) Normally when the Forward Clutch is applied the pressure will be equal to the Main Line pressure. (See Figure 6) When the above causes take place, the pressure seen at the Forward Clutch will suddenly drop to Zero, and this is when the neutral condition will be felt.

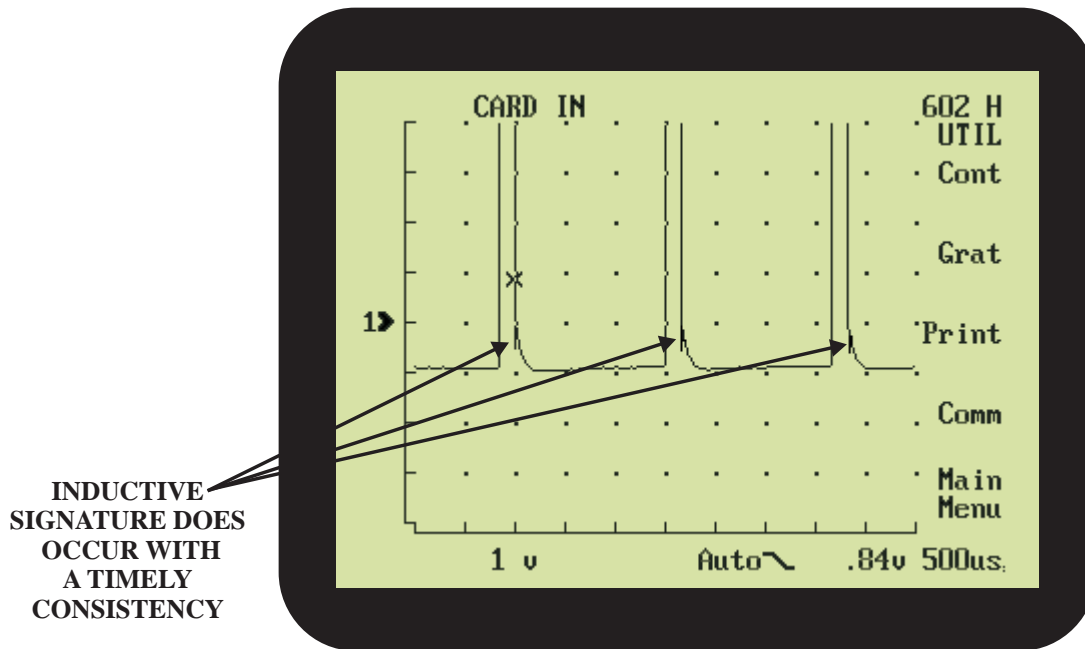
Figure 1

- (1) At the start of production for the 1997 model year Ford vehicles with the 4/5R44/55 series of transmissions were built with a PCM that would recognize a specifically timed signal from the EPC solenoid, this signal is known as "Inductive Signature".
The time that it takes current to flow through the solenoid coil and there is enough magnetic energy to make the armature begin to move, the magnetic field is momentarily disrupted, this causes a slight backward movement of current through the coil.
This creates a slight dip in the electrical pattern of the solenoid which is referred to as an "Inductive Spike".
The PCM is looking for this "Inductive Spike" to occur within a specific time frame from the time the solenoid was turned on by the PCM. ***This is how the PCM makes certain the solenoid is properly working as seen in Figure 1.***
Therefore, in order for this spike to occur at the same time, every time, the solenoid must be manufactured under tight specifications. This is the reason why a solenoid without inductive signature (Refer to Figure 2), should not be used in a vehicle that requires an inductive signature.

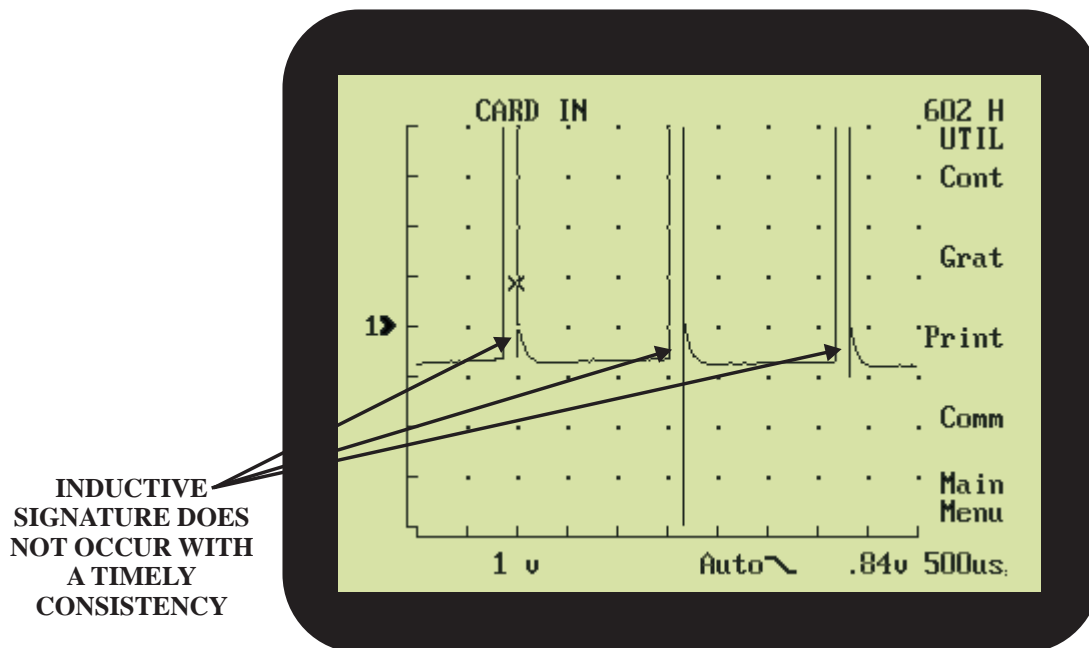
Figure 2

The PCM will not see an inductive signature occur when it is looking for it and could therefore store a FALSE EPC solenoid circuit code.
- (2) If system voltage is low, the EPC solenoid will not have enough current to move the armature quickly enough, therefore the PCM will not see the inductive signature occur at the correct time and once again a false EPC solenoid electrical fault code may be stored. It is necessary to verify the condition of the vehicle battery, battery cables, alternator output and power and grounds at the PCM. These items must be in proper working order.

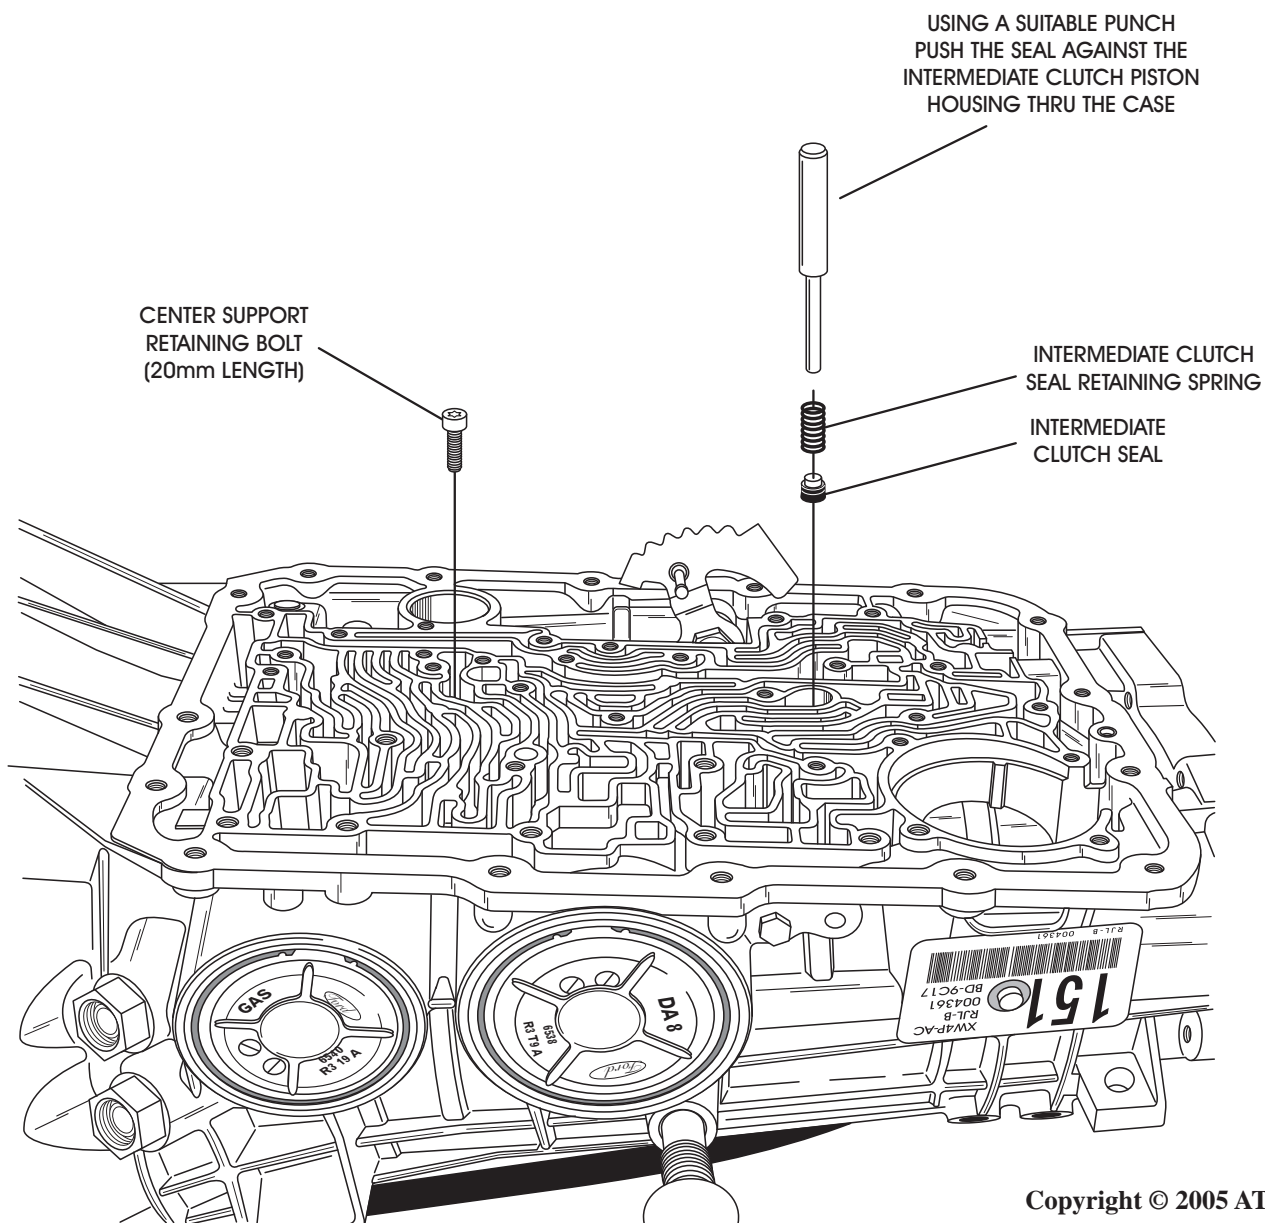
Figure 3

CAUSE: The cause may be the Intermediate Clutch Seal, as shown in Figure 1, was not installed deep enough into the case. When this happens Intermediate Clutch pressure is lost between the case and the Intermediate piston housing.

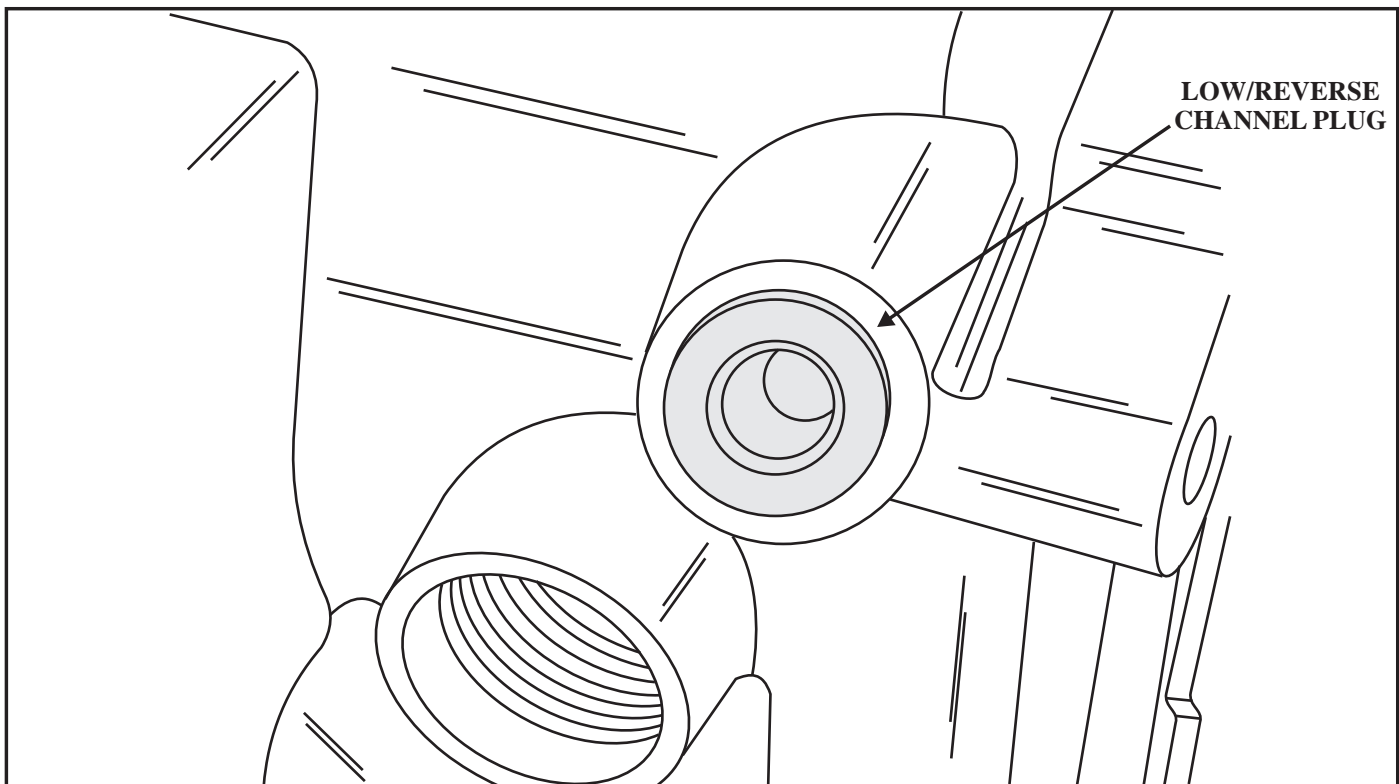
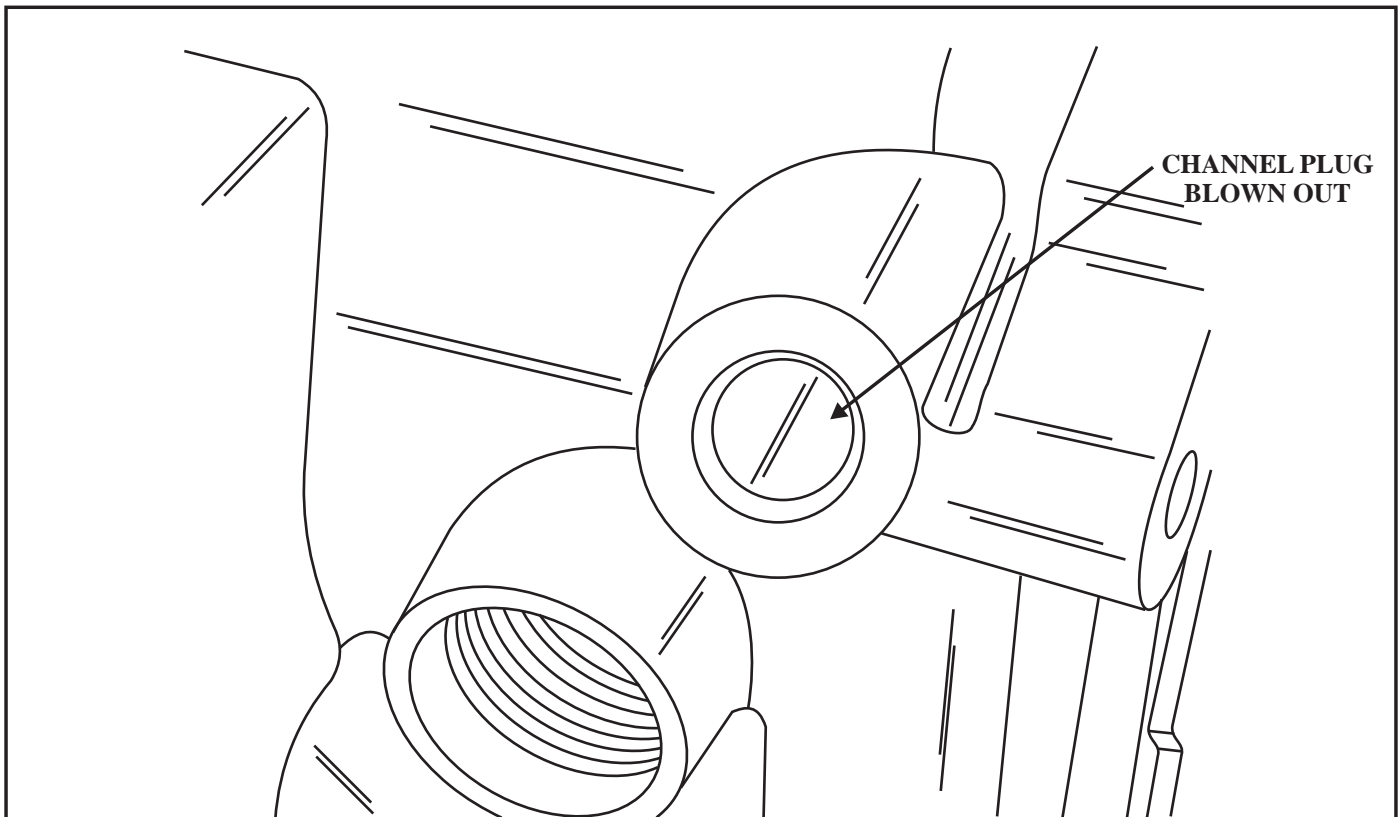
CAUSE: The press in plug that is located at the end of the factory drilled low/reverse clutch passage has blown out, (Refer to Figures 1 and 2).

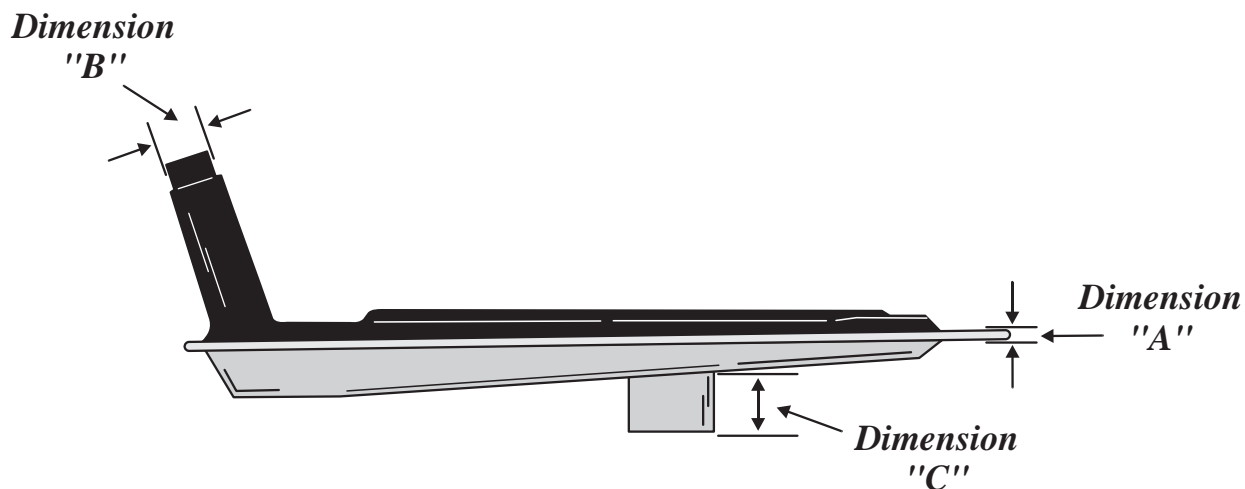
Figure 2

Dimension "A" = .180" This is the thickness of the tab that the retaining bolt clamps to the valve body.

Dimension "B" = .746" This is the diameter of the neck of the filter that fits into the seal in the pump.

NOTE: These dimensions are smaller on some aftermarket filters allowing the filter to fall out of the pump or cause pump cavitation and low pressure.

CORRECTION: Locate the Primary Oil Filter as shown in Figure 1. Remove it from the pump and verify the dimensions of the filter are the same as shown in Figure 2. Replace as necessary.

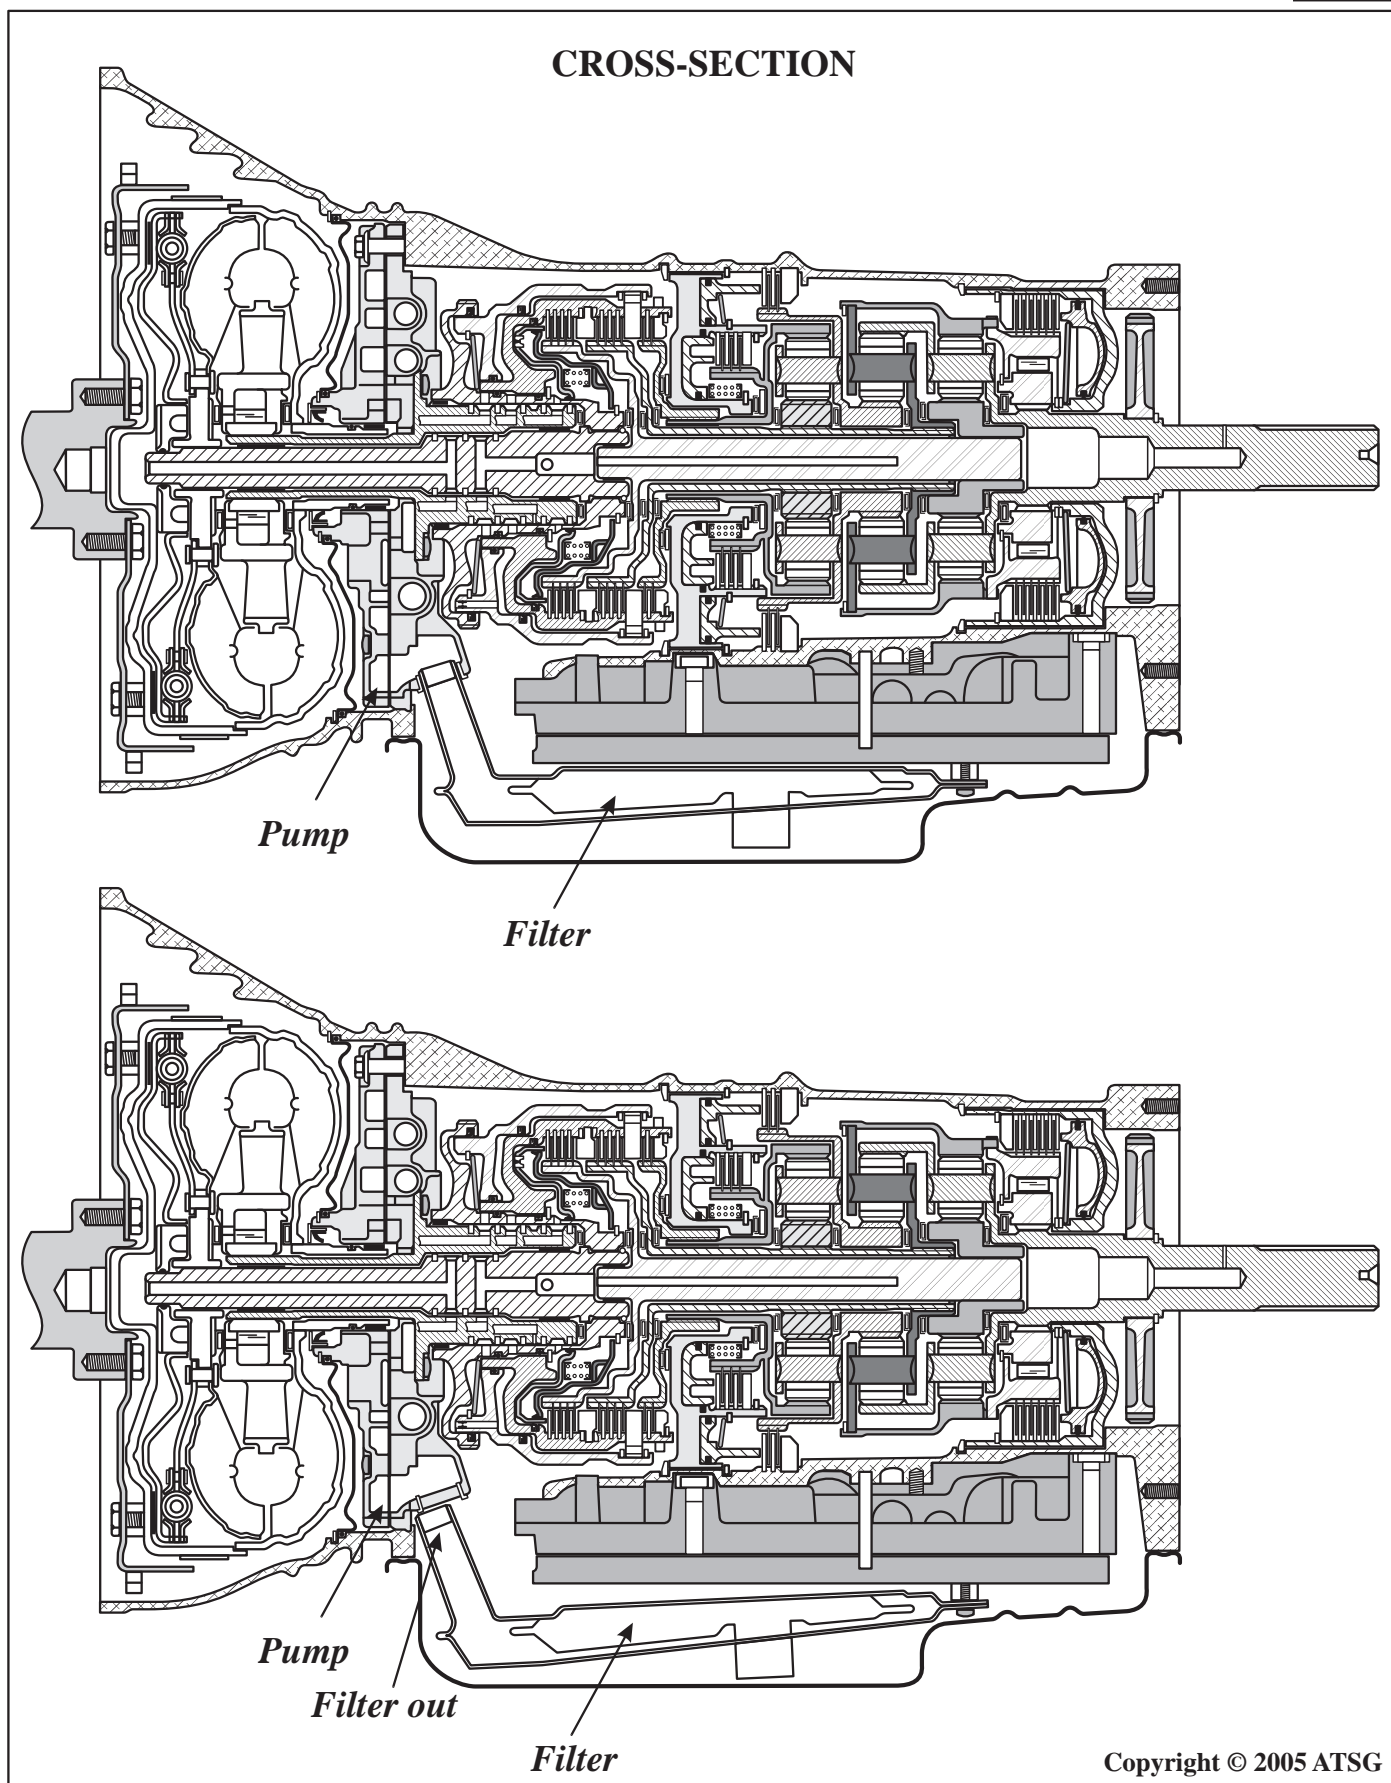
Figure 3

CAUSE: The cause may be, an aftermarket Primary Oil Filter was installed into the transmission and the neck of the filter is too narrow allowing the filter to fall out of the pump, causing fluid aeration and/or no pump suction, as shown in the cross-section located in Figure 3.
